Frank Mohn Services AS

No. 6 - 1991

# Service Bulletin

## Recondition of impellers & oversized wear-rings

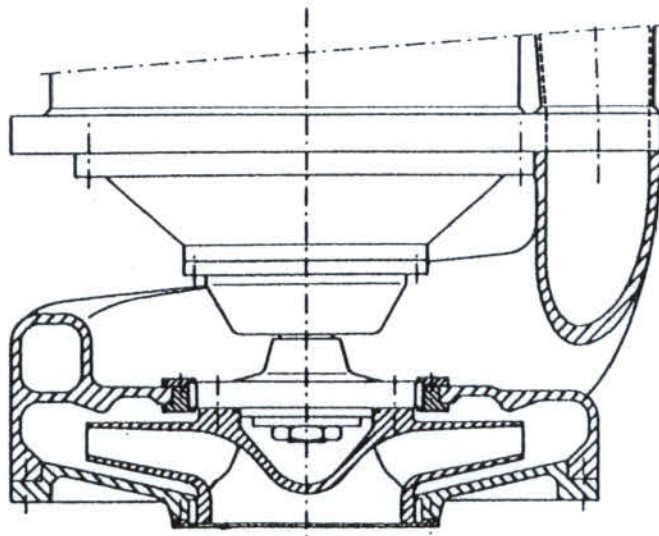
Step No. 1

Original size wear rings

Original size wear rings can normally be installed quite a few times before the wear on the impeller and impeller flange increases to an intolerable level.
