# Service Bulletin

## Recondition of components in FRAMO Cargo Pumping System

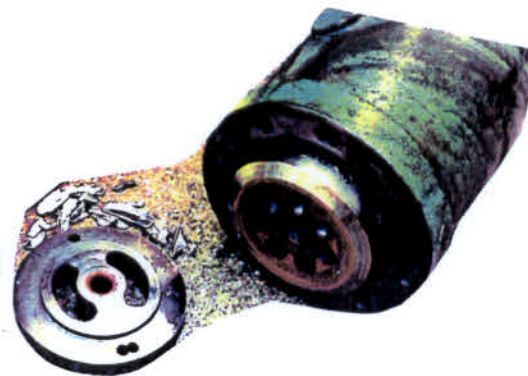
By bigger damages it may be necessary that the cylinder and distributor plate have to be lapped, the driveshaft and housing must by some occasions be built up and the pistons and the cylinder ports must be inspected for scratches and be reconditioned or renewed. Before re-assembling in the housing the building in tolerances of the rotating group must be measured and corrected within the recommended tolerance.

**Damaged hydr.  
pump parts.**

In such cases the cost of repair must be weighed against the price of a complete new pump.

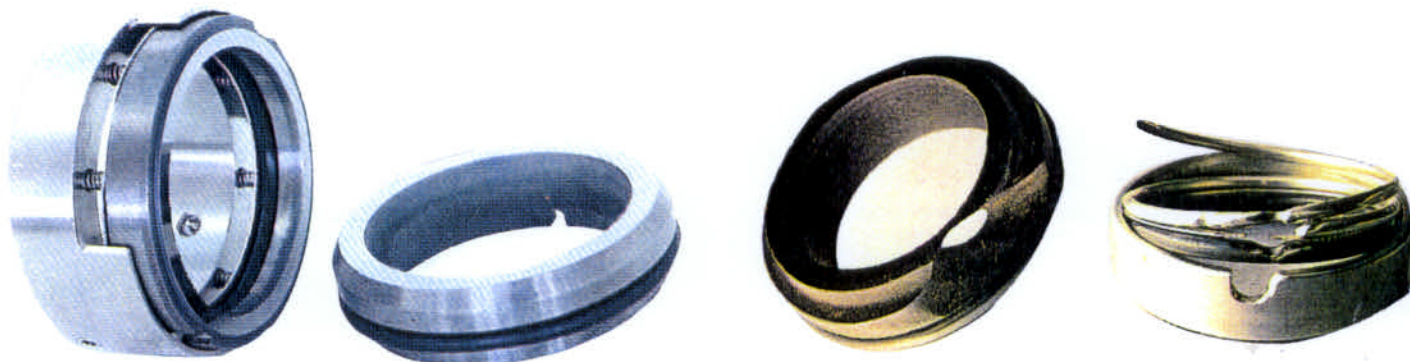
Reconditioned mech. seal inspected and checked before return to customer.

Damaged mech. seal

This fact is also taken into consideration during the reconditioning of the mechanical seals. The seals are carefully measured, stationary and rotary part are being lapped or exchanged, o-rings exchanged and measures and tolerances are checked before return to the customer.

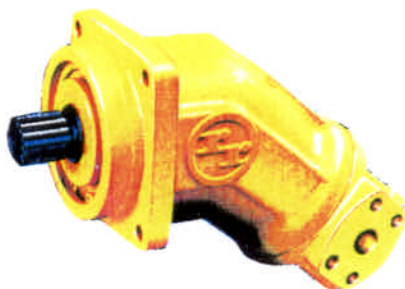
**Reconditioned  
hydr. powerpack  
pump for return  
after inspection**

We strongly advice that overhaul of these items are carried out in our workshop. This due to the very fine tolerances in these units.

If a deteriorating pump is stopped early enough (i.e. by use of magnetic chip detectors) it is usually sufficient to renew bearings and seals and cap sealface. This is a rather low-cost repair.
