# Service Bulletin

## UPGRADED FRAMO STRIPPING / PURGING VALVE

**Upgraded stripping/purging valves  
drg.no.264-363-2 & 293-514-2**

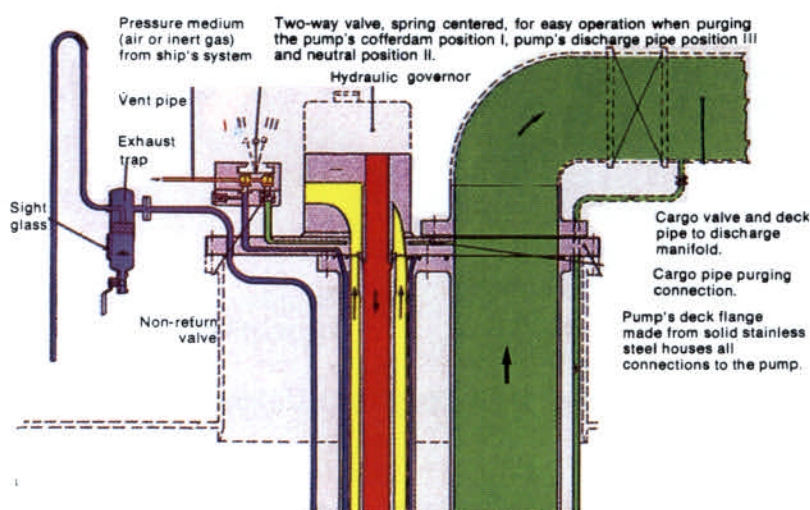
- Cargopump with the old design stripping/purging valve

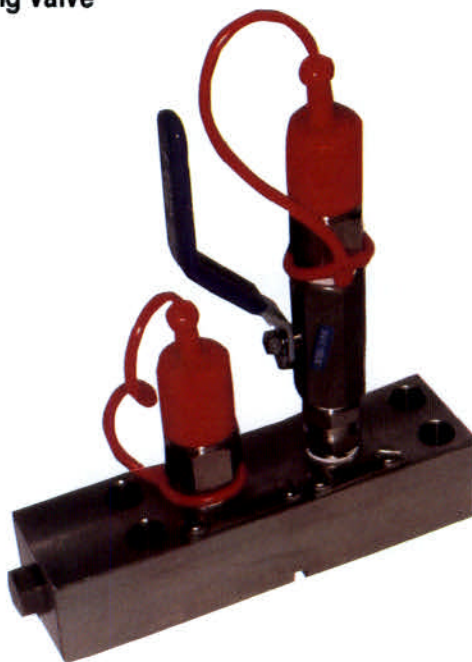
-New design

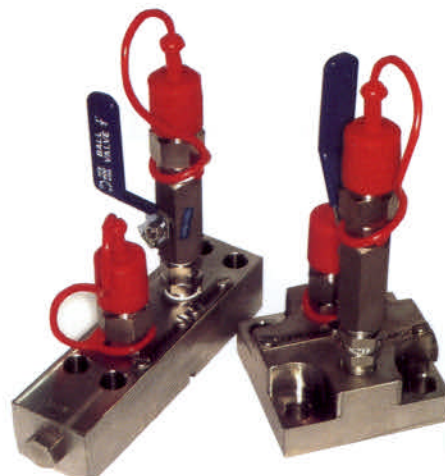
On older FRAMO cargo pumps there is a combined purging and stripping valve. On newer pumps we have supplied two completely separate valves.

We have now also developed a modified valve, with complete segregation between cargo and cofferdam, which can be installed on older pumps, where the combined valve originally is used.

We are pleased to present the new upgraded FRAMO stripping and purging valves for the FRAMO cargo pump, our drg. no. 264-363-2 and 293-514-2. This modification is carried out according to the latest FRAMO design on new hydr. systems and class requirements. The drg. no. 264-363-2 replaces old design valve drg. no. 264-117-2 and drg. no. 293-514-2 replaces old design valve drg. no. 269-436-2.

- easy operation
- the new design is almost maintenance free, due to less o-rings and seals.
- Full segregation between cargo and cofferdam. (Class requirements):
- favourable price !  
(Please contact our spares dept. for a price offer).
- fully interchangeable with the old design.

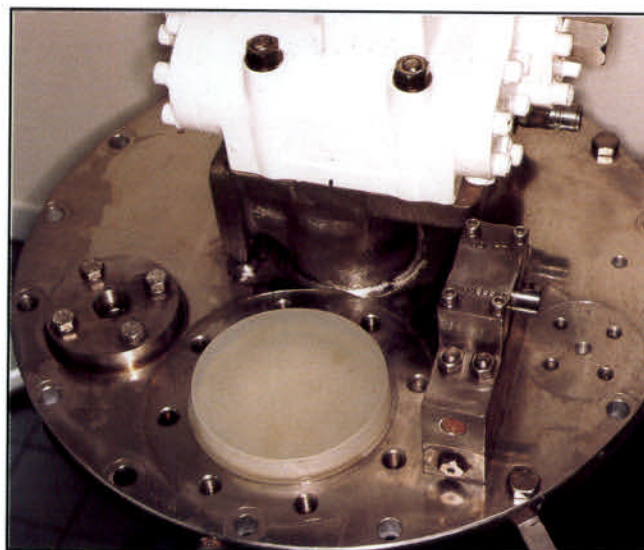
**Old design stripping/purging valve fitted on topcover plate.**

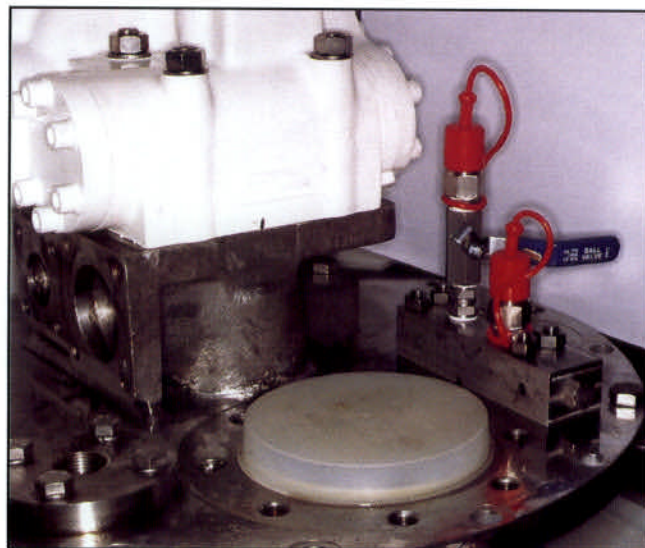
**Upgraded stripping/purging valve fitted on topcover plate.**
