# **Hangar 9 Solo Trainer Aircraft Structure Restoration**

**Master's in Aerospace Engineering  
Projeto Aeroespacial**

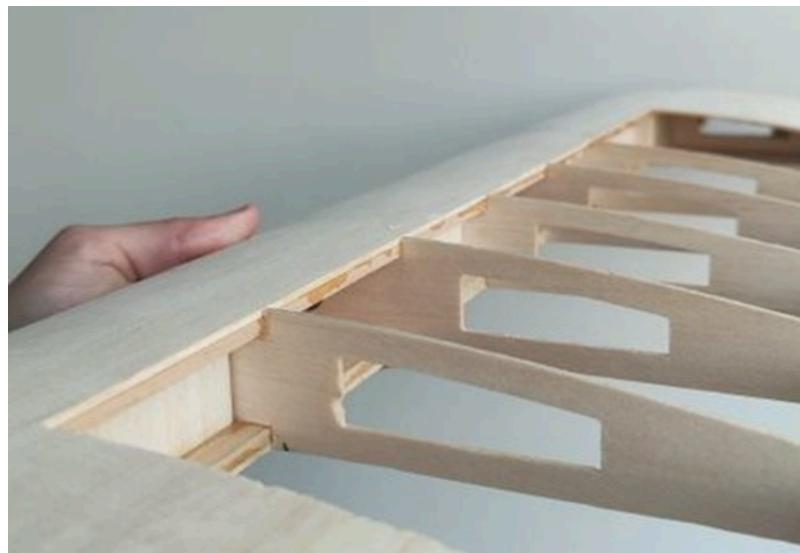
**Figure 4** - Wing after ribs replacement.

Finally, after a rest time to ensure that the glue had already dried, the attachment regions were carefully sanded to remove any glue excess.

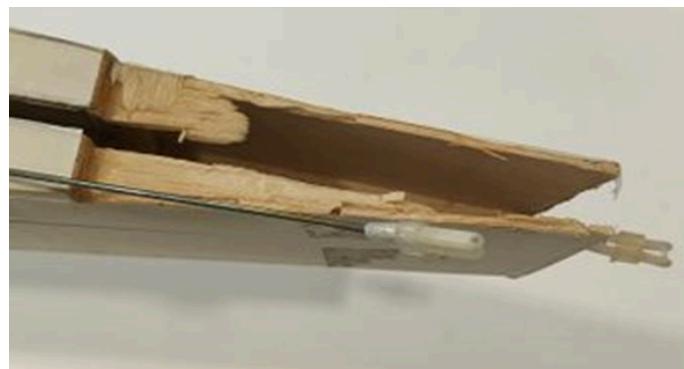
The fuselage's back region was severely damaged, as can be observed in Figure 6, where a top cover was missing.

**Figure 6** - Fuselage's back region severely damaged.

To repair the damage, the first step was to remove the remaining parts of the previously existing cover and properly sand the region to remove residues and smooth the surface. Afterward, measurements were made to define the design of the top cover to be made, which was drawn on a wood balsa board whose thickness was 5 mm. The cover was cut from the board using a bistoury and sanded to fit the opening.

Additionally, three holes to allow screwing will be made manually using a drill, and a keyway to allow the vertical stabilizer assembly was cut using the bistoury.

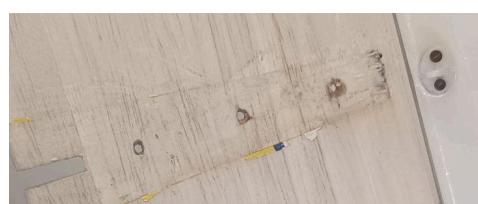
Along with the placement of the top cover at the fuselage's back region, the horizontal stabilizer was also repaired. As can be seen in figure 8, the screw holes that attached it to the fuselage were wide and did not guarantee good cohesion between parts.

**Figure 8** - Screw holes before intervention.

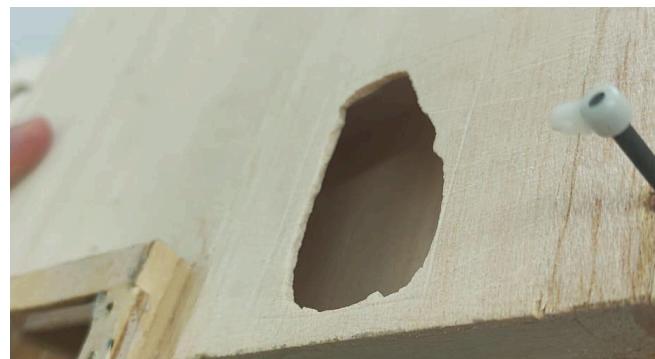
Among the repairs identified, an accident occurred with the left wing: localized excess pressure caused a hole measuring around 3x4 cm area, visible in figure 10.

**Figure 10 -** Left wing hole.
