Projeto Aeroespacial

Apresentação intermédia

Grupo de Estruturas

UAV Repair

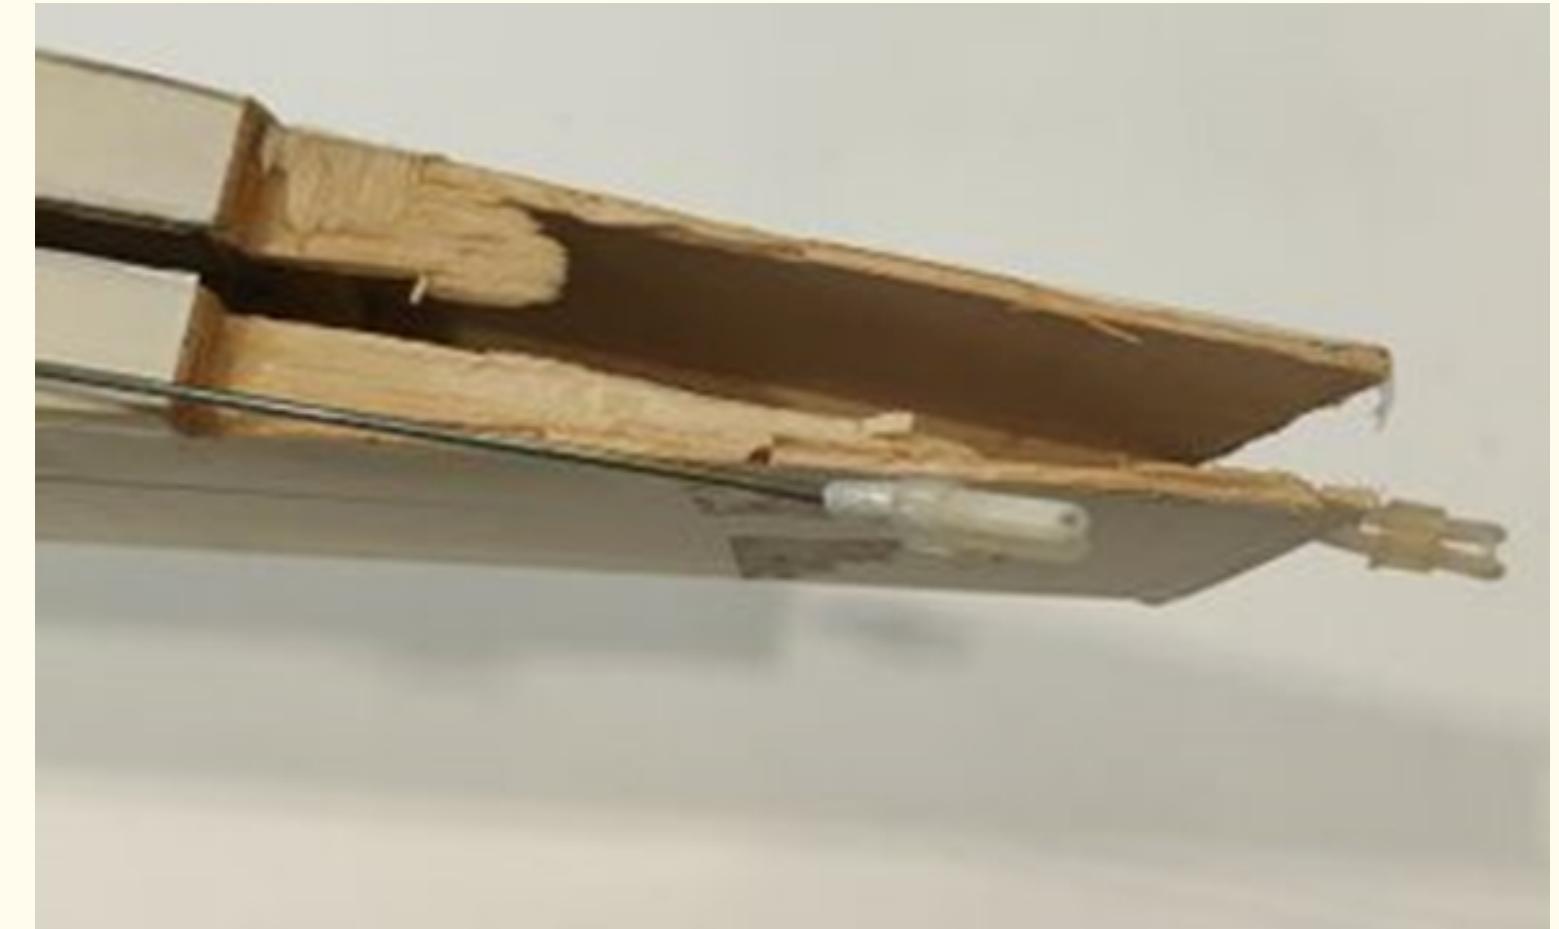
Fuselage's back region severely damaged.

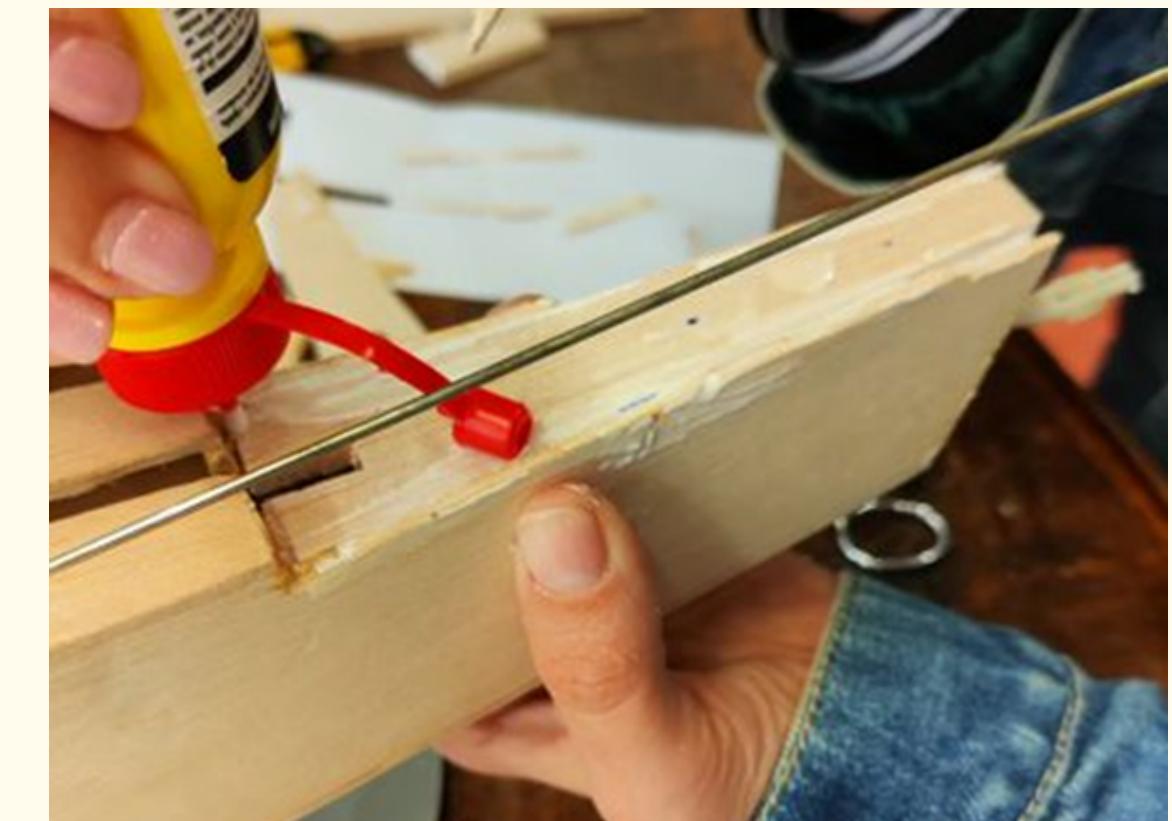
Placement of the top cover at the fuselage's back region

- **2nd step:** define the design of the **top cover** to be made, which was drawn on a wood balsa board whose thickness was **XX** mm.
- **3rd step:** make **three holes** using a drill and a **keyway** to allow the **vertical stabilizer assembly**.
- **4th step:** place the **cover** at the fuselage's back region and **attach** it using **wood glue**.

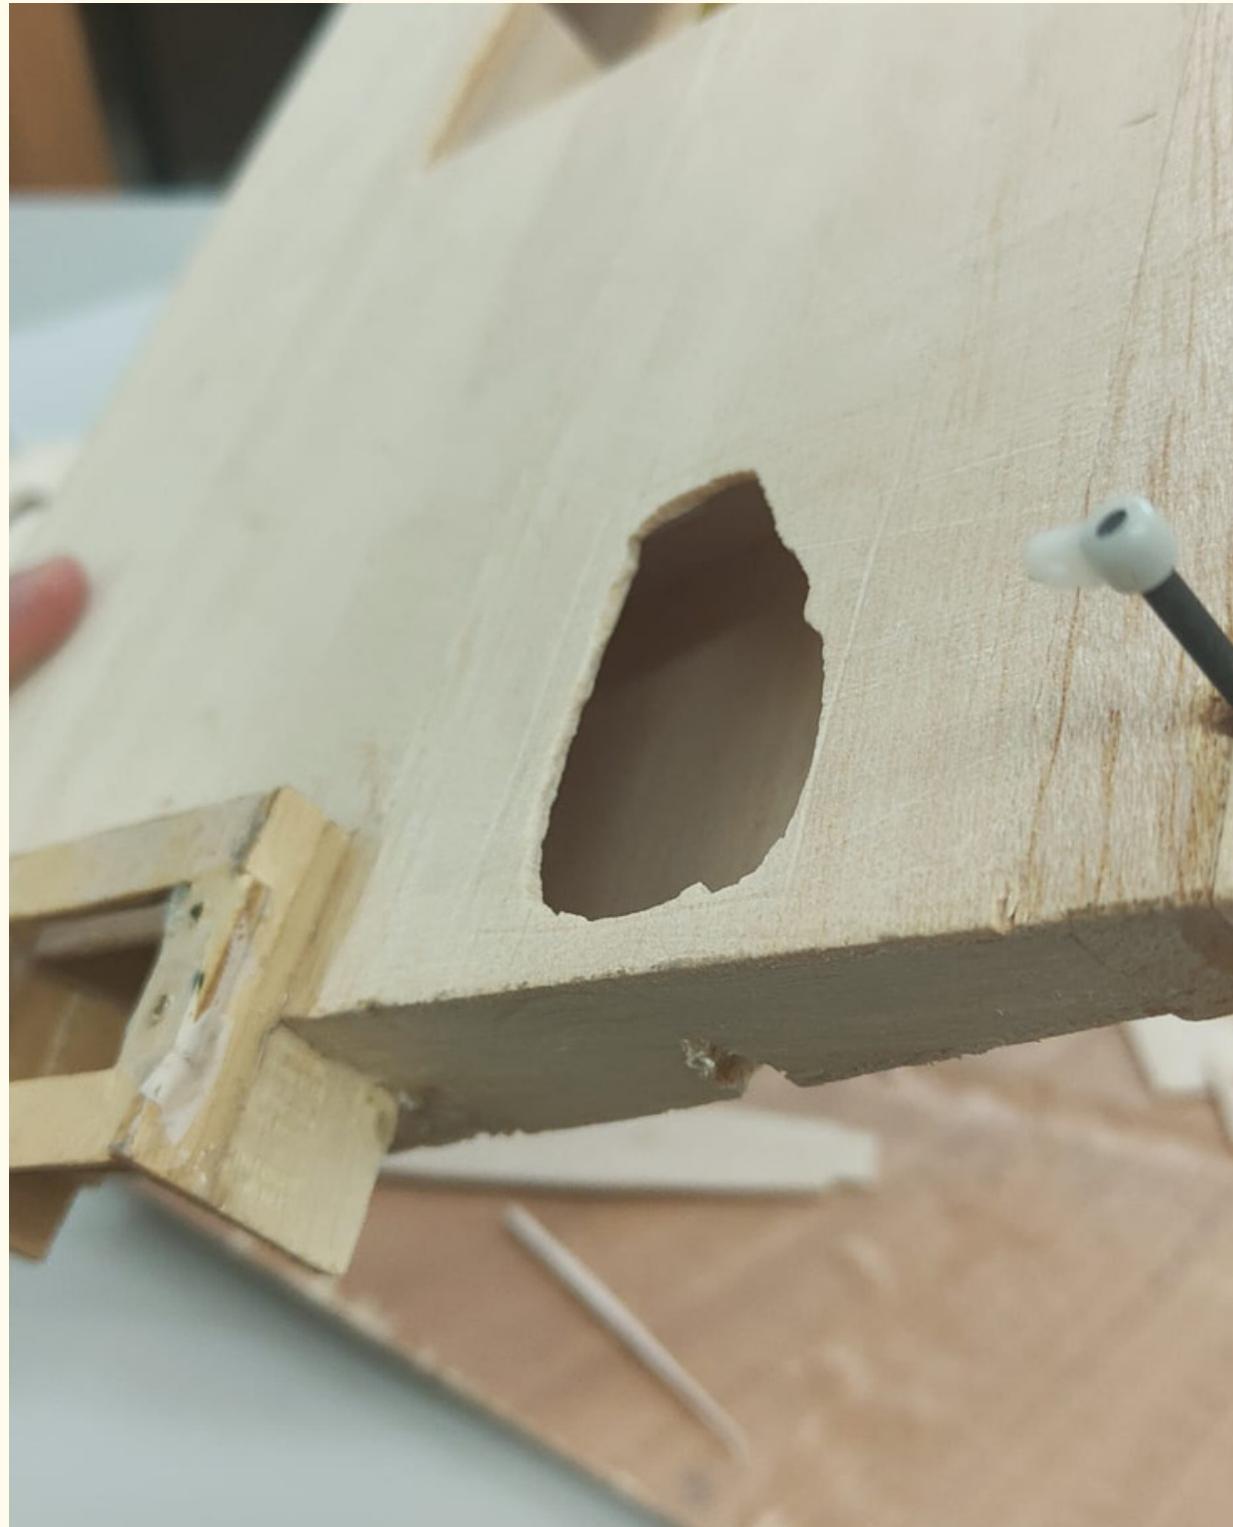
An accident occurred with the left wing: localized **excess pressure** caused a hole measuring around 3x4 cm area.

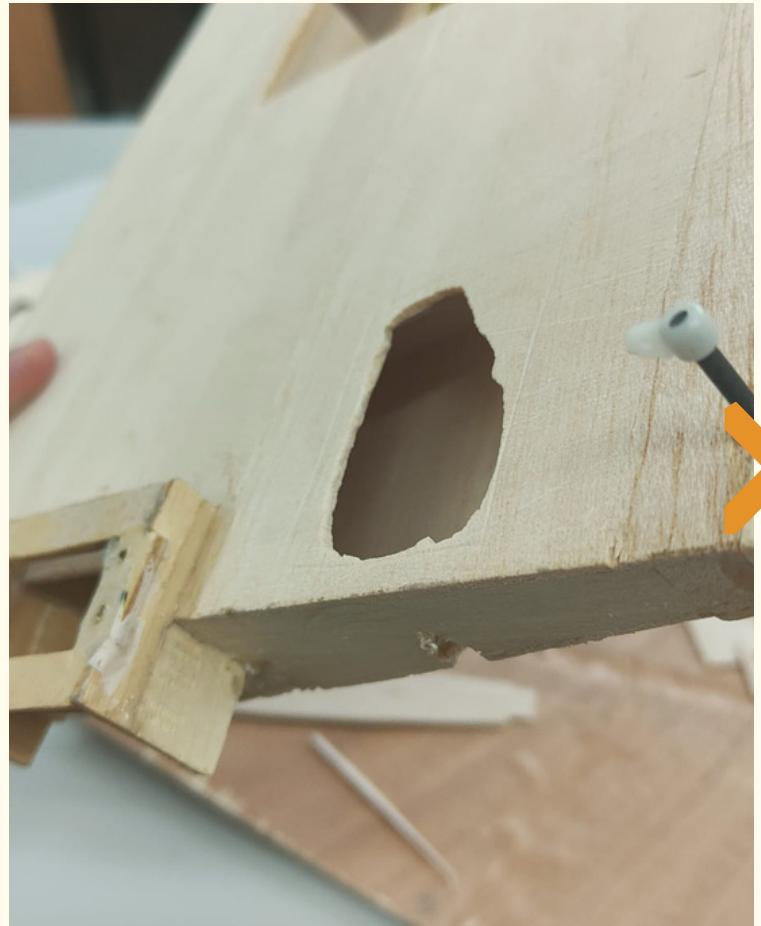
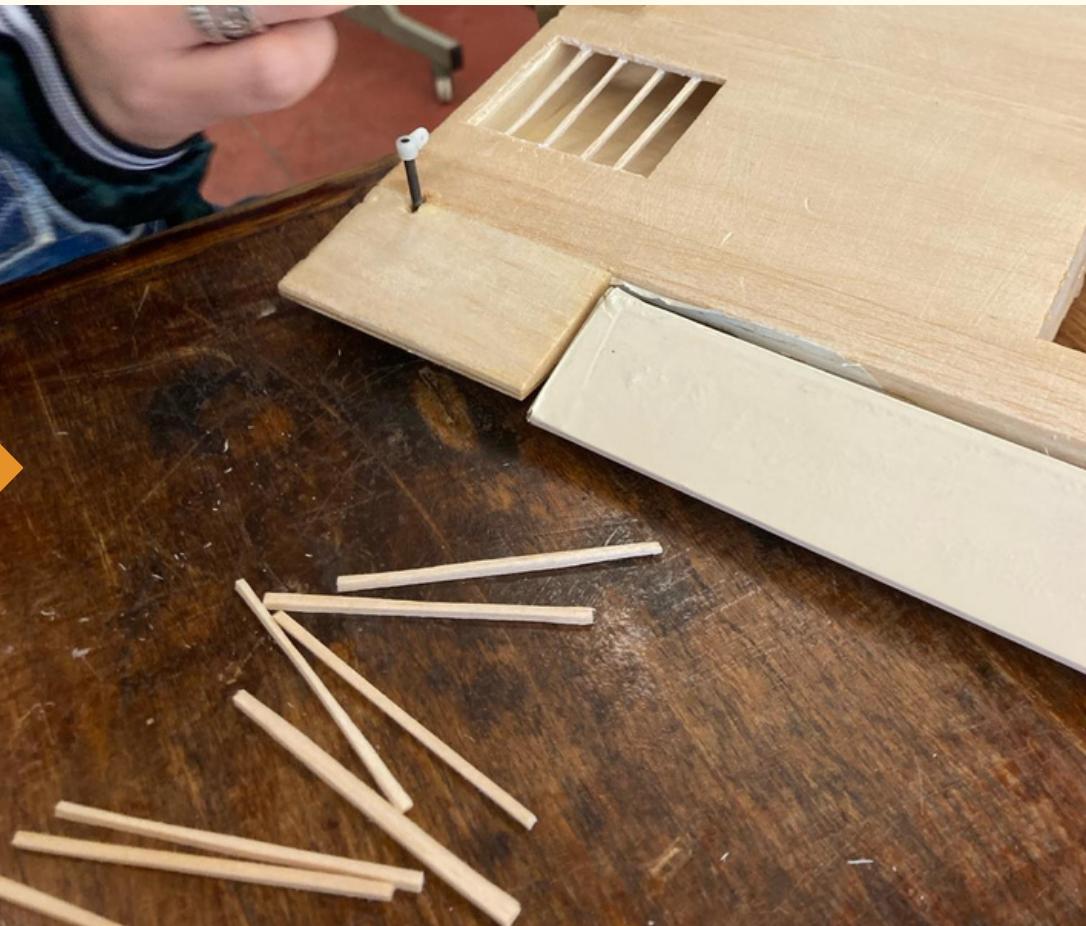
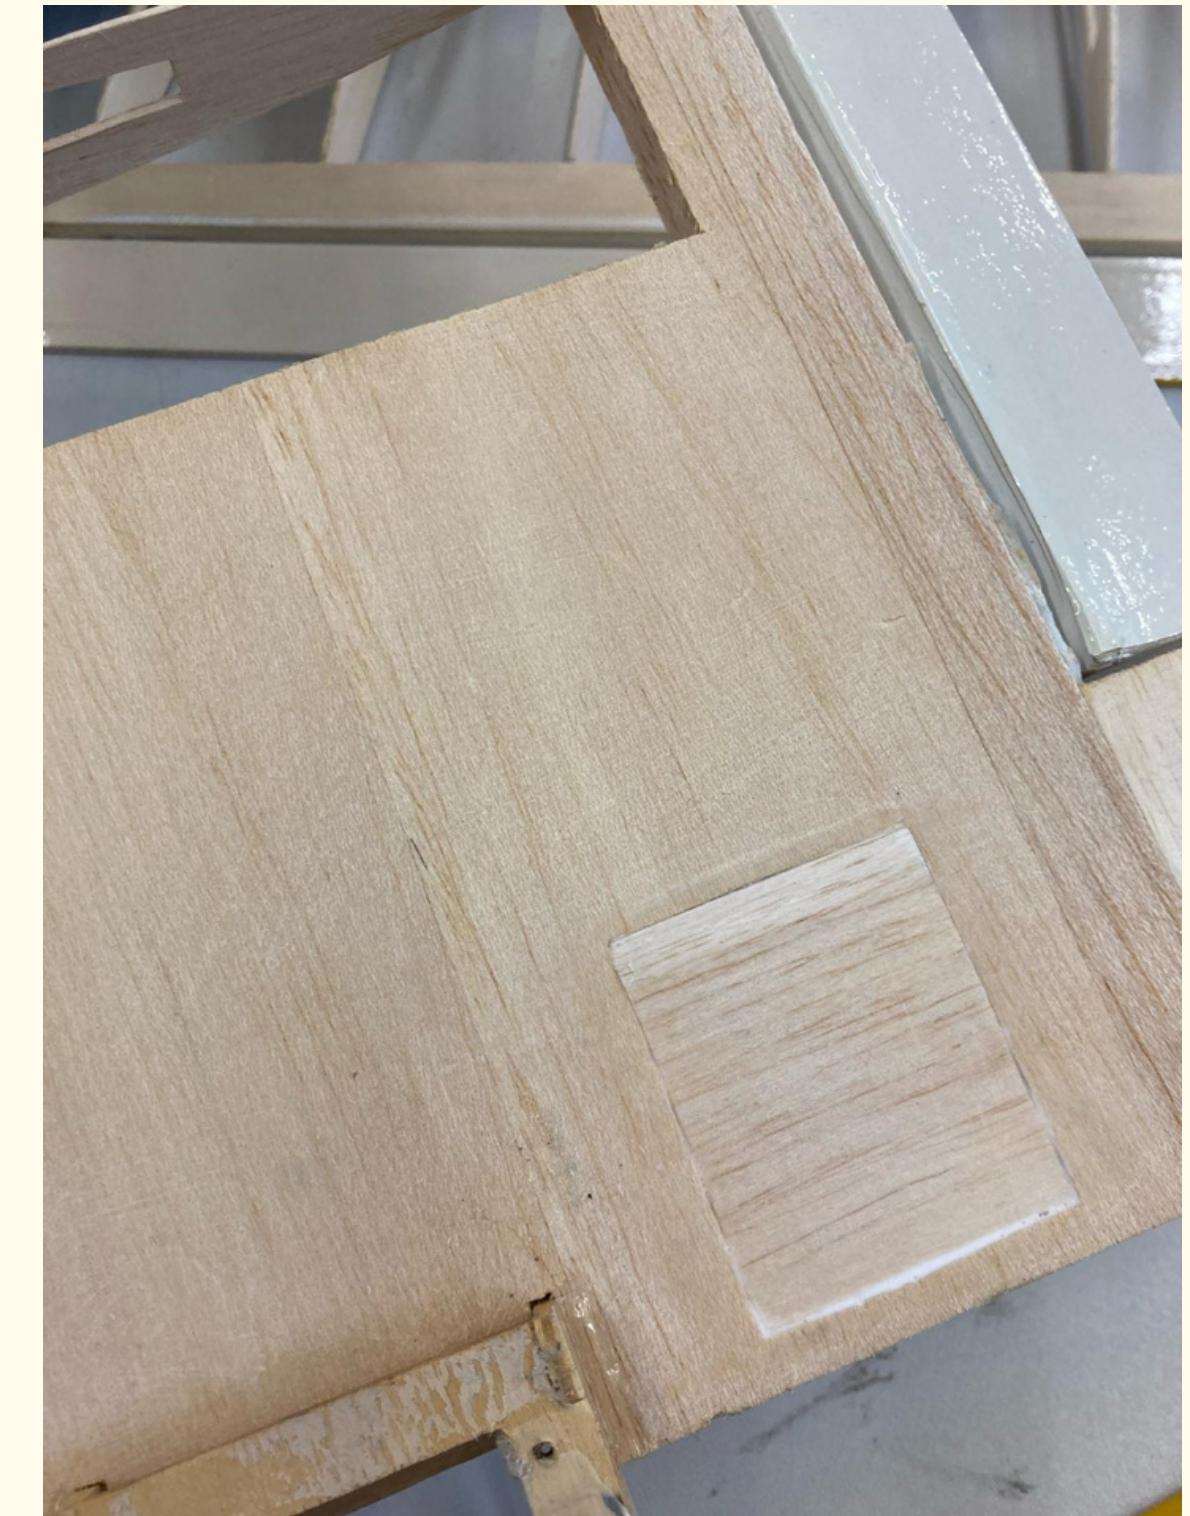
The final result exceeded expectations, as the area appears to be reinforced !!

The square was filled with a piece of balsa, which edges were completed with wood glue.
