University of Minho
School of Engineering

Hangar 9 Solo Trainer Aircraft Structure Restoration

**Master's in Aerospace Engineering
Projeto Aeroespacial**

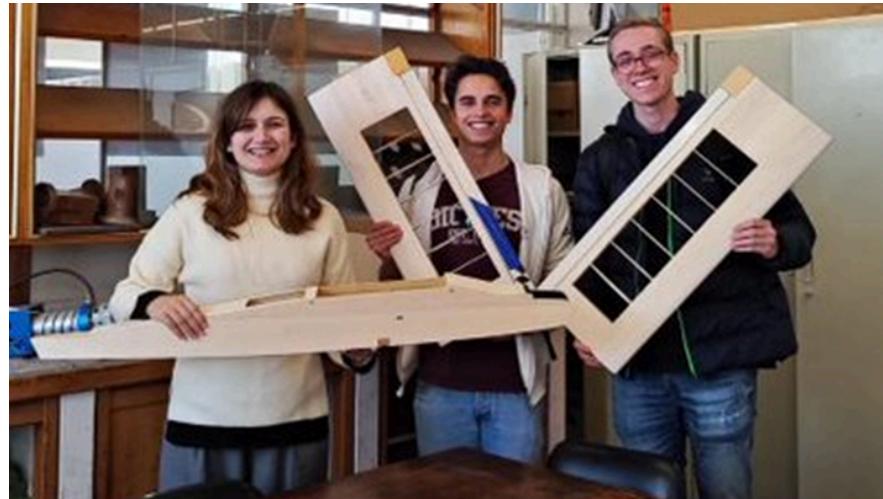
Figure 2 - UAV after cover removal.

After removing the cover (see Figure 2), the whole structure was sanded to remove the glue residues to create a clean and smooth surface suitable for the application of the new cover chosen - Oracover®.

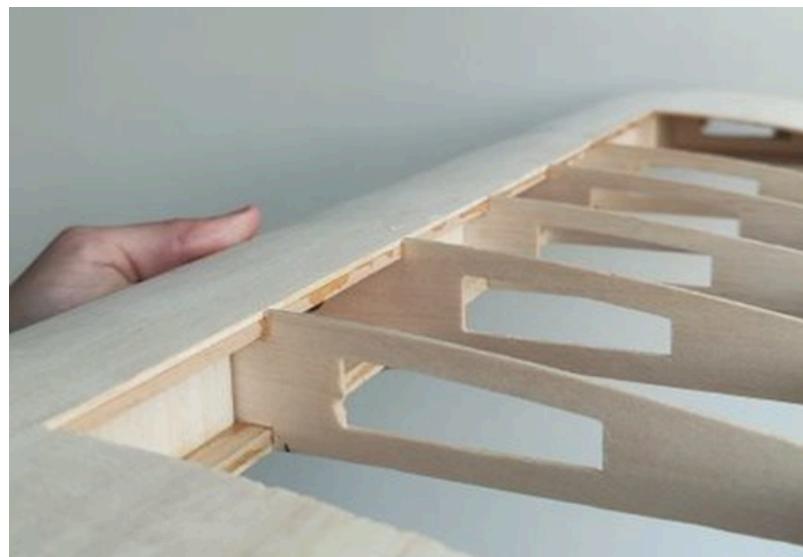
Figure 4 - Wing after ribs replacement.

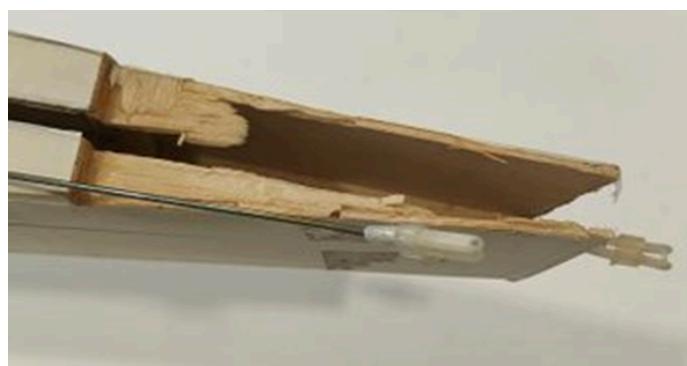
The fuselage's back region was severely damaged, as can be observed in Figure 6, where a top cover was missing.

Figure 6 - Fuselage's back region severely damaged.

To repair the damage, the first step was to remove the remaining parts of the previously existing cover and properly sand the region to remove residues and smooth the surface. Afterward, measurements were made to define the design of the top cover to be made, which was drawn on a wood balsa board whose thickness was 5 mm. The cover was cut from the board using a bistoury and sanded to fit the opening.

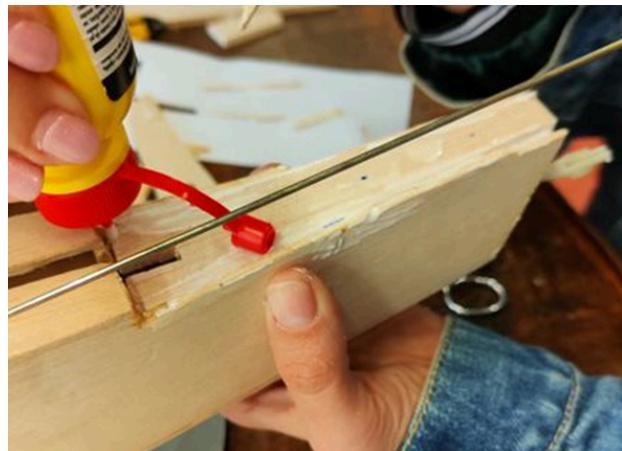
Figure 7 - Placement of the top cover at the fuselage's back region.

Additionally, three holes to allow screwing will be made manually using a drill, and a keyway to allow the vertical stabilizer assembly was cut using the bistoury.

The cover was then placed at the fuselage's back region and glued using wood glue, as presented in Figure 7.

After completely drying, the whole region was carefully sanded to remove the glue residues, granting a smooth surface.

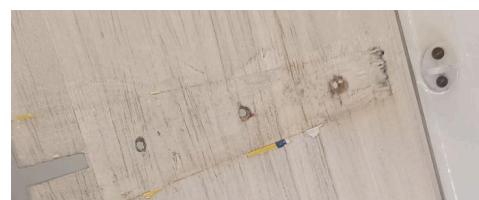
Along with the placement of the top cover at the fuselage's back region, the horizontal stabilizer was also repaired. As can be seen in figure 8, the screw holes that attached it to the fuselage were wide and did not guarantee good cohesion between parts.

Figure 8 - Screw holes before intervention.

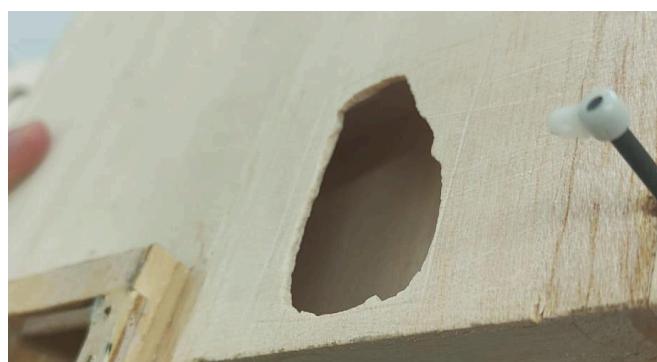
Among the repairs identified, an accident occurred with the left wing: localized excess pressure caused a hole measuring around 3x4 cm area, visible in figure 10.

**Figure 10** - Left wing hole.

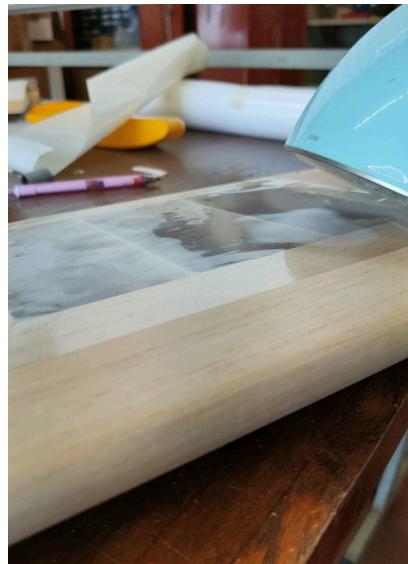
Initially, two Oracover - transparent and white - were intended to be applied: the first in the open region of the wings, so the ribs geometry and avionics connection elements could be observed, and the latter in the remaining areas. However, during the application, it was observed that the transparent Oracover was not able to be glued to the balsa, detaching from the surface as the heat source was removed. Such attempt is shown in Figure 12.

Figure 12 - Transparent Oracover application attempt.

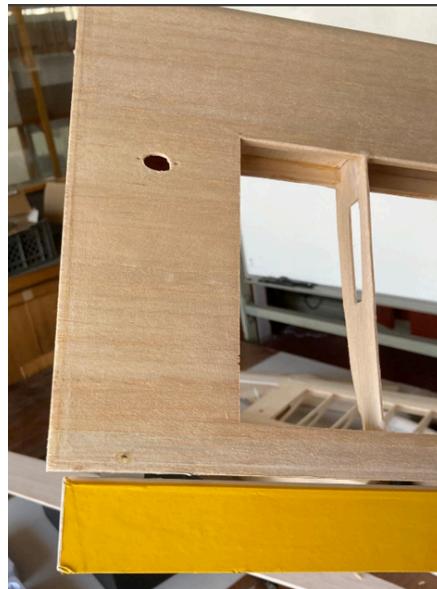
Figure 14 - Hole made in the wings to allow the LED connection.

One hole in each wing was needed to accommodate an LED, which was made using a cutter (see Figure 13a) in both the balsa wood and the Oracover, as shown in Figure 14.

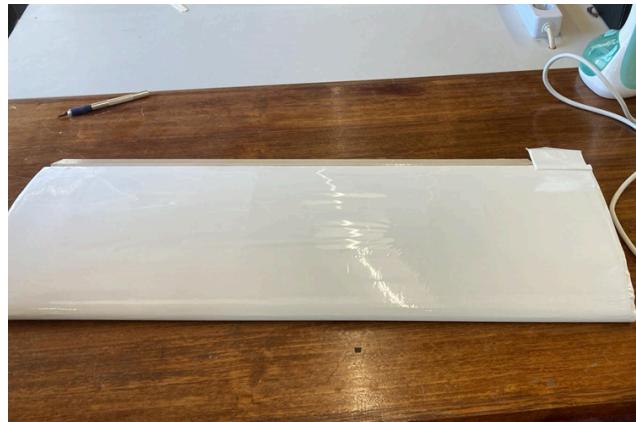
Figure 15 - Wing covered with Oracover.

Due to some details, namely coupling elements that allow the assembly of the UAV, some cutouts had to be done to enable the full coverage of the wings. The final result is presented in Figure 15.
