# Electrical Submersible pumps (ESP) Failure mechanisms

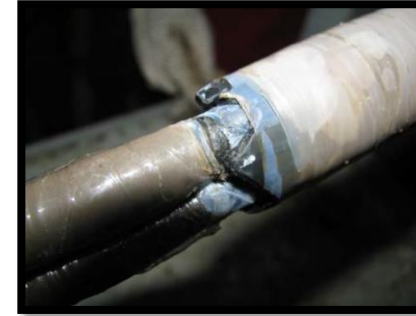
Insulation at cable ends found subjected to scratches/ minor cutting.

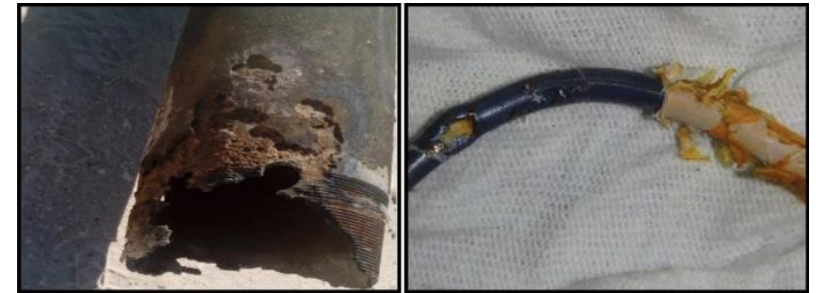
Metallic Thread Failure and Electric Cable and Insulation Degradation Corrosion

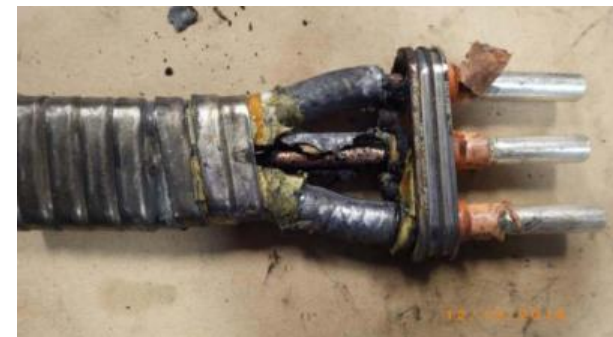
Pothead failure due to common mode current at a reflection point

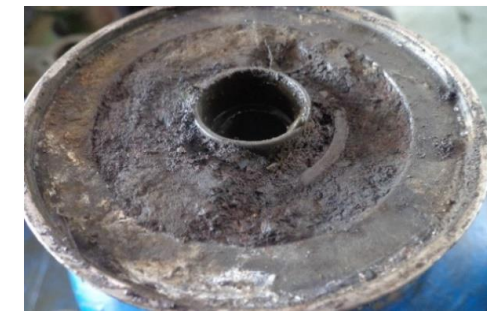
Scale deposition on pump stage shows that it is dominated by Calcium Carbonates
