**SPE-199091-MS**

## **Electric Submersible Pump Troubleshooting Guide, an Effective Way to Improve System Performance and Reduce Avoidable System Failures**

Walter Nunez and Jessica Del Pino, OXY – Occidental de Colombia; Sebastian Gomez, Douglas Rosales, Juan Puentes, and Hamilton Rivera, Baker Hughes

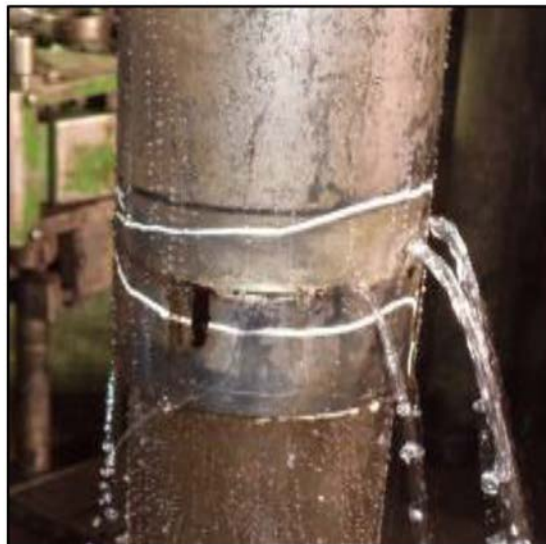
It occurs as a result of holes at some point in the production pipe, corrosion, *"jetting"*, severe wear on the gaskets of the production pipe or in applications with *"Y-tool"* due to dismantling of *"the blanking plug"*. The parameters generally behave as follows:

Figure 2 shows the evidence after the extraction of the Bottomhole equipment.

Figure 2—Evidence of extraction of Bottomhole equipment with drilling. Source Baker Hughes.

**Possible solutions:** Once this condition arises, it is necessary to perform the well intervention to make a pump change (*Well Service - WS*). To avoid recurrence, a strategy for the review and inspection of pipe quality, "*blanking Plu*"g settlement tests, a strategy for corrosion management and avoiding prolonged pipe reuse.

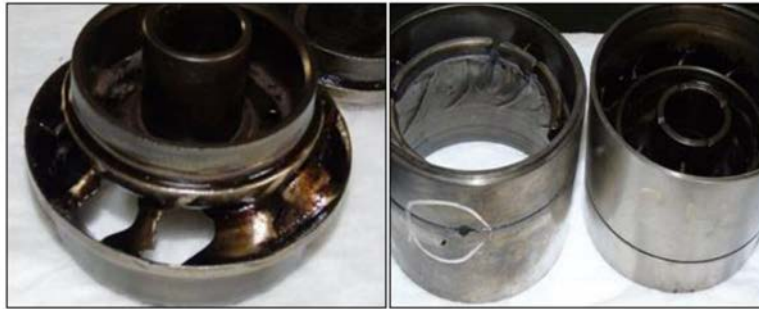
It is presented as a consequence of wear associated with the useful life of the equipment, by deposit of scales, asphaltens, paraffins or by wear of the stages associated with sand production. The parameters generally behave as follows:

Figure 4, shows the evidence found during disassembly of the bottomhole equipment, where severe erosive wear and / or loss of material can be seen. This condition generates accelerated loss of efficiency in the pump triggering a drop in the production rate.

**Figure 4—Evidence found during disassembly of the Bottomhole equipment, where severe erosive wear, loss of material can be seen. Source Baker Hughes.**

It is advisable not to operate the equipment with frequencies greater than 60 Hz in wells with high sand content.

**Possible solutions:** Once this condition arises it is necessary to perform the well service intervention. To avoid recurrence, a strategy is needed to study a redesign considering the origin of the fault, for example: Scale, abrasive sand, formation fines or other solids such as paraffins and / or asphaltenes. Additionally, in these redesigns it is necessary to consider the frequency of operation of the ESP equipment and evaluate the installation of additional controls to the ESP such as a sand control system.

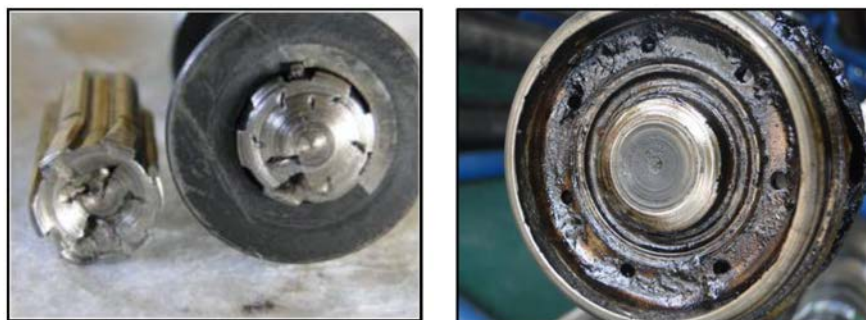
It occurs as a result of catastrophic damage to the pump shaft caused by restriction of rotation, fatigue, back spin, wear due to high life or defects in the material. The parameters generally behave as follows:

Figure 6—Evidence found during disassembly of equipment with broken shaft. Source Baker Hughes.

**Possible solutions:** Once this condition arises, it is necessary to do the well intervention to do a well service work. To avoid the recurrence of faults, it would be necessary to apply equipment operation strategies such as: Controlled starting plan, a controlled stopping plan, proper configuration of control parameters in the variable speed drive (VSD) for its acronym in English, a proper handling of the "Drawdown" and control strategy for the production of solids.

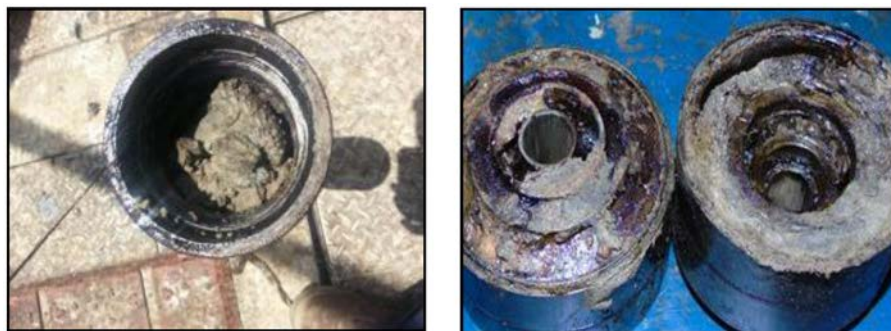
This condition occurs when the high sand production from the formation results in the decantation of the sand along the well until it causes a partial or total obstruction of the producer interval or causes plugging in the ESP pump, restricting the movement of fluid from them. Depending on the severity, several production pipe joints can be found above the discharge of plugged ESP equipment, which may require fishing jobs to recover ESP system. The parameters generally behave as follows:

[Figure 8](#), shows the typical evidence found during the extraction and subsequent disassembly of the Bottomhole equipment.

Figure 8—Typical evidence found in the disassembly of the deep well equipment with sandblasted well. Source Baker Hughes.

Not all cases show evidence of sand in the pump, since it can be removed during the work being done to try to start the bottomhole equipment, for example, the recirculation of fluid in the well.

**Possible solutions:** In wells considered critical, conservative acceleration ramps are recommended even from startup. The ESP service provider suggests a rate of 100 psi/day. "Drawdown" administration is required and the use of high volume flow stages is suggested.

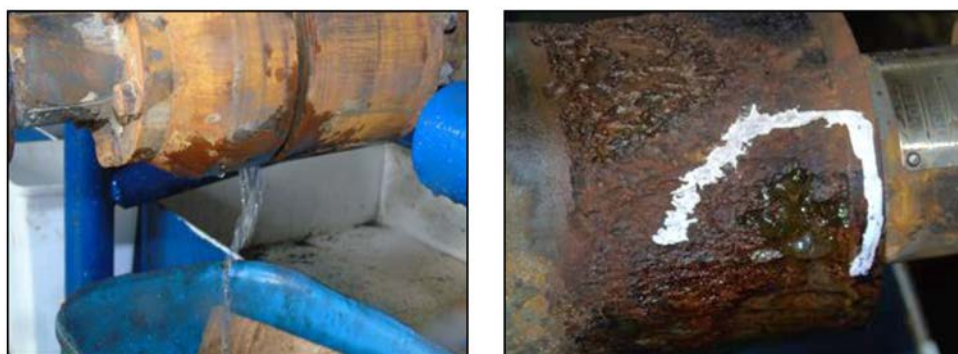
- Power cable hits (bottom or surface) that affect the insulation of the power cable and consequently the transmission of sensor data to the surface is lost.
- Problems with the surface electronic components of the ESP system Bottomhole sensor.
- Well fluid Migration through the sensor affecting the dielectric properties of the oil. In this particular case, sensor failure occurs and consequently engine failure. Migration can also occur due to mechanical seal failures due to high life among others. [Figure 10](#) shows a sensor data loss event.
- Failure of insulation penetrators and surface connectors or gaskets.

Figure 11 shows the typical evidence found during *pulling and tear down*.

Figure 11—Typical events found during pulling and tear down as a result of migration of well fluid through the sensor. Source Baker Hughes.

In wells with sensor data loss, it is recommended to avoid to the maximum vary the operating conditions of the equipment, such as frequency changes and shutdowns, in general not to make changes in the operating conditions. It is also advisable to avoid electric "*stres*"s conditions and overload the motor beyond 60% load. If absolutely necessary, the acceleration ramps must be carried out in a conservative manner in order to minimize electrical "*stres*"s on the system.

**Possible solutions:** First, the origin of the electrical fault must be identified, since, in the event that it is located on the surface it is repairable, in the event that the fault is located in the bottom once this condition occurs, it is necessary to make the intervention of well to do a well service job. Depending on the location of the fault in depth with an intervention taken from the string to the point of failure and cable repair is sufficient.
