**SPE-194392-MS**

## **Identifying and Preventing ESP Failures Resulting from Variable Speed Drive Induced Power Quality Issues**

Milan Heninger, Enel Green Power North America; Salvatore F Grande, Magney Grande Distribution, Inc.; David D Shipp, Capstone Power Systems Engineering

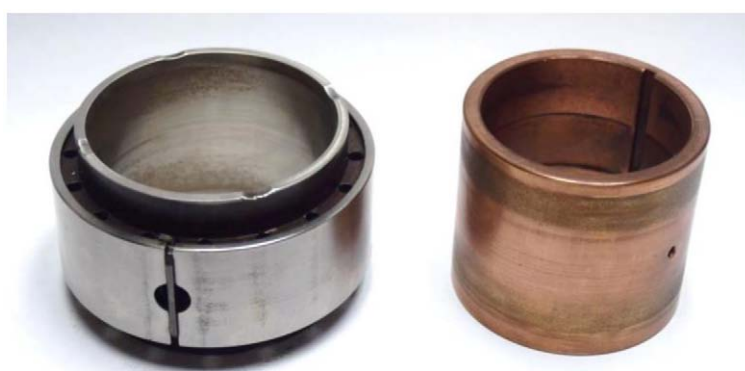
over current. Teardown and failure analysis of the second ESP system found the rotor mechanically locked, and the motors exhibited the same bearing anomalies as the first instance (see [figure 12](#)), however in this case there was no water found within the motor. The motor oil had fine brass colored particles suspended throughout, and the oil failed dielectric tests. These findings suggested that galvanic corrosion was unlikely to be the root cause of this failure; thus a technical investigation was launched by the authors to understand and eliminate this failure mode from the ESP fleet. Since these ESP's had been used for years in similar non-VSD applications without this type of failure, the VSD became the most likely contributing factor towards the equipment failures. Over the following 18 months and across 10 separate ESP system failures, the authors performed detailed power quality studies of the ESP systems and performed teardown and inspections of every failed ESP with the motor manufacturers to determine the root cause of failure. The following sections of this report detail the data collection and key results of these studies such that others can understand the techniques required to diagnose and correct VSD output power quality related failures.

Figure 11—Bearing from first failure

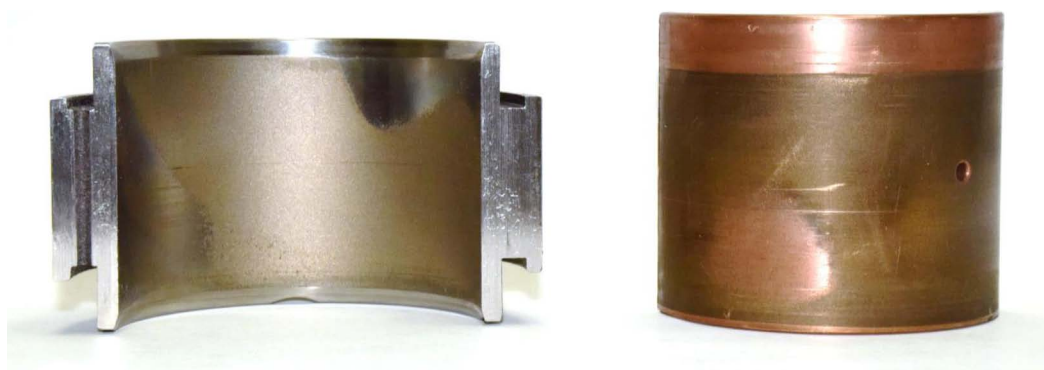
Figure 12—Bearing segments from second failure

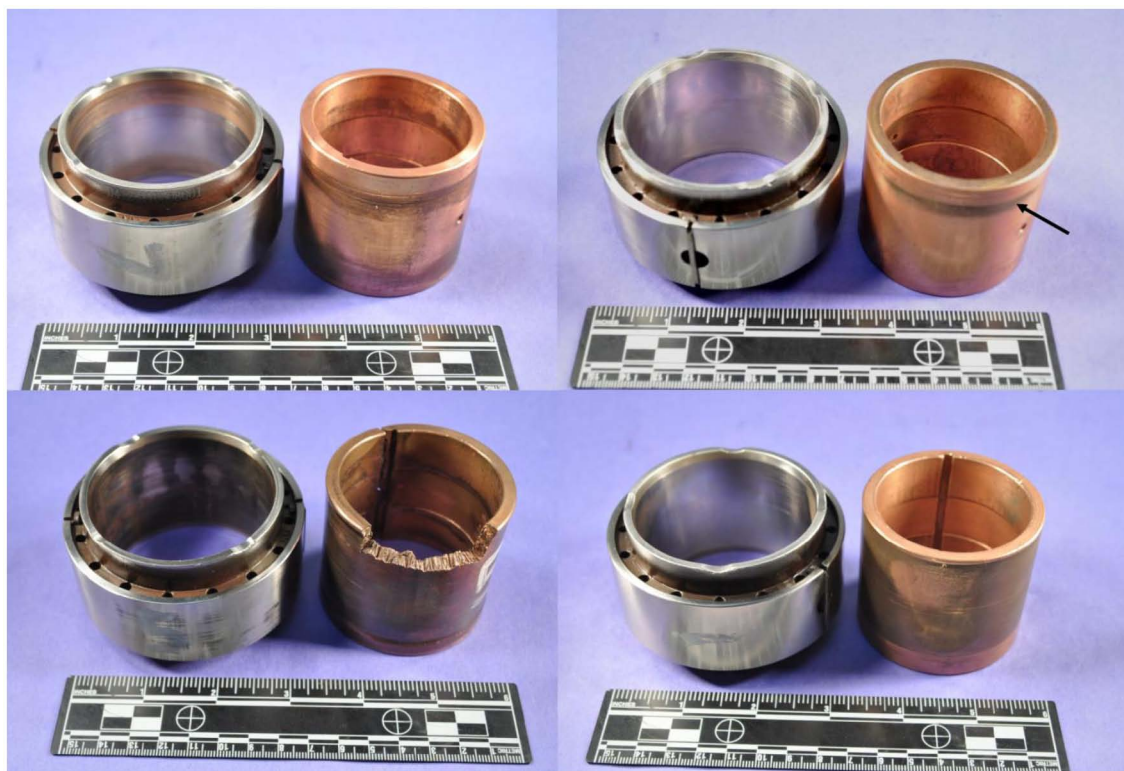
Four bearing samples from 4 different motors at various stages of failure were collected for 3<sup>rd</sup> party laboratory analysis, as shown in figure 13. These lab tests included Stereomicroscopy and Scanning Electron Microscopy (SEM) of the bearing surfaces, measurements of unusual structures that were identified, Fourier Transform Infrared Spectroscopy (FTIR) of the oil collected, chemical analysis of the bearing and sleeve materials via energy dispersive x-ray spectroscopy (EDS), and metallographic preparation of the samples in order to identify the cause of fractures. Additionally, virgin oil samples were provided to the lab for comparison to the oil recovered directly from failed motors. These tests were performed before and after cleaning of the bearing samples, such that any foreign materials could be identified. Cleaning was completed using an ultrasonic acetone bath, which removes oil and foreign material deposits from the surface of the bearing. Any materials embedded in the surface due to mechanical forces would remain. After inspection of the bearings was completed, representative specimens were prepared in cross-sectional metallurgical mounts. These mounts were again examined in an unetched condition in order to identify surface irregularities or defects. They were then etched in order to reveal material structures and aid in identifying any underlying metallurgical issues.

Figure 13—Bearings sent to laboratory for analysis
