# Detailed Diagnostic Report (DDR)

## 1. Property Issue Summary

This report details significant moisture ingress and structural integrity concerns identified throughout the property. Key findings include widespread dampness across multiple internal areas such as the Hall, Bedroom, Master Bedroom, and Kitchen, evidenced by both visual inspection and thermal imaging. Efflorescence is present in the Master Bedroom, indicating prolonged moisture presence. Critical issues include tile gaps and suspected plumbing failures in the Common Bathroom, active leakage in the Parking area, and visible cracks on the External wall. Thermal analysis consistently revealed cold spots, correlating with visual dampness and indicating potential hidden moisture pockets.

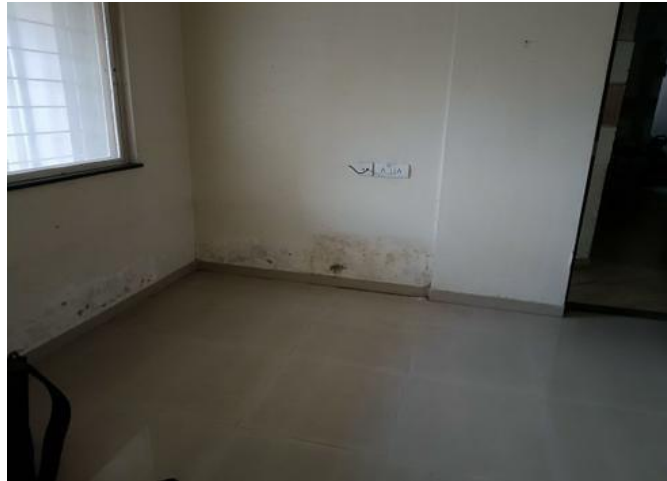
### Hall

Issue: Skirting dampness

Observation: Visible dampness observed along the lower skirting boards, indicating moisture ingress at the wall-floor junction.

**Rising Damp:** Skirting dampness in the Hall and general wall dampness could indicate capillary action drawing ground moisture upwards through the wall structures, especially if there is a compromised or absent damp proof course.

Skirting dampness

**Rising Damp Assessment:** For skirting dampness, assess the existing damp proof course (DPC) and consider remedial action such as injecting a new chemical DPC if necessary.
