## HOME INSPECTION REPORT

4014 Sparrow House Ln  
Burtonsville, MD 20866

Tizita Ayane  
05/16/2026

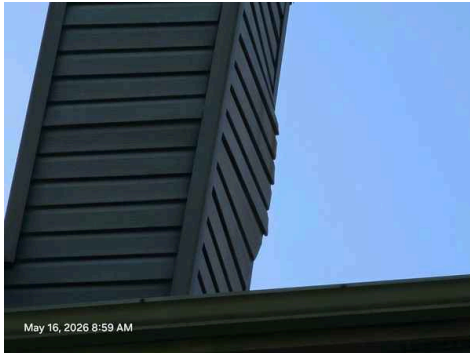
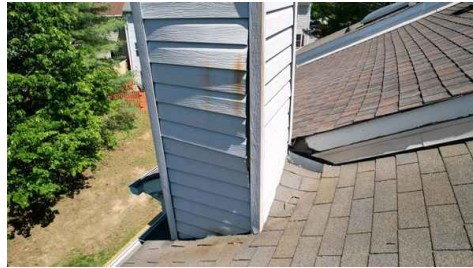
#### SIDING LOOSE

Siding was loose, which could result in moisture intrusion.

**Recommend:** siding is refastened and/or repaired.

Contact a qualified siding specialist.

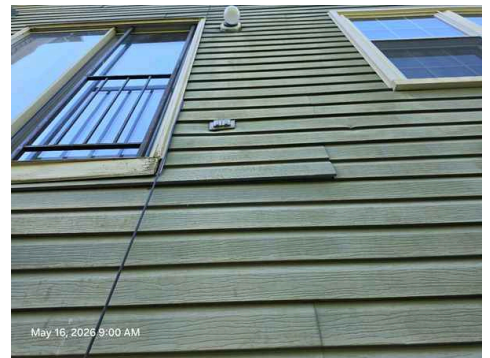
#### 4.1.2 Siding, Flashing & Trim

##### **SIDING LOOSE 2**

Siding was loose, which could result in moisture intrusion.

**Recommend:** siding is refastened and/or repaired.

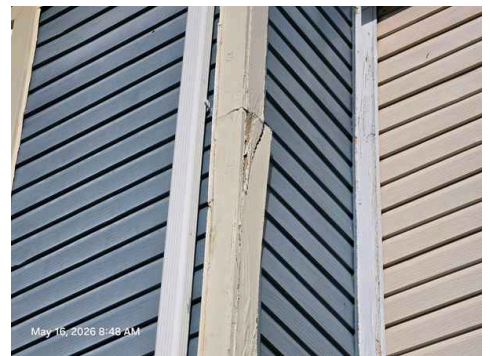
#### 4.1.3 Siding, Flashing & Trim

##### **SIDING TRIM DAMAGE**

Trim or wood siding shows signs of damage which will continue to degrade leading to moisture issues.

**Recommend:** correction by replacing fouled wood and/or applying a protectant stain/paint.

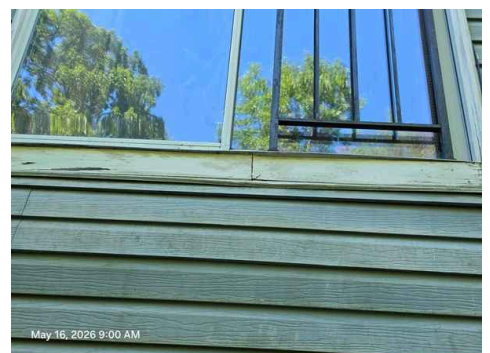
#### 4.1.4 Siding, Flashing & Trim

##### **PEELING AND CHIPPING EXTERIOR PAINT**

Peeling and chipping paint on exterior surfaces exposes underlying materials to moisture intrusion and weather-related damage.

**\*\*Recommend:\*\*** remove loose paint, properly prepare surfaces, and apply exterior-grade paint to restore protection.

Contact a qualified professional.

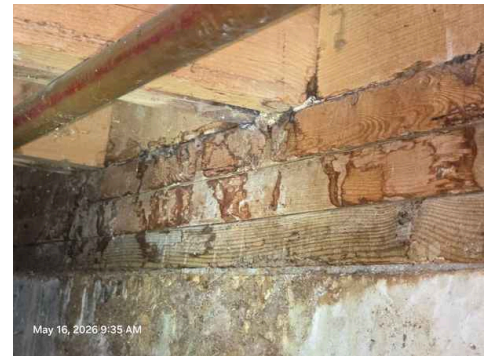
### 5.1.1 Foundation

#### EVIDENCE OF MOISTURE INTRUSION

##### Foundation Shows Evidence of Moisture Intrusion

Contact a foundation contractor.

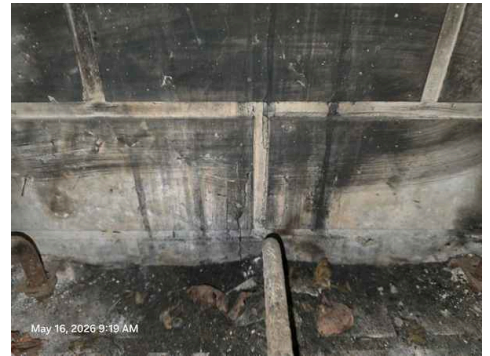
## 8.7.2 Fireplace

**FIREPLACE REQUIRES FURTHER EVALUATION**

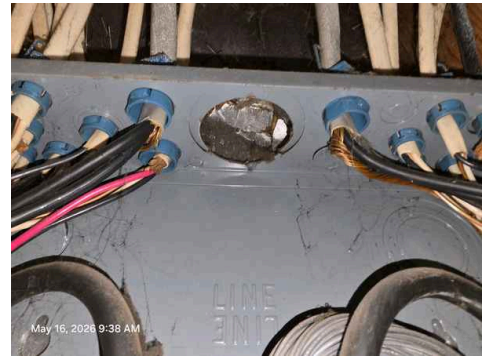
## 9.3.2 Service Panel

**WHITE WIRE CONNECTED TO CIRCUIT BREAKER**

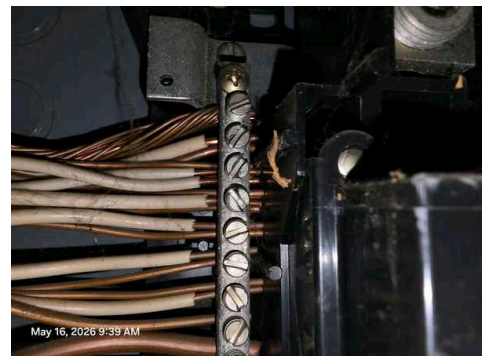
## 9.4.1 Branch Wiring Circuits, Breakers &amp; Fuses

**GROUND (NEUTRALS) DOUBLE TAPPED**

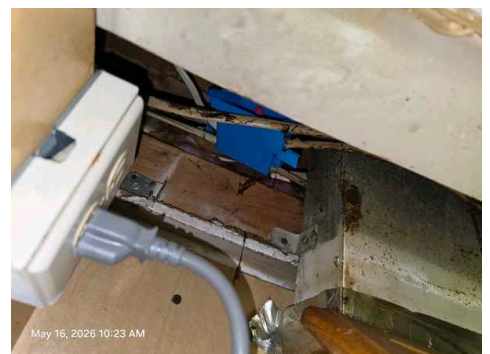
## 9.5.1 Receptacles (All Accessible)

**JUNCTION BOX COVER MISSING - HIGHER**

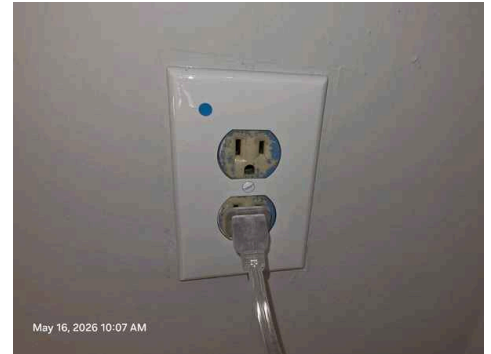
## 9.5.2 Receptacles (All Accessible)

**RECEPTACLE LOOSE**

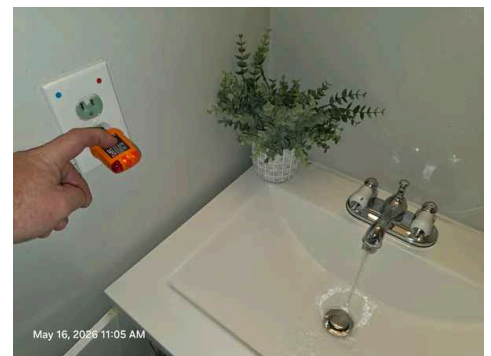
## 9.5.3 Receptacles (All Accessible)

**RECEPTACLE NOT HOLDING PLUG - MANY**

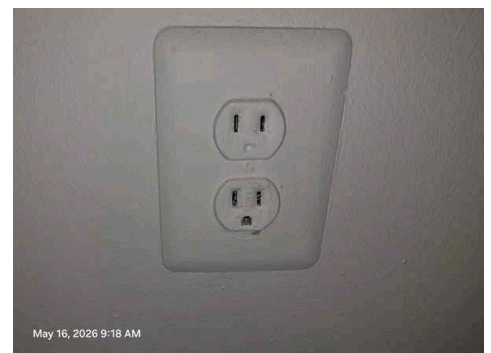
## 9.5.5 Receptacles (All Accessible)

**RECEPTACLE PAINTED**

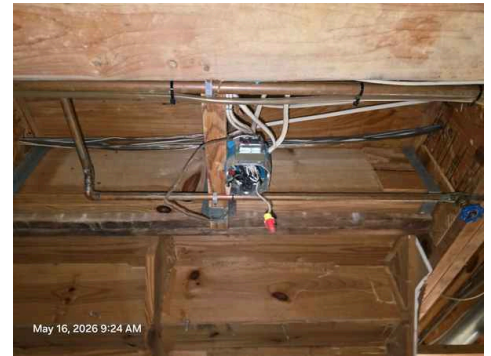
## 9.6.1 Switches &amp; Lighting (All Accessible)

**LIGHT FIXTURE MISSING**

Contact a qualified professional.

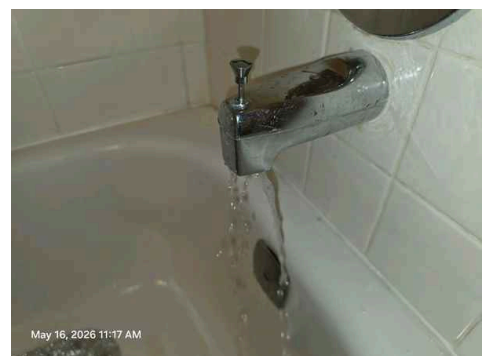
### 10.3.1 Faucets

#### **DIVERTER DEGRADED - TUB SPOUT**

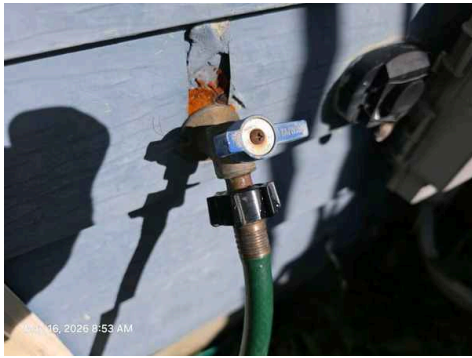
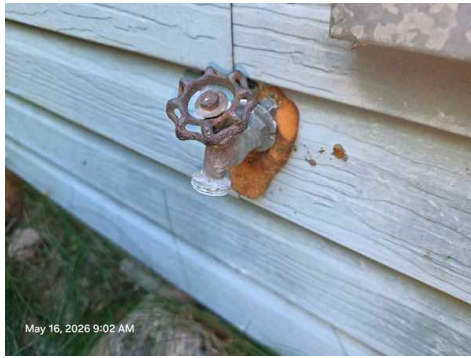
### 10.3.2 Faucets

#### **HOSE BIBB ANTI-SIPHON MISSING**

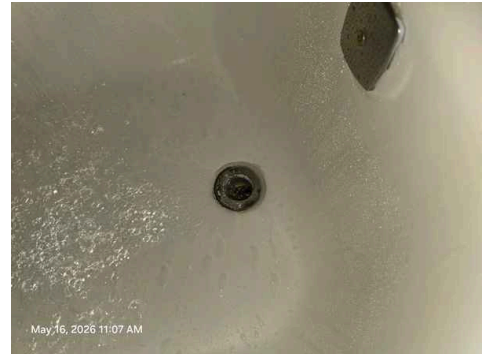
#### 10.4.1 Sink, Shower, Tub Fixtures

##### **DRAIN STOP MISSING - TUB**

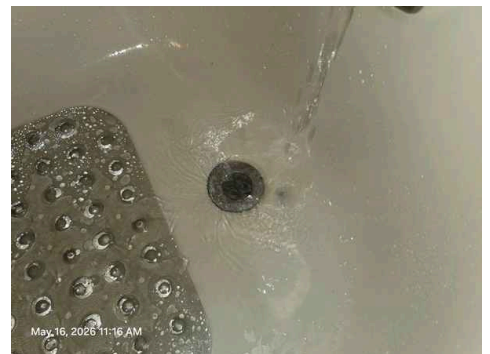
#### 10.4.2 Sink, Shower, Tub Fixtures

##### **DRAIN STOP MISSING - TUB 2**

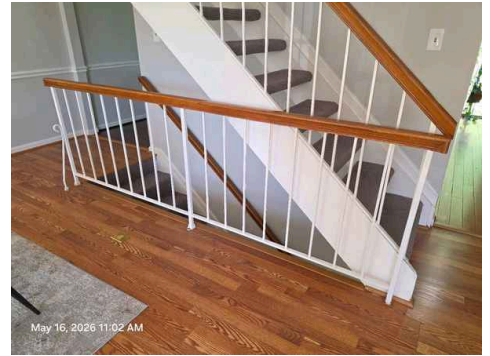
## 11.5.2 Steps, Stairways &amp; Balustrade

**INTERIOR GUARD RAIL LOOSE**

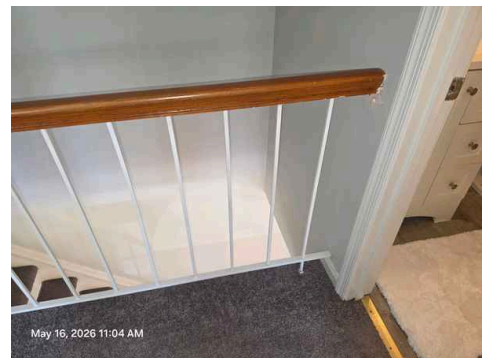
## 11.5.3 Steps, Stairways &amp; Balustrade

**INTERIOR GUARD RAIL LOOSE 2**

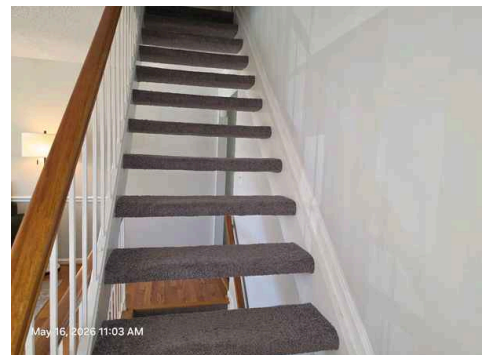
## 11.5.4 Steps, Stairways &amp; Balustrade

**OPEN RISERS ON INTERIOR STAIRS**

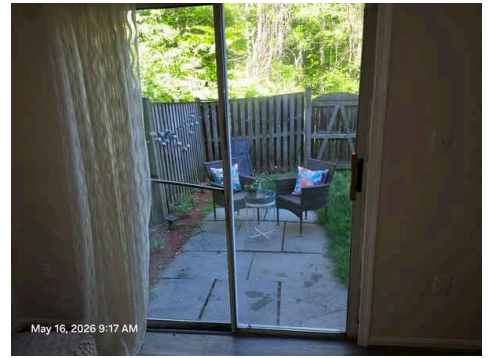
## 12.1.2 Exterior Doors

**SLIDING GLASS / SCREEN DOOR DOES  
NOT LATCH**

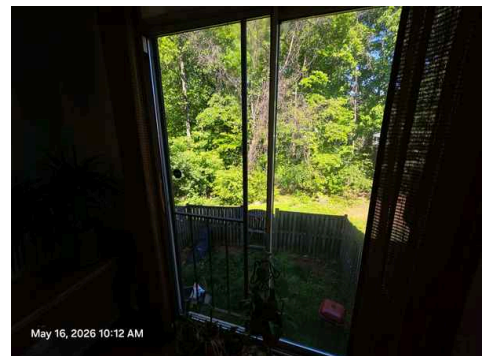
## 12.1.3 Exterior Doors

**SLIDING GLASS / SCREEN DOOR DOES  
NOT LATCH 2**

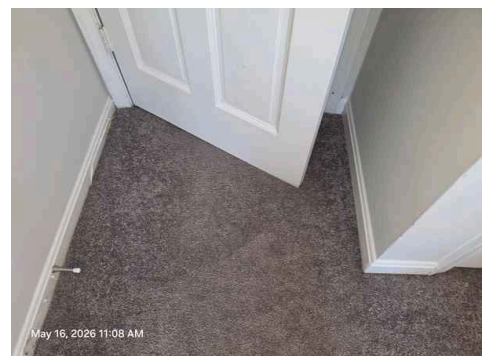
## 12.2.1 Interior Doors

**INTERIOR DOOR RUBBING - FLOOR**

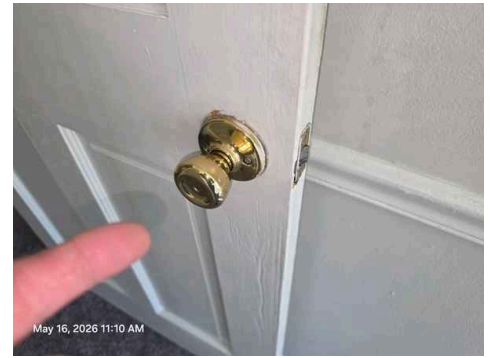
## 12.2.2 Interior Doors

**INTERIOR DOOR HARDWARE  
DAMAGE**

Contact a handyman or DIY project
