## The Japanese Tower at the Royal Domain in Laeken: A remarkable application of Japanese lacquer techniques in Belgium

Delphine Mesmaeker

Supplementary issue paper

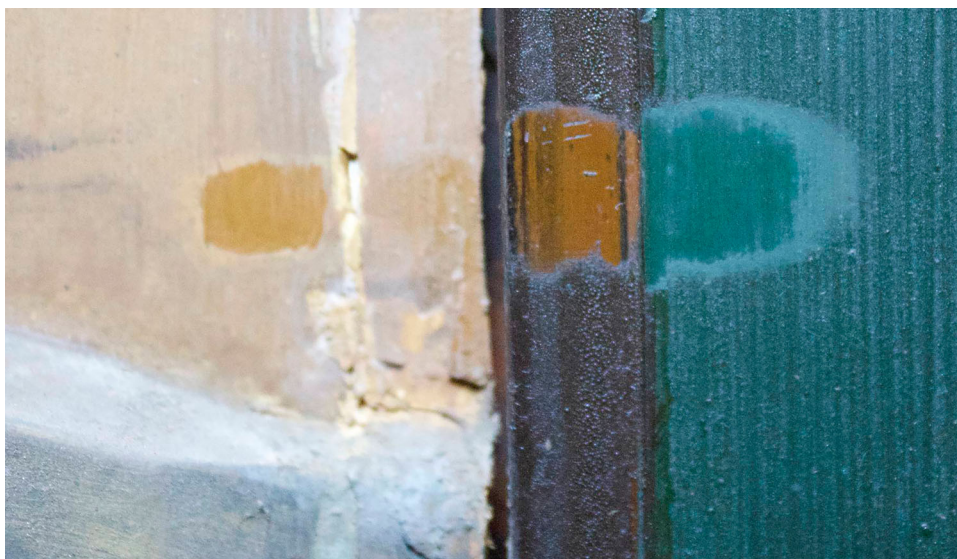
**Figure 7** Ochre, dark red, and seishitsu urushi on the frame of the large wall panel on the second floor. Image: courtesy of Fenikx bvba.

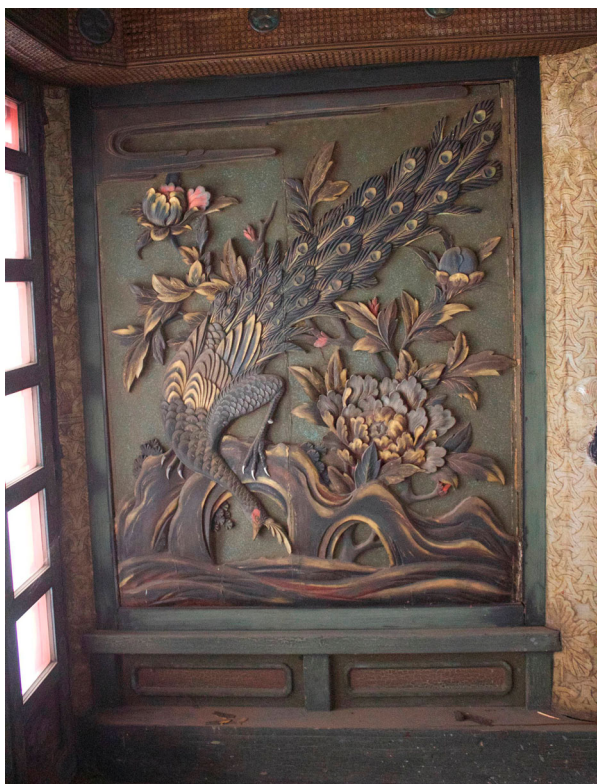
includes fading and colour changes (Fig. 8), micro-cracking, flaking and lifting, powdering, and many types of loss, ranging from superficial losses to those that extend to and through the ground layers and substrate.

**Figure 8** Colour change of the lacquer in the large wall panel on the second floor. Image: D. Mesmaeker.
