Candidate violation

SEVERITY HIGH · 63.7/100

| Location | Costa Brava, south Beirut |

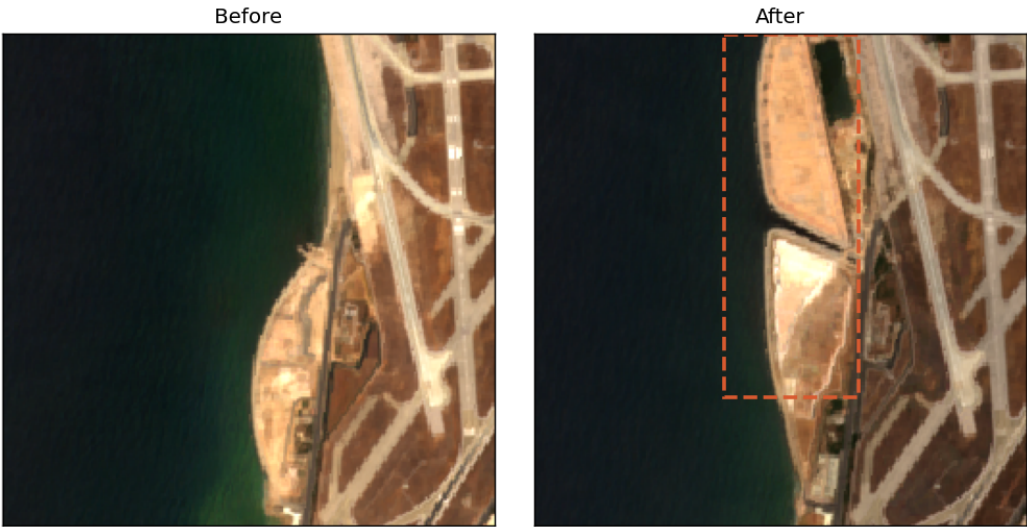
| Change area | 58.5 ha (585,000 m2) |
| Type | coastal_construction (confidence 0.98; gemini) |
| Evidence | NDVI drop -0.244, BSI rise 0.21 |
| Severity | high 63.7/100 - within the coastal public-domain setback +30, change area 58.5 ha +20.0, signal strength (NDVI -0.244, BSI 0.21) +3.9 |
| Flags | within the coastal public-domain setback |
| 2nd opinion | confirm - The 'AFTER' image clearly shows extensive land reclamation where open water was present in the 'BEFORE' image, forming large new landmasses along the coast, which is a definitive sign of coastal construction. |
| Reasoning | The 'BEFORE' image shows a natural coastline. The 'AFTER' image reveals extensive land reclamation and construction extending into the sea, forming large, artificial landmasses where there was previously water. This dramatic alteration of the coastline to create new land is a clear example of coastal construction. |
