Candidate violation

| Location | Costa Brava, south Beirut |

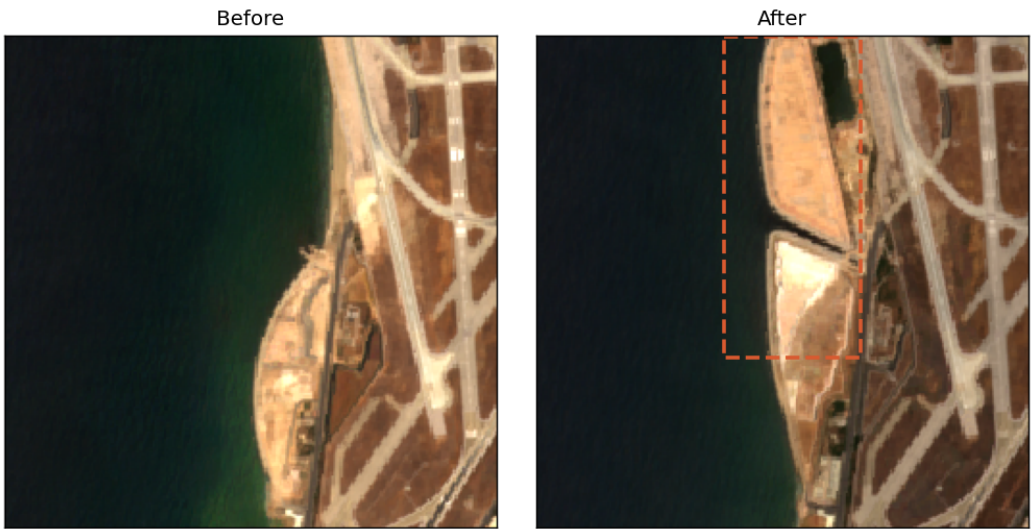
SEVERITY HIGH · 63.2/100

| Change area | 56.13 ha (561,300 m2) |
| Evidence | NDVI drop -0.267, BSI rise 0.213 |
| Severity | high 63.2/100 - within the coastal public-domain setback +30, change area 56.13 ha +20.0, signal strength (NDVI -0.267, BSI 0.213) +4.0 |
| Flags | within the coastal public-domain setback |
| Legal basis | Maritime public domain - 150 m setback from the coastline (proxy width) |
| 2nd opinion | confirm - The AFTER image clearly shows large exposed bare/sandy areas and what appears to be reclaimed or constructed land where the BEFORE image showed dark water/vegetation, consistent with coastal construction or land reclamation rather than seasonal or tidal variation. |
| Reasoning | The before image shows a coastal area with water (dark green/blue) and a small sandy shoreline with minimal development. The after image shows significant land reclamation and construction activity with exposed earth/sand fill material, indicating coastal construction or land reclamation project has taken place at this Lebanese coastal location. |
