## Lumo OLV data produce by Bad Lumo Injector causing OQ execution time out during Instrument Priming

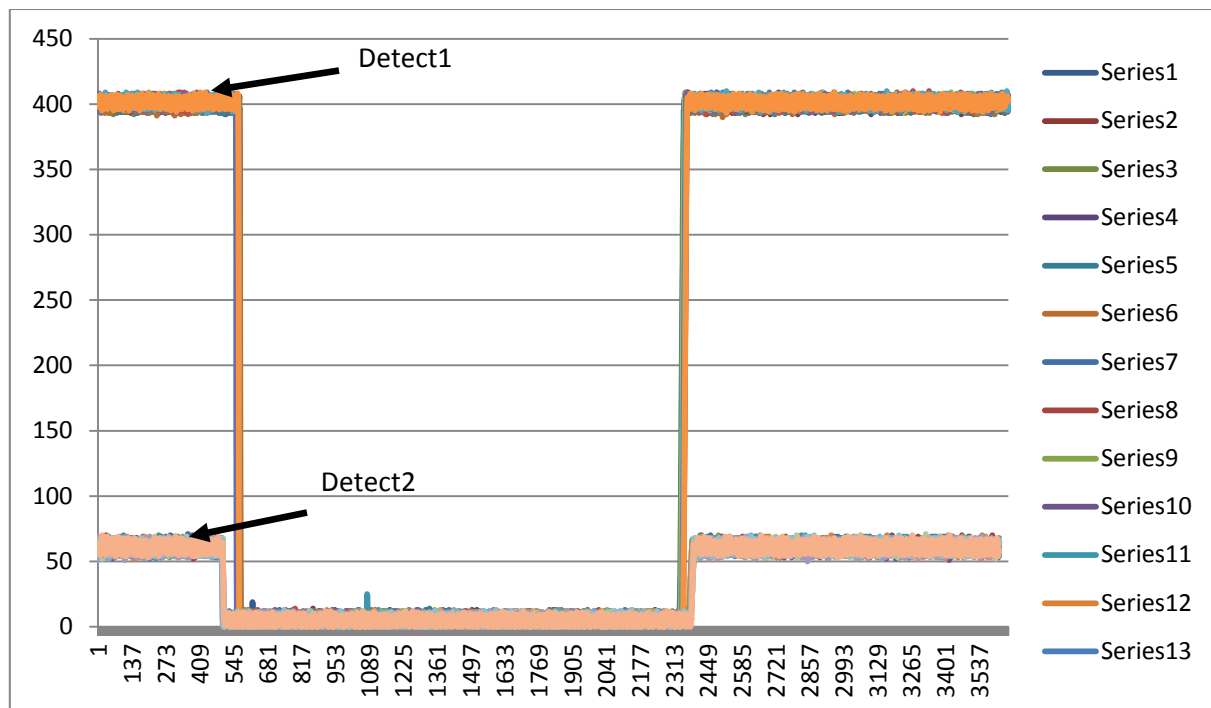
Suspect that there might be obstruction in the Lumo Injector, Detect2, where the process control light/signal passes through. Calibration of Lumo OLV board was performed several times but still getting the same result. Replacing the Lumo injector fixed the issue.
