## **PANTHER® System**

### **Distributor Informational Update- Top Failure Modes**

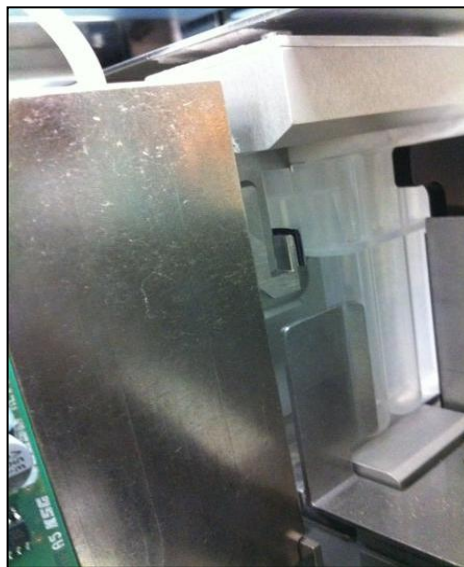
6. **Input Queue- Loose Belt:** A loose Input Queue belt will lead to stacking issues and Distributor Step Losses. Confirm the Input Queue Belt is properly tensioned.
7. **Input Queue Drift:** If there are no Input Queue errors, then check to see if the Input Queue has drifted toward the back of the instrument. Repeated use of the Input Queue can cause the module to drift toward the Luminometer over time. When this occurs, the IQ and Distributor will no longer be aligned in the Y-Direction (Instrument front to back).
  1. Manually check the alignment of the Input Queue to the Distributor. (See the Panther Service Manual).
  2. The Distributor hook should sit between the two vertical lines drawn on the MTU.

3. If the Distributor and IQ do not line up, adjust the Input Queue appropriately.
  4. Implement GP12-247-FSN to add lock washers to the Input Queue.
8. **Distributor Teaching** If there are no errors in steps 1-7, then the problem is probably a Distributor teaching issue. It is very important for the FSE to pay close attention to the teaching of the Distributor to the Input Queue to ensure that the teaching is accurate. (see the PANTHER Service Manual for a step-by-step guide on teaching the Distributor to the Input Queue)
    1. Historically, the 2 axes that have given the most difficulty teaching are the Hook Depth and the Z-Height.

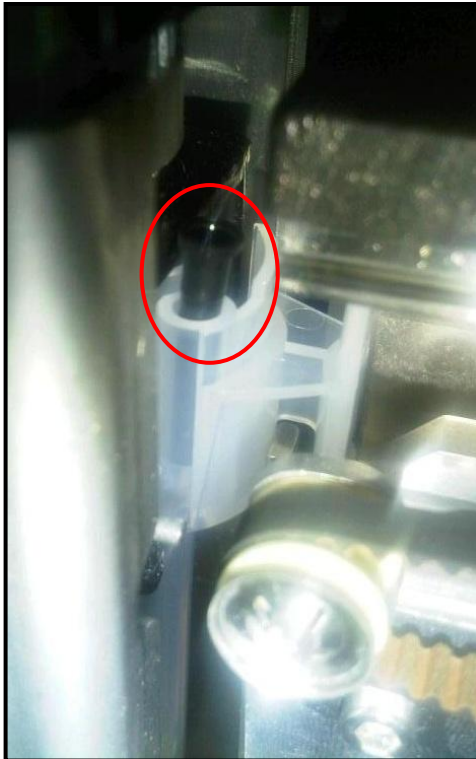
2. The too tight MTU Carriers are especially harmful at the **Sample Mix Station** and the **MagWashes** because the tight MTU Carrier causes the tiplets in the MTU to pop up, causing a jam. See Figures 2 and 3. (Tiplets are no longer present at the Amp and HPA Load Stations).

**Figure 3-** Triplet popped at carriage when placing an MTU

1. **Magwash:** Tiplet popups most often occur when the MTU is being removed from the module (Pick command). The only time that the MTU still has Tiplets when it is being picked from the MagWash is during Advance Clean. (During normal processing, the Tiplets are picked during the MagWash step.)
  1. Upgrade the instrument to software version 3.2.5 (or higher). This software changes the Advance Clean process to pick the tiplets immediately when the MTU is placed in the MagWashes.
  2. **Sample Mix Station:** If the tiplet popup failure occurs at the Sample Mix Station (or the Amp or HPA Load Stations or upgrading SW did not fix the issue at the MWs), it is best to replace the Module.

**Note-** The MTU Carrier will become a spare part as soon as October 15, 2012. When the MTU Carrier is released as a spare part, just the MTU Carrier should be replaced instead of the entire module. See GP12-244-FSN, Replacement Procedure for Load Station and MagWash MTU Carriers.
