## OQ Injectors Cleaning Procedure

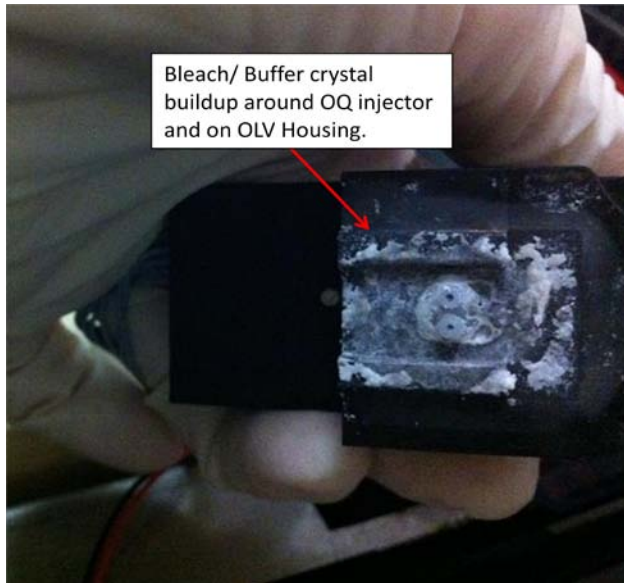
The bleach and buffer tend to buildup crystals around the OQ injector, often leading to an occlusion of the OQ MTU presence sensor. When this occurs, the instrument will crash with a - “The MTU presence sensor in the Output Queue detects a MTU after the loading process” error (081.000.00069). To prevent this, the OQ injector and OLV housing should be cleaned of all crystal buildup.
