## केस स्टडी / CASE STUDY

OISD/CS/2022-23/POL/07

Dated: 09.03.2023

Title: Fire incident during loading of tank trucks at Tank lorry filling gantry resulting in fatalities.

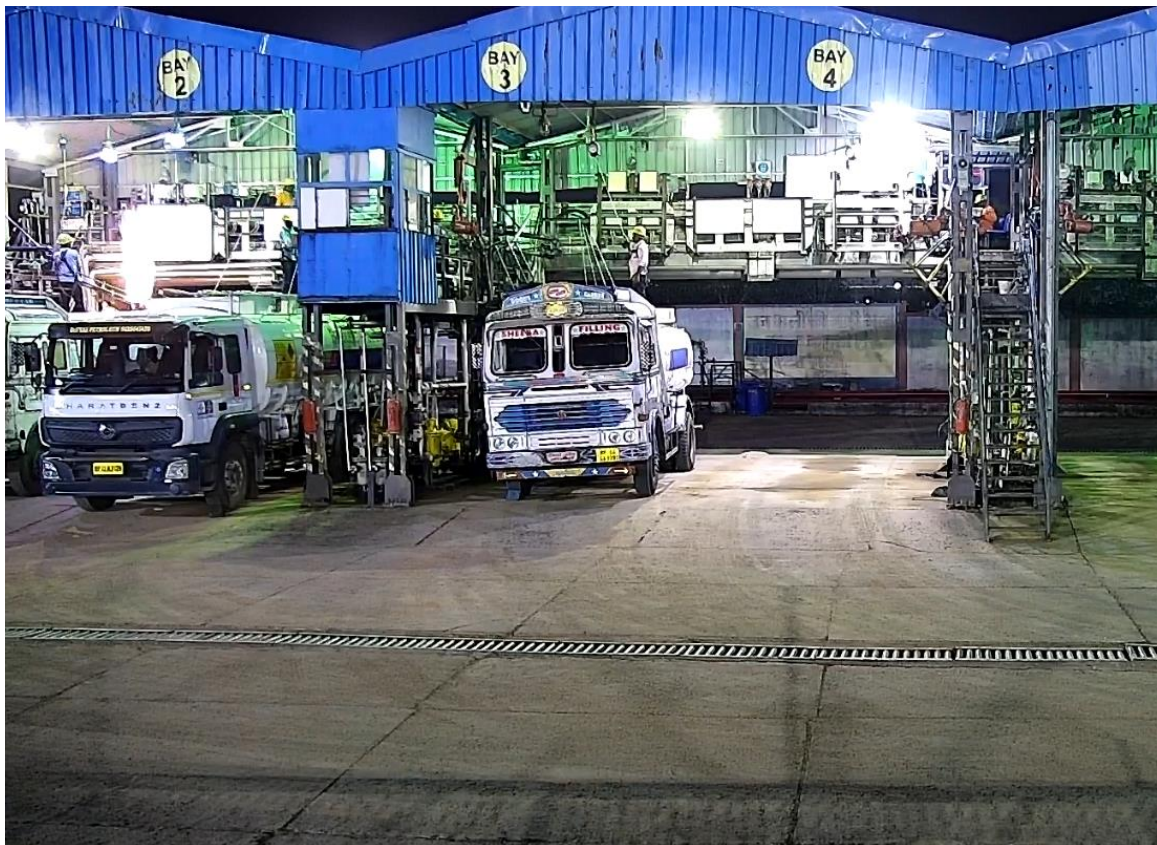
**JET FIRE EMANATING FROM TANK TRUK UNDER LOADING AT TLF BAY NO. 1**

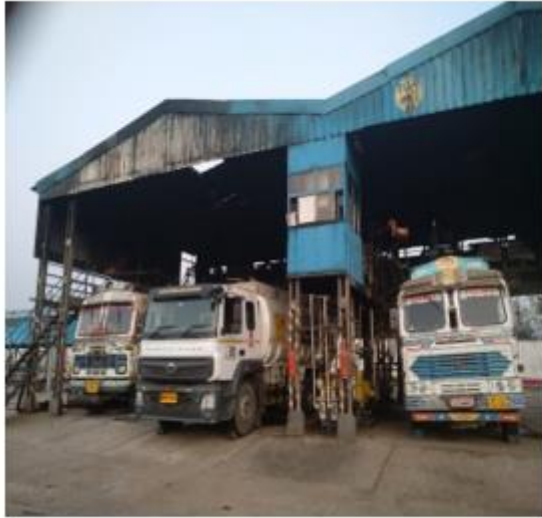
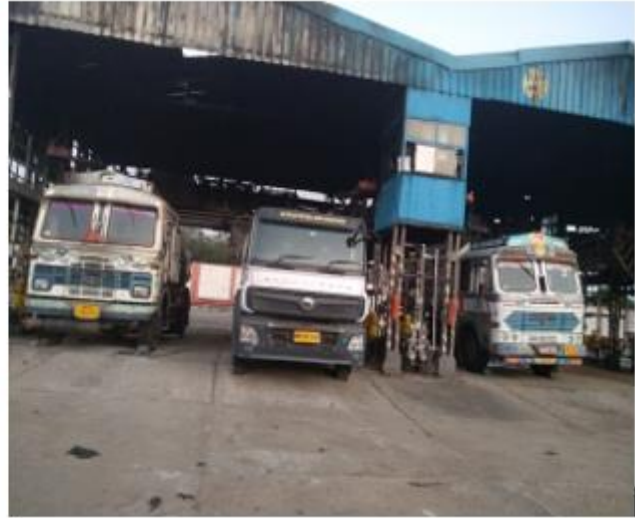
**DAMAGED TANK TRUCKS AT TLF GANTRY**

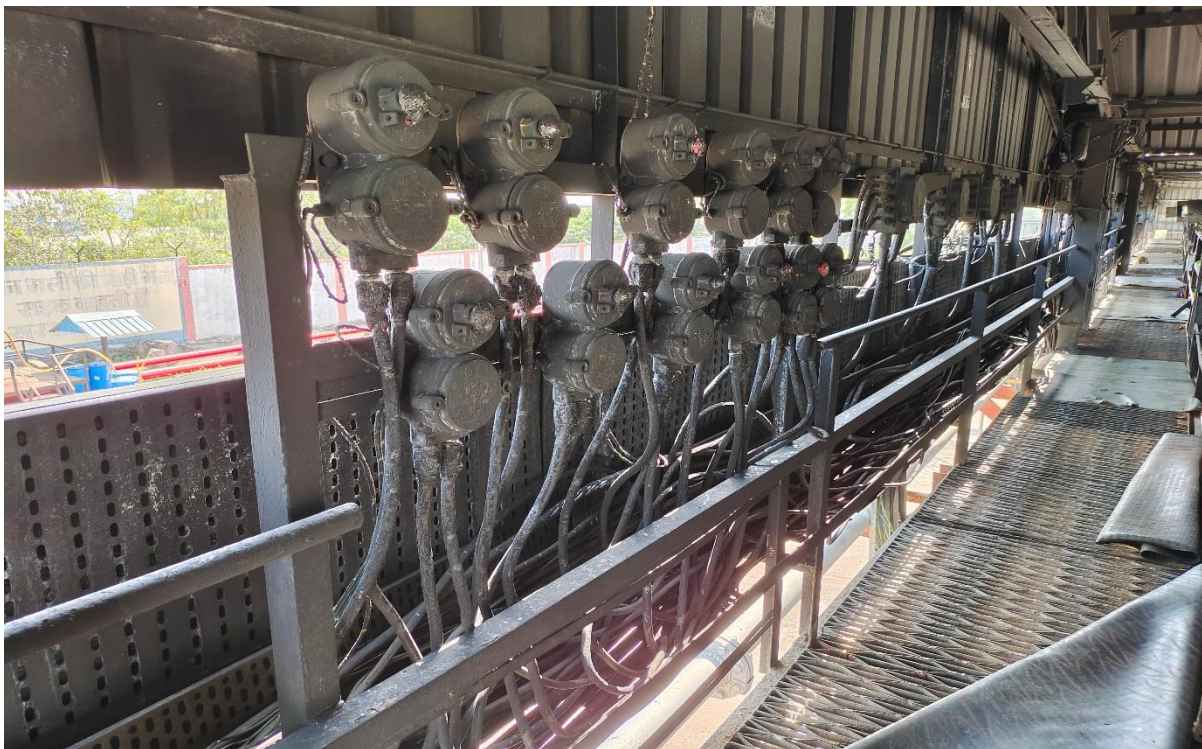
**DAMAGE FOR ELECTRICAL & INSTRUMENTATION SYSYTEM AT TLF GANTRY**

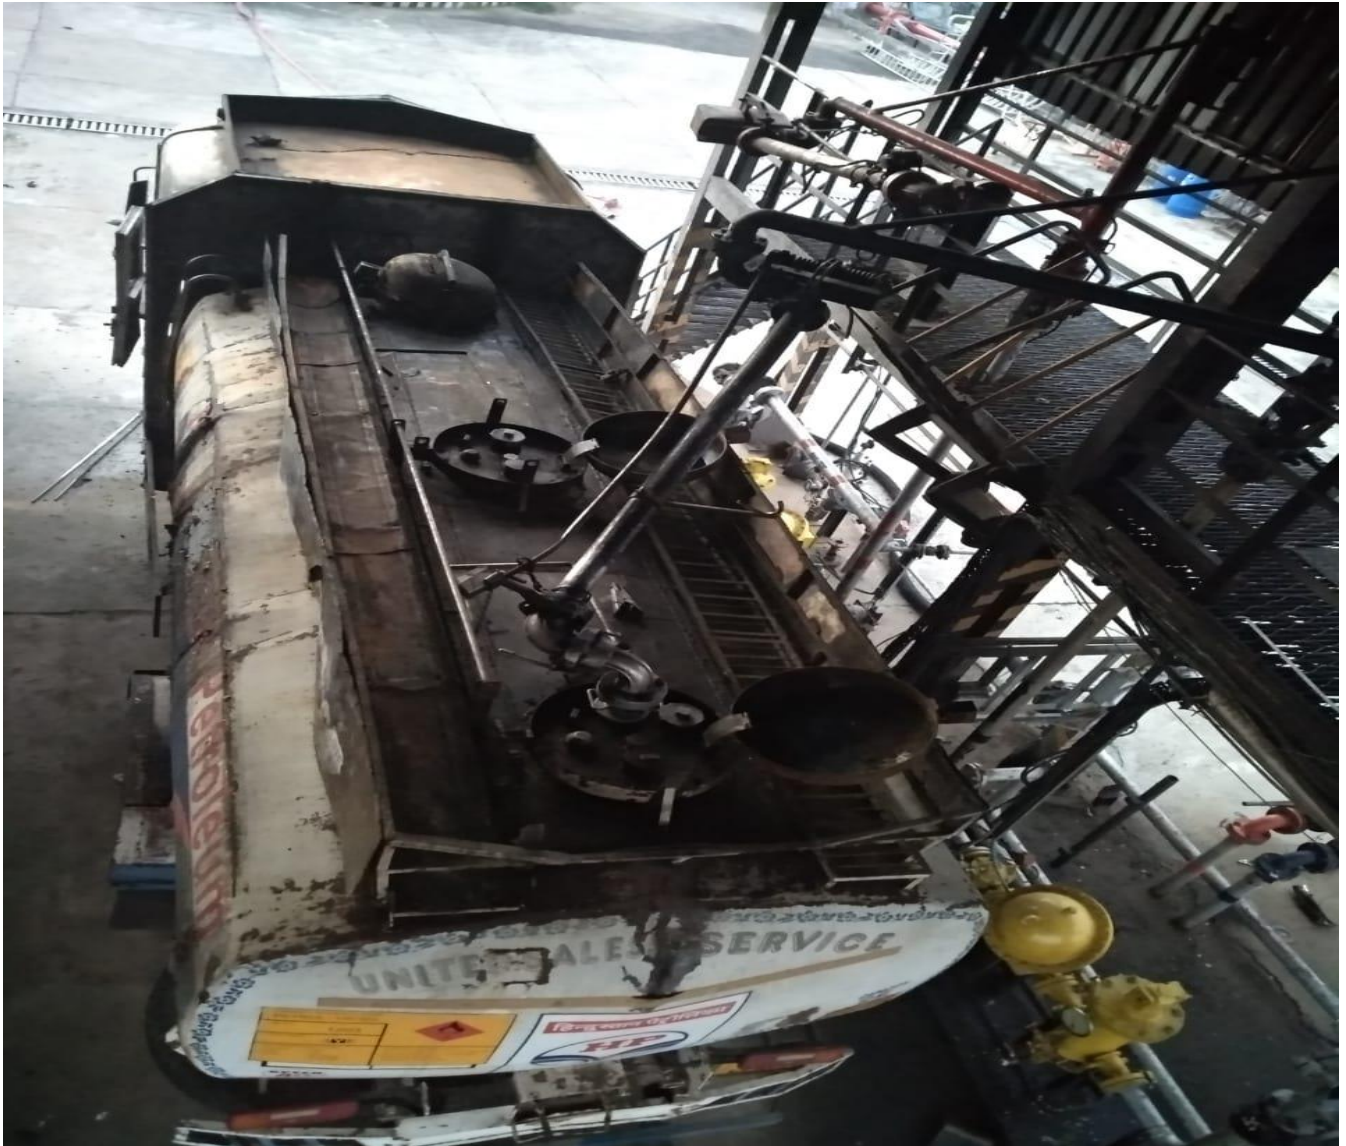
**DAMAGED TT INVOLVED IN THE INCIDENT**
