## CASE STUDY

OISD/CS/2024-25/P&E/11

Title: Fatal accident at maintenance fabrication yard during cleaning & stacking of tubes.

Location: Refinery

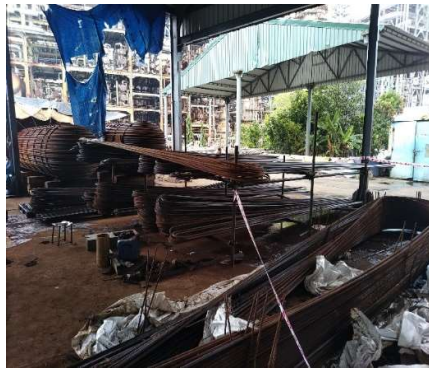
Stacking of U-Tube bundle beside the collapsed structure
