## CASE STUDY

OISD/CS/2024-25/P&E/12

Title: Explosion in furnace.

Location: Process (Crude Distillation) unit in refinery.

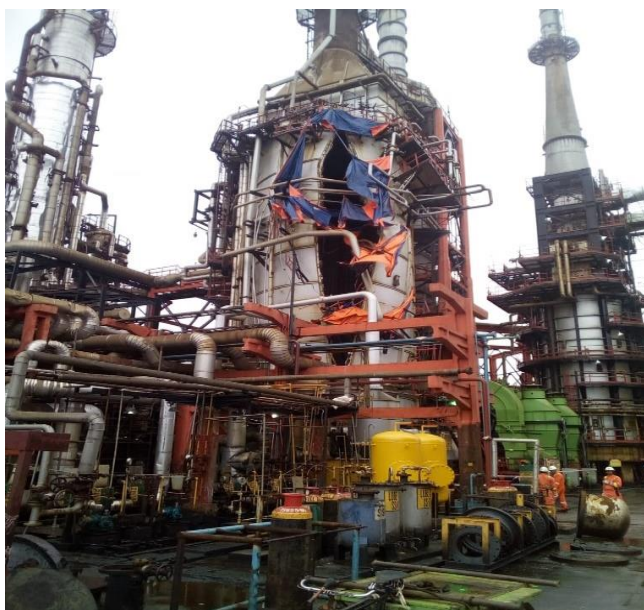
The panel operator re-opened the fuel gas control valve manually from Distributed Control System (DCS) panel. Around 3 minutes later, explosion occurred in the furnace with momentary fire. Consequently, the shell of the furnace burst open.

- The furnace shell had split from around 1 m about the burner floor to the furnace arch level. Furnace tubes were also uprooted from hangers. Some piping, electrical cables & trays, instrument & cables and insulation lining (blanket) inside furnace were damaged.

The resetting of the fuel gas supply to furnace control valve analogue control card resulted in closure of the valve. Hence, the flame of the burners must have extinguished. Subsequently, when the panel operator opened the fuel gas controller manually, without following the procedure of purging the furnace before relighting it, the un-combusted gas got ignited on coming in contact with the already hot tubes and detonated.

- In case of flame failure/ failure of Fuel Gas/ Fuel Oil, furnace light up procedure i.e., box purging, pilot burner light up, main burner light up etc. shall be followed in line with Cl. 11.3 of OISD-STD-111.

- Installation of Burner Management system (BMS) in furnaces should be reviewed.
- Organization should reinforce the system of reporting of unsafe act emphasising acts of procedural bypasses, not following SOP, etc. followed by appropriate rectification measure and dissemination of learnings in endeavour to enhance the safety culture in line with OISD-GDN-206 cl no 5.1.4.
