## CASE STUDY

OISD/CS/2024-25/P&E/13

Title: Fire in Atmospheric Vacuum Unit (AVU).

Location: Process (Crude Distillation Section) unit in refinery.

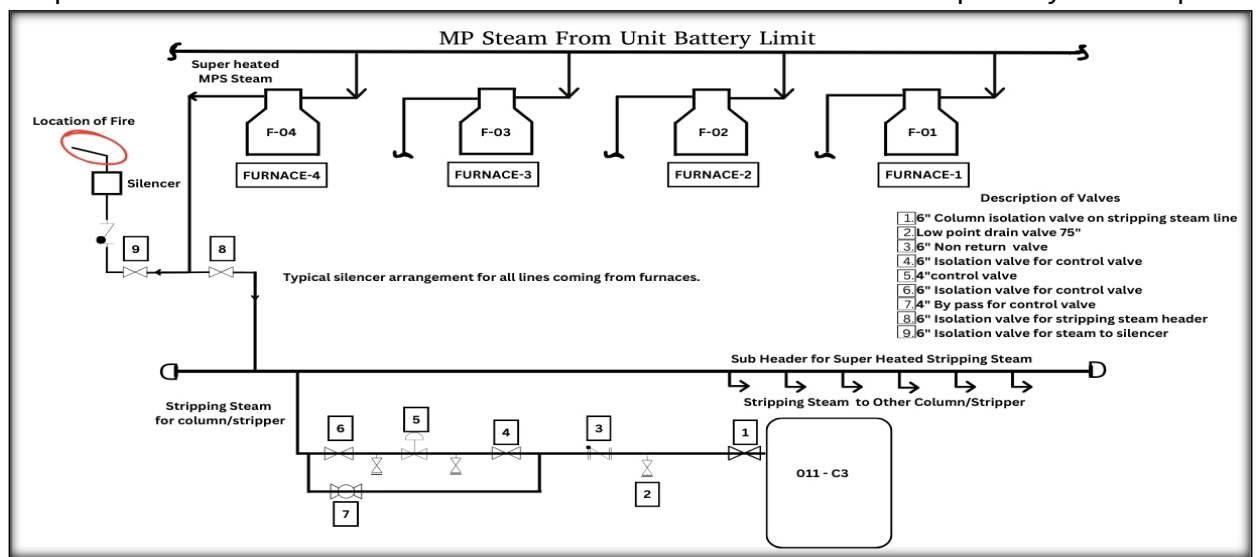
**Fig 1: Schematic of MP Stripping Steam to Columns/ Strippers**

Accordingly, the field operator was re-routing the steam from vent to the stripping steam header by closing the vent valve (V9- Refer FIG:1) and at the same time opening the main steam header valve (V8- Refer FIG:1), both located on the operating platform at approx.8.5m from grade. Upon diverting super-heated steam to steam header, a flash fire occurred at the vent of the crude furnace. One fire tender was already available in standby at CDU as per unit startup protocol. Fire fighting started immediately. A nearby remote operated "high-volume long-range monitor (HVLRM)" was used. Fire was extinguished within 12 minutes. Nine persons, who were involved in various startup activities in nearby area, sustained burn injuries. They were taken to refinery hospital and then were referred to other speciality hospitals.

1. The pipe length from the valve (V8- Refer FIG:1), from where steam was being diverted to the stripping steam header that led to the stripping columns steam inlet control valves, was around 20M implying a hold up capacity of approximately 1.4 m<sup>3</sup>. Instead of first preparing the header and heating by means of venting/ draining till the point (V2- Refer FIG:1) nearest to location of process mixing, the diversion was attempted from distant location (V8- Refer FIG:1).

4. Post incident, sample from drain points (V2- Refer FIG:1) of the stripping steam header was collected and sent to QC lab for testing. The reported density of hydrocarbon sample was 731.5 kg/m<sup>3</sup> and the sample also contained 10% of free water.

7. After the incident, it was reported that heavy naphtha was observed in drain points of the stripping steam header at multiple locations. Reportedly, the 4" control valve bypass valve (V7- Refer FIG:1), 6" non-return valve (V3- Refer FIG:1), and 6" block valve (V1- Refer FIG:1) in the stripping steam line to heavy naphtha stripper were passing.

8. It was informed that the non-return valves (i.e. V3- Refer FIG:1) in the stripping steam line to the columns had been replaced during the turnaround. The non-return valves had been tested prior to installation.

Naphtha backed up from heavy naphtha stripper (11-C-3) due to passing of isolation valves and NRV in stripping steam circuit (V1, V3, V7- Refer FIG:1), possibly aided by high liquid level in the HN stripper. Hence, the stripping steam line up to the 6" diversion valve (V8- Refer FIG:1) located at silencer platform was already full of Naphtha before the 6" diversion valve for routing steam from vent to the stripping steam header was crack opened. The liquid naphtha, when came in contact with superheated steam (320°C) vaporized and discharged through the steam silencer (V9- Refer FIG:1) as in the downstream side, there was a blocked outlet condition.

Auto ignition of Heavy Naphtha vapours (auto ignition temperature was 287.7°C as per the composition analysis) occurred.

- a) SOP to be developed for charging of steam headers. The same shall be known to all the concerned operating personnel.
- b) Latest approved version of SOPs with a version number to be made available with proper access control to prevent duplication of SOPs as per 7.5.2.1 of working group report. Industry to make a system to ensure availability of controlled document to the working personnel.

- f) Industry shall ensure minimal manpower is deployed in process area during critical activities such as unit startup, shutdown, etc.
- g) Method to check such critical NRVs should be developed. Means should be explored for online checking of such NRVs. Installation of double NRV shall be reviewed in utility/ process interface circuit for enhancing system integrity.
