## CASE STUDY

OISD/CS/2025-26/E&P/05

Title: Fatal Accident at Workover Rig

Location: Onshore- Workover Rig

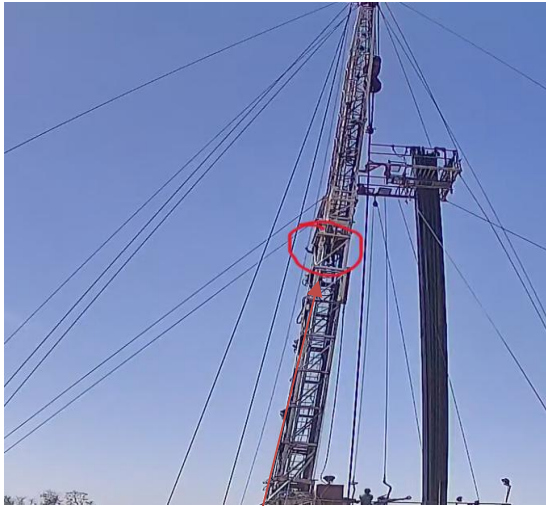
Approximate position from  
where the deceased fell down

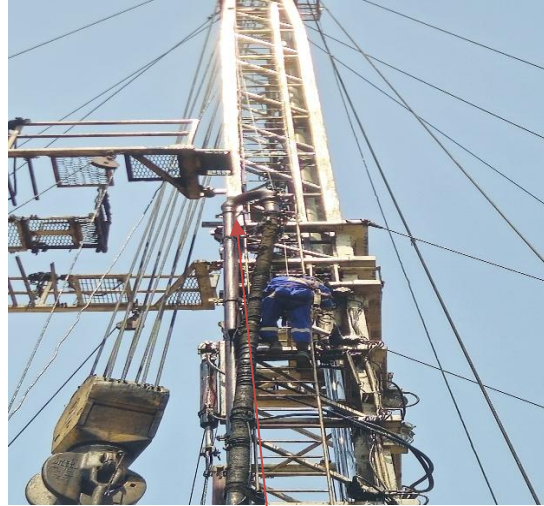
- e) The gooseneck with Kelly hose of the standpipe was positioned halfway across the monkey ladder, partially obstructing the monkey ladder and creating an additional climbing hazard. This seems to be something unusual. The ladder should always remain free of obstructions.

- a) The gooseneck with Kelly hose of the standpipe partially obstructed the ladder, forcing a sideward ascent. This likely caused the FPD wire rope to become entangled with the hammer union or similar obstruction. In attempting to manually free it, the device may have inadvertently disengaged, leading to a fatal fall.
- b) The victim had no training in working at heights and was not assigned a mentor or supervisor. This lack of competency and oversight contributed directly to unsafe practices and poor hazard recognition.
- c) Crude oil spillage resulting from a wet pull-out was observed on the derrick floor and monkey ladder. The presence of oil-contaminated surfaces likely created hazardous footing conditions, significantly increasing the risk of slipping or loss of stability during the victim's ascent. This environmental factor may have directly contributed to the fall.

Gooseneck with Kelly hose  
obstructing the monkey ladder.

- e) All safety gear like harnesses and FPDs must be checked before use. If anything looks damaged, it should not be used.
- f) Ladders and climbing areas must be free of anything that could block the way, like pipes or hoses etc. Before starting the job, workers must make sure the path is clear and safe.
