## CASE STUDY

OISD/CS/2025-26/E&P/06

**Title:** Major Fire at Drilling Rig

**Location:** Onshore- Drilling Rig

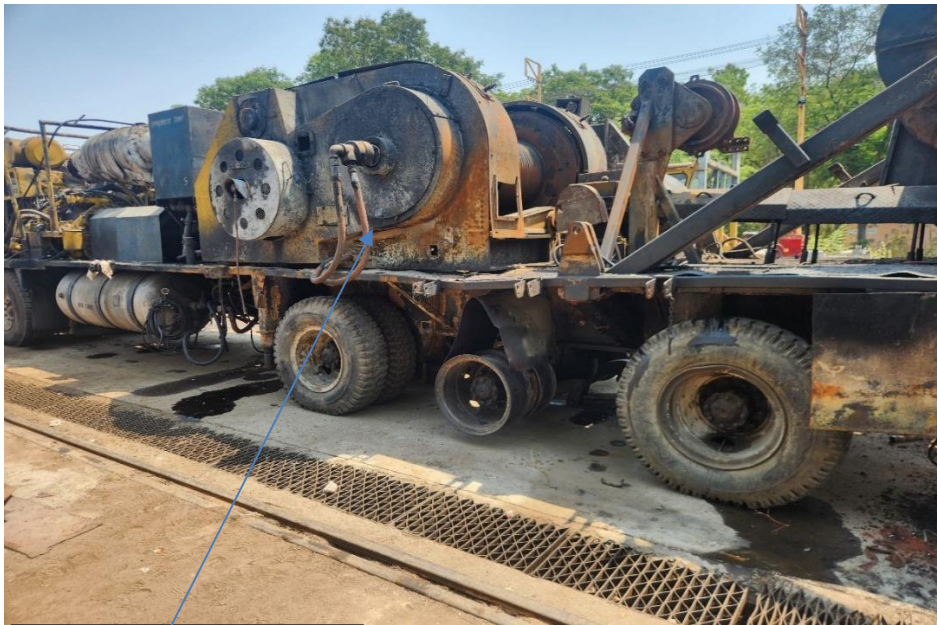
Draw works condition after fire
