## CASE STUDY

OISD/CS/2026-27/E&P/07

**Title:** Fatal incident at offshore vessel working with fixed unmanned platform  
**Location:** Offshore  
**Outcome:** Fatal injury.

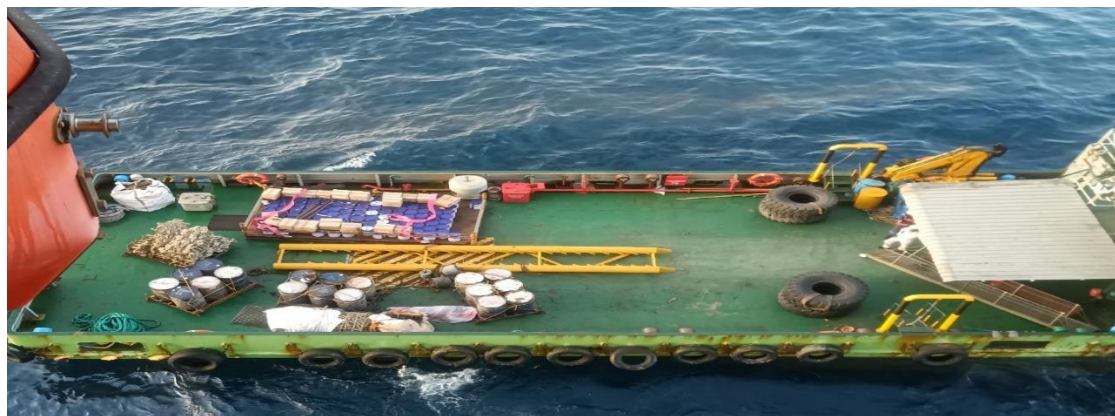
The operation was being carried out using the 2-ton auxiliary hoist under normal weather conditions. Four lifts were completed successfully and thereafter, during the fifth lift, an unintended upward movement of the idle main block caused it to strike the boom tip sheaves. The main hoist wire rope immediately failed, causing the main block to fall onto the vessel deck and fatally injuring a rigger engaged in rigging operations.

Figure I – Incident site area

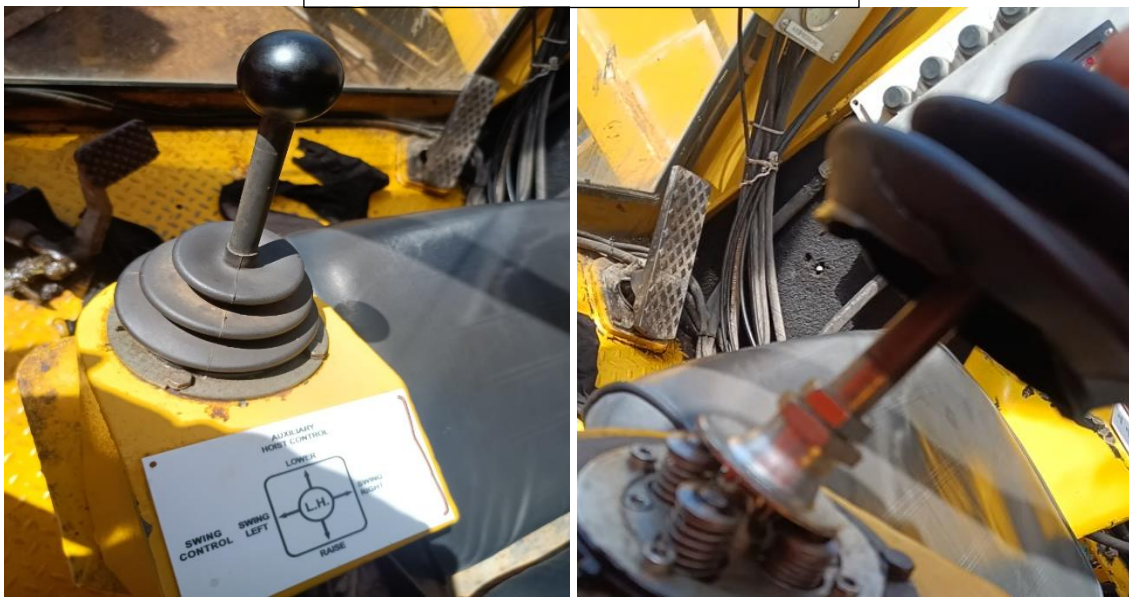
- The modified dual-joystick crane control system lacked engineering interlocks to prevent unintended simultaneous operation of blocks & boom, increasing the risk of operator error and unsafe operations.
- Adequate training, familiarization, and competency validation of the crane operator for operation of the modified dual-joystick crane system were not evident, including refresher training and handling of abnormal operating scenarios.
- Revamping work was carried out in 2019 by OEM which included installation of two dual-joystick control system in place of old four-lever function system. No Management of Change (MoC) records were available for this change.

Describing multiple controls on single joystick

**Figure II – Dual-joystick control system of crane**

- Introducing engineering safeguards and interlocks/barriers in crane control systems with help of OEM which will prevent unintended movement of main, auxiliary hoist & boom during the crane operation (through appropriate risk assessment and MOC procedure). Assess ergonomic suitability and human-factor engineering aspects of dual-joystick configurations. Install alarms, visual indicators, to minimize inadvertent joystick operation.

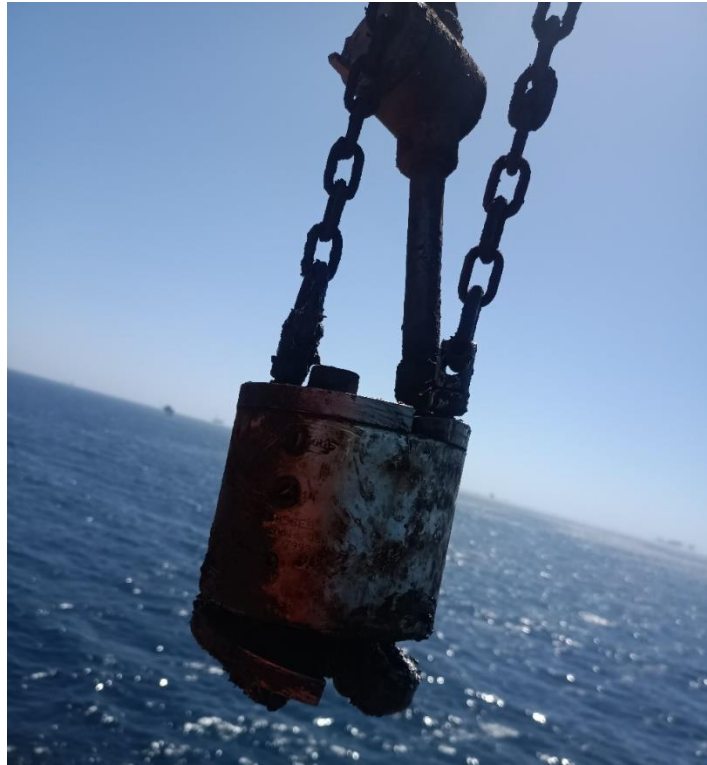
- The crane was operated without adequate pre-use verification and functional testing of the safety-critical Anti-Two-Block (A2B) system of the main hoist prior to commencement of lifting operations. The alarm system in the crane operator cabin was not functional.

- The Anti-Two-Blocking (A-2-B) system and alarm system of the crane were non-functional, as evident from operator interaction.
- The dual-joystick system lacked any preventive interlock/barrier against unintended simultaneous movement. During boom lowering, inadvertent activation of the main hoist caused the main block to strike the sheave assembly at the boom tip, leading to wire rope failure and fall of the block onto the vessel.
- Crane operators had not received adequate training specific to the modified dual-joystick crane system, and competency verification was found inadequate, adversely affecting safe crane operation.

**Figure III – Main Anti-Two Block**

- Strengthen verification and testing of safety-critical crane systems –
  - a) Verification of mandatory documented functional testing of A2B systems, limit switches, overload protection systems, and other safety devices prior to commencement crane operations.
