## CASE STUDY

OISD/CS/2025-26/E&P/14

**Title:** Fatal accident caused by tubing drop after the elevator was unlatched at the monkey board

**Location:** Onshore Workover Rig

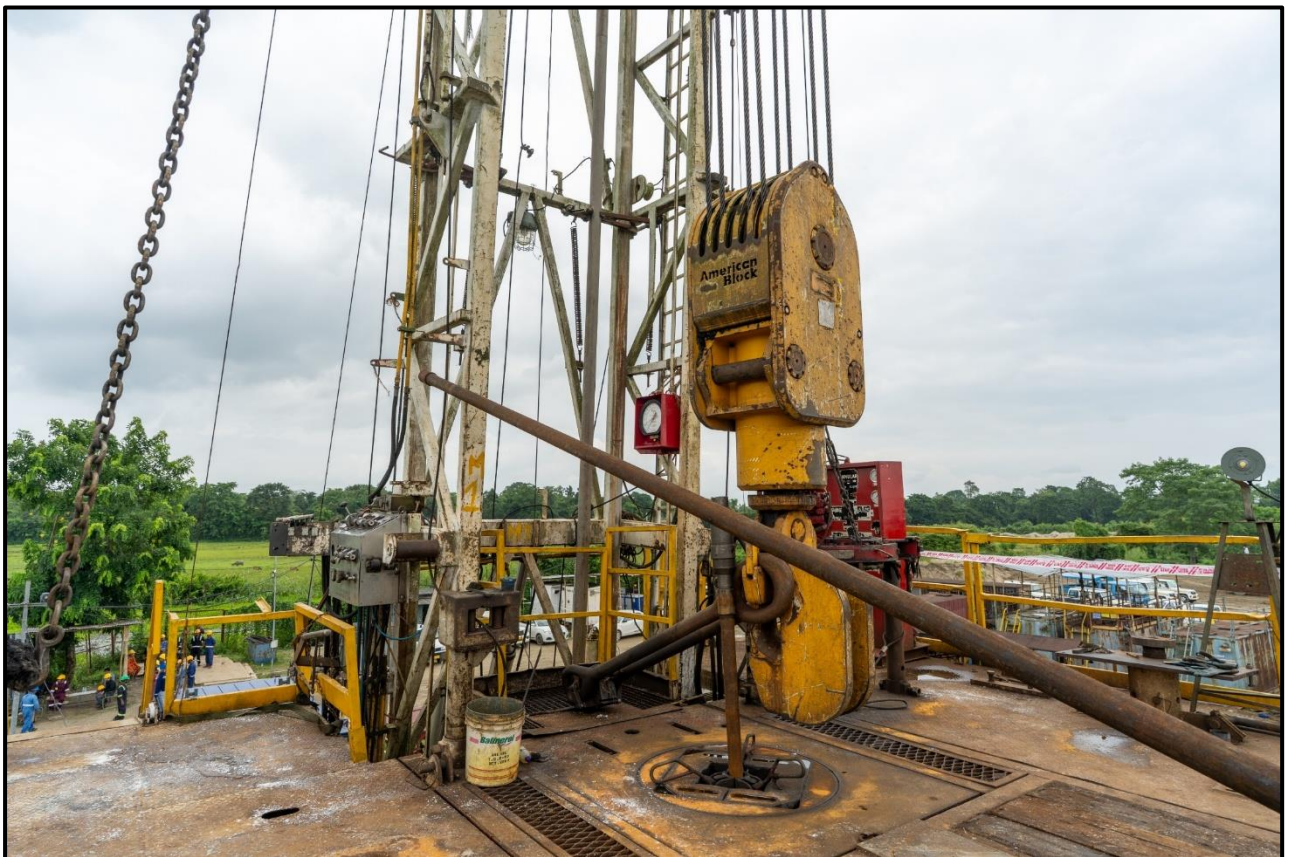
## POSITION OF TUBING DOUBLE AND TRAVELLING BLOCK POST INCIDENT

The topman pulled the tubing-double toward the racking fingers with the rope and unlatched it from the elevator. The tubing-double then slid down suddenly and uncontrollably. Its box end struck Night Tool Pusher near the driller console, causing a severe head injury. The tubing also hit a rig-man, who was descending the stairs, causing a serious injury by crushing him against the stair handrail, resulting in multiple rib fractures and broken left hand. The travelling block then descended uncontrollably, struck the box end of the tubing held on the slips, and its elevator and links hit the rig floor. Another rig-man engaged the brake. Fortunately, the travelling block's fall caused no further injury or damage.

5. The catwalk showed multiple impact marks and was misaligned with the substructure. Tubing-double, which had slid down the ramp, bounced over the V-door handrail and box end hit the tool pusher.
