## CASE STUDY

OISD/CS/2025-26/E&P/19

Dt.: 02.01.2026

Title : Fatal Accident during dismantling of Drilling Rig  
Location : Onshore  
Loss/ Outcome: Fatal Accident

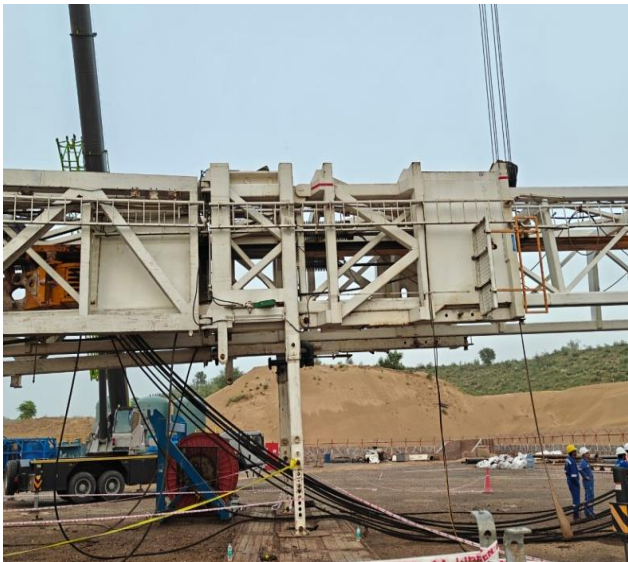
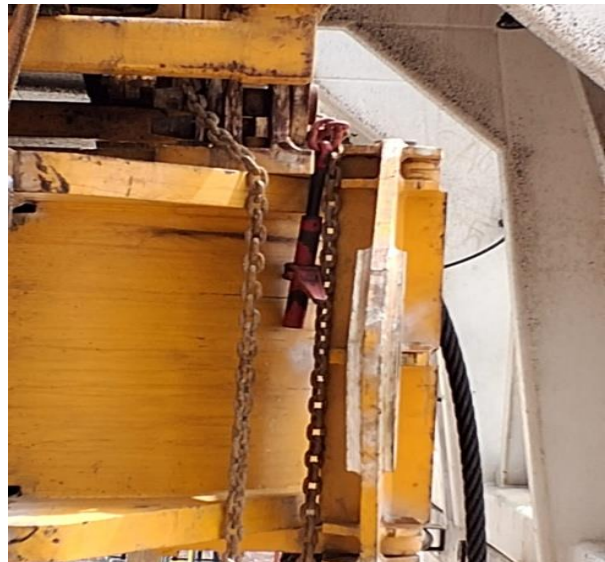
## Event Description (Visual – Layout)

The crane operator, acting on signals from the Driller who was relaying the IP's instructions, began tensioning the sling. When the chain securing the travelling block appeared slightly slack, the IP started loosening it using the ratchet boomer. Suddenly, the travelling block shifted approximately 1.5 meters toward the crown block, pulling the IP along with it. The IP struck the TDS (Top Drive System) guide rails and nearby rig structures, sustaining severe injuries. He was taken to a nearby hospital and later referred to city hospital, where he was declared dead on arrival.

- 4) Safety Harness of IP was anchored at incorrect location and harness lanyard was in the line of movement of the travelling block sling. Correct anchoring position for lanyard was not discussed in JSA.

- 5) Crew might have incorrectly assumed the travelling block would slide toward the derrick floor due to mast incline; instead, slack drill lines and block weight caused upward movement toward the crown.

- 7) The boomer's hook portion detached from one side during loosening, possibly due to excessive tension or pre-existing damage. Part of the failed ratchet boomer remained stuck with the travelling block. No periodic inspection report was available.

- 4) A pre-task harness inspection checklist should be incorporated requiring verification that the lanyard anchor point allows movement without risk of entanglement or getting trapped in the path of movement of heavy objects.

- 6) A dedicated signalman stationed with direct line-of-sight to worker and crane operator should be deputed for the job.
- 7) All equipment including ratchet boomer should be inspected before use. Periodic inspection of lifting and associated devices (including slings and ratchet boomer) should be practiced.
