## केस स्टडी / CASE STUDY

OISD/CS/2025-26/LPG/12

**Title:** Fatal accident due to electrical shock

**Location:** LPG Bottling Plant

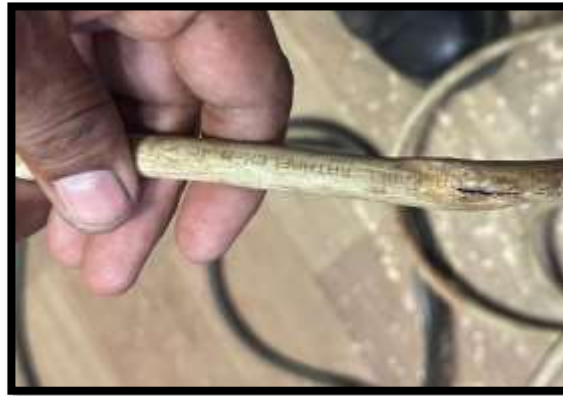
First responder, upon hearing a hitting sound on the floor, rushed to the incident site and saw the victim shivering by holding a damaged flexible electric cable in his hand and hitting the floor with his feet. Immediately he pressed the emergency push button of the PTDU.

- 1.1** The electrician used a non-standard extension box with damaged cable and connected it to an incorrect and unauthorized power source (PTDU: Motor push button station) inspite of having dedicated single-phase and three-phase connection sockets located at distance of 24 meters approx.
- 1.2** The temporary extension box was not fit for use. It was a makeshift arrangement where two different cables were joined together using insulation tape, and the cable was found damaged at multiple places. Sockets were not of industrial type (metal clad) and did not have any human protection like ELCB, RCCB.
- 1.3** Though plant was having industrial type of plug and junction box suitable for temporary power connection; however, it was not kept ready connected to an armoured cable. Non availability of this arrangement would have prompted electrician to use nonstandard extension board.

Temporary extension Box and cable

- 1.1.** Ensure that the dedicated single-phase and three-phase sockets are used for temporary electrical connection.
- 1.2.** Temporary electric power connection with Human body protection devices such as ELCB, RCCB etc shall only be used.
- 1.3.** The correct plugs and suitable armoured cables must be kept readily available at all times.
- 1.4.** Entity to review the current provision of sockets in the LPG shed and install additional connections wherever necessary to eliminate the need for temporary or unsafe wiring.
- 1.5.** Defective cables/ equipment should be identified and removed from the system.
