## CASE STUDY

OISD/CS/2025-26/MOLPG/22

**Title:** Major accident while operating service water valve for topping up of soap solution tray used for lubricating conveyor chain.

**Location:** LPG Bottling Plant

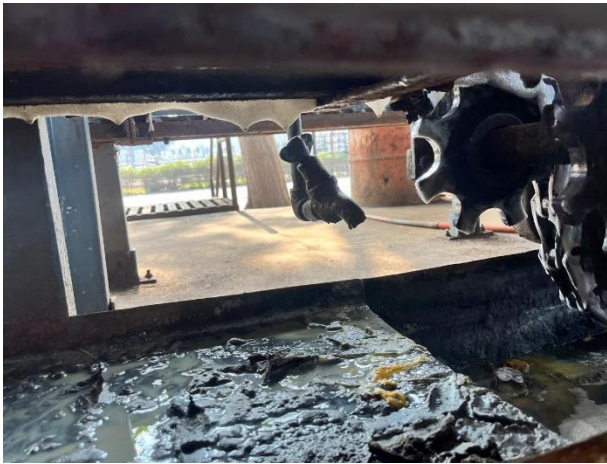
1. The IP (Injured person) operated the valve of service water line from beneath the conveyor on the other side of valve, without stopping the chain conveyor. This indicates an unsafe act and deviation from Standard Operating Procedure (SOP).
2. The isolation valve of service water line near the soap trays is positioned too close to the running sprockets
3. Approach towards the valve of service water line of soap tray of Drive Unit is very difficult due to the narrow clearance between the two conveyors, resulting in constrained and unsafe access to the valve.
4. The following unsafe act were observed from the CCTV footage:
  - a) IP was wearing a two-piece coverall with sleeves folded at both arms, resulting in loose end.
  - b) Many workers were seen using mufflers with loose ends.

Isolation valve position

- 2 **Relocation of isolation valve of service water line:** - Possibilities may be explored to position the valve at a convenient location away from the soap tray. Additionally, valve may be installed on both sides of the soap tray for easier access and safer operation.

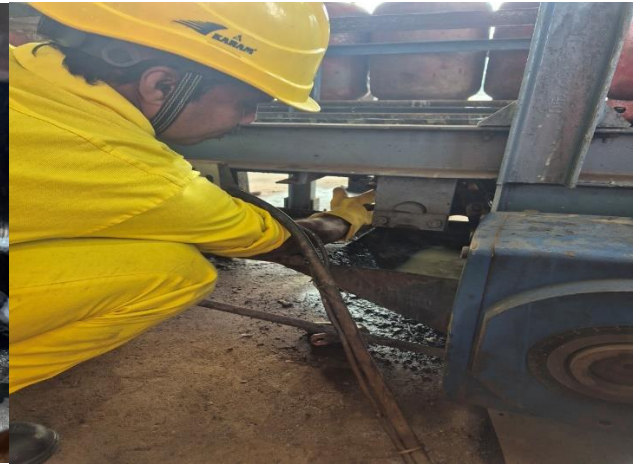
A contract workman was assigned the task of pouring soap solution and topping up of soap solution tray by opening the valve of service water line for chain lubrication. Instead of going to the other side of the chain conveyor where the valve of service water line was located, workman attempted to operate the valve from beneath the conveyor from the other side, without stopping the chain conveyor. This action caused his coverall sleeves to come into contact with the sprocket and further his hand near elbow also got trapped in the sprocket resulting in the amputation of his right hand.

Demonstration of act

- 3 **Sprocket Guard Installation:** - To install suitable safety guards on both sides of the sprockets to prevent accidental contact and ensure additional safety.
