## CASE STUDY

OISD/CS/2025-26/MOPOL/01

Title : HSD overflow from underground tank  
Location: POL Depot  
Loss/ Outcome: The overflown HSD reached the internal stormwater drain and the municipal drain outside the depot premises.

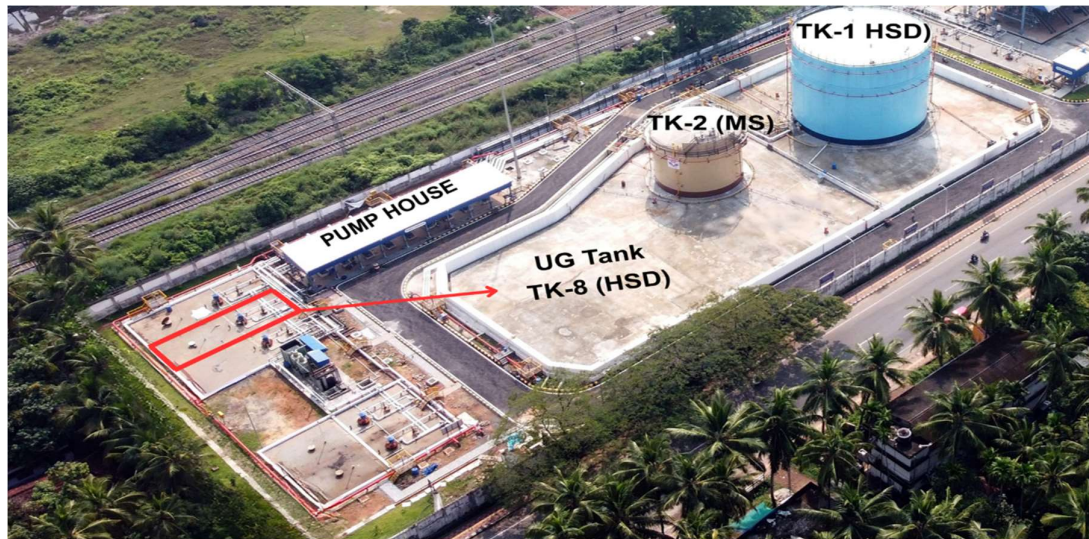
(Bird's-eye view of location)

The underground tank farm was enclosed by a kerb wall and the kerb wall had holes. The overflowed product drained through holes in the kerb wall and reached to the internal storm water drain near UG tanks kerb wall and the municipal drain outside the location adjacent to the boundary wall. The distance between UG tank farm kerb wall to the boundary wall towards north was 4.7 meters.

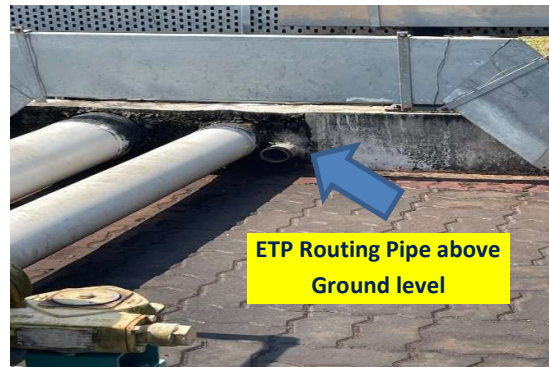
- III. The drain in the UG tank kerb wall area was provided. However, the slope of UG tank farm was towards north side whereas the existing drain was provided at southwest side and was directed towards ETP. The inlet of the drainpipe was approx. 80 mm above the dyke floor. The provided drainage was not effective, and this deviation was not recorded by location during routine inspection and maintenance and during the internal audits.

- The location shall strengthen the inspection and maintenance of the underground tanks (UG) kerb wall area. The kerb walls around UG tanks shall be inspected to ensure there are no holes. Drains shall be provided in the UG tank kerb wall area so that in case of any spillage, the overspilled product is directed to the ETP/OWS.
- Depot shall be provided with boundary wall with gates and sluice gates on drain to meet the objective of tertiary containment in accordance with cl. 6.4.2 (f) of OISD-STD-244). Inspection and maintenance of the drain valves shall be strengthened.
