## केस स्टडी / CASE STUDY

OISD/CS/2025-26/MOPOL/20

**Title:** Fire Incident at Above-Ground Ethanol Storage Tank During Receipt Operations

**Location:** POL Installation

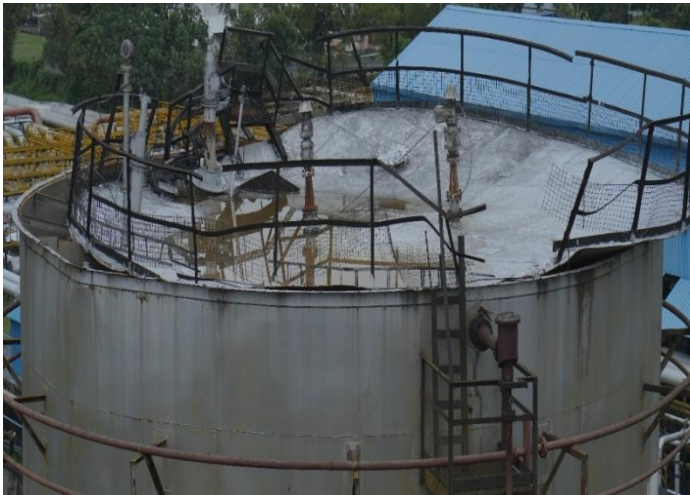
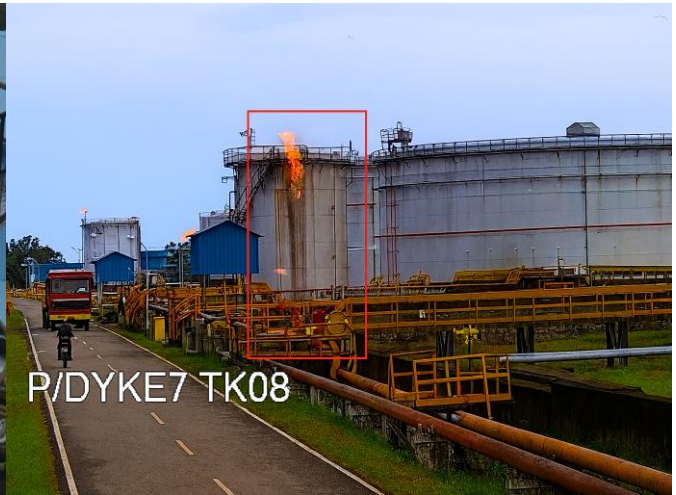
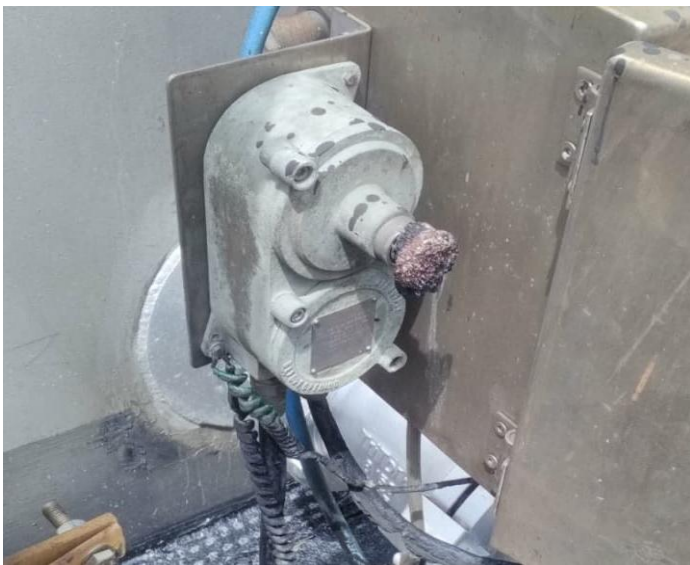
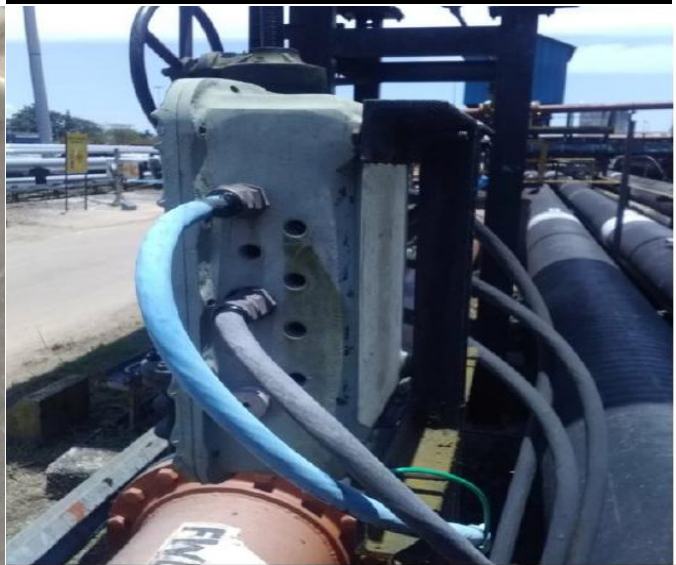
- Maintenance and inspection records for the expansion line were not available.
- The explosion occurred due to abnormal vapor pressure buildup in the tank. The tank and its bottom plate momentarily lifted, severing anchor bolts, before settling back. Subsequently, the shell-to-roof frangible joint failed, displacing the roof horizontally by about 1 meter. The top hand railing broke at multiple locations, the rooftop platform was damaged, and stairway grating with its support structure fell to the ground.

- All rooftop appurtenances were displaced or damaged. The dip hatch housing assembly, PV valve mounting assemblies, and HLS assembly were observed leaning in the same direction.

- The concrete ring beam foundation of the tank was fractured at multiple points.
- Of 17 anchor bolts, 10 were damaged and 2 were missing. Several bolts were severely corroded and thinned out. Anchor bolts were not checked during the last inspection.

- The tank had three earthing points, two taken from anchor chairs instead of using austenitic stainless steel grounding lugs on the shell.
- Earthing cables of rooftop instruments were found hanging along the stairway.

- Earthing bonding jumpers were not provided at multiple flange joints of MOV and ROSOV in the tank inlet pipeline.
- Inlet ROSOV and MOV cables were damaged by fire. The push button and indicator cover mounted on the ROSOV were also fire-damaged.
- The fixed foam pourer feeding pipeline was disconnected inside the dyke for modification work while the tank was in normal operation.
- Several flameproof enclosures inside and outside the tank dyke had compromised flameproof integrity.

- Adequacy of tank venting and design calculations shall be verified for any modification in the PVRV arrangement of storage tanks. The design shall also incorporate provisions for a silica gel trap and a flame arrestor for ethanol tanks while determining vent size adequacy.
- All the operations shall be carried out as per SOPs.
- Product storage tanks and thermal expansion pipelines shall be inspected and maintained.
- The flameproof enclosures shall be inspected for FLP integrity and that records are maintained.
- ROSOV cables leading to the control room shall be fire resistant.
- The tanks earthing shall be provided through grounding lugs and grounding lug material shall be austenitic stainless steel when attached to carbon or low alloy steel parts.
