OISD/CS/2025-26/P&E/07

Dt.:26.06.2025

Title: LNG leakage at LCNG Station.

Location: Liquefied to Compressed Natural Gas (LCNG) station.

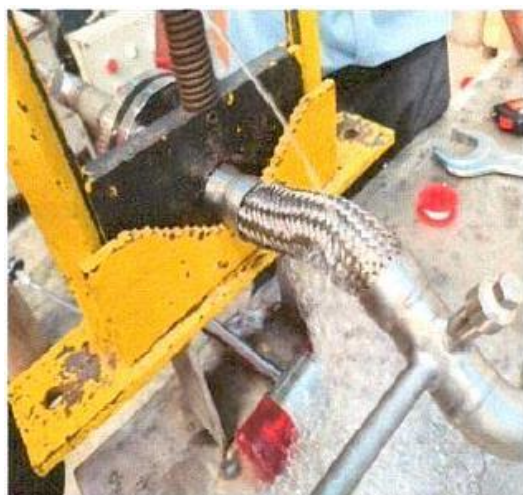
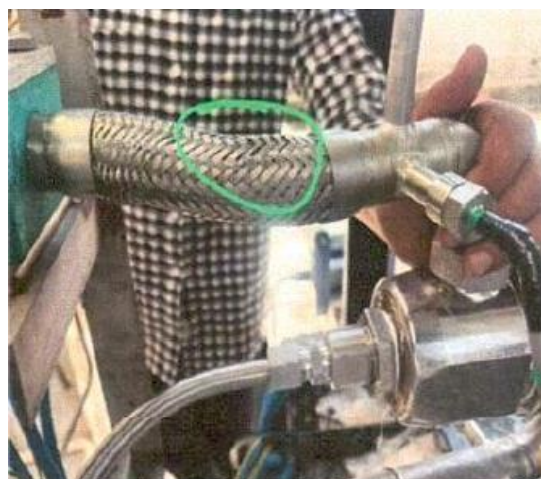
- h. The LNG leak occurred in the flexible connector (hose) on the pump return line (25 NB), which was a wire-braided, corrugated stainless-steel hose rated for the intended service. The rupture point was located at approximately the 10 o'clock position.

- i. Third-party failure analysis attributed the hose rupture to prolonged cryogenic exposure and continuous vibration from the reciprocating pump, resulting in fatigue and eventual failure.

- j. Although the Quantitative Risk Assessment had recommended visual inspection checklists for flexible connectors, no inspection records were available. The flexible hose had not undergone hydrostatic testing after commissioning, despite being in service for nearly four years. Similar maintenance deficiencies were observed in other hoses installed at the facility.

The return line flexible connector (hose) of Pump P-21C, which leaked, failed due to cyclic exposure to cryogenic temperatures, intermittent operations, and continuous vibrations. No hydrotesting of the flexible connector (hose) was carried out in past 4 years.

- a. As per Annex-D of EN 12434:2000 (Cryogenic Vessels: Cryogenic Flexible Hoses), all cryogenic flexible connectors (hoses) must undergo routine visual inspections under operating conditions at defined intervals to identify early signs of deterioration. Further, a formal flexible connector (hose) replacement policy should be established for all flexible connectors (hoses) subjected to cryogenic temperatures and mechanical vibrations.

- b. A review of the requirement of hydrotesting the connecting flexible connectors may be carried out, preferably in consultation with OEM. The review may keep in view that for similar application of LNG transfer hoses, it is prescribed in clause 4.10.7(e) of OISD-STD-194 (2025 edition), that LNG transfer hoses shall be tested annually to the maximum pump pressure or relief valve setting.
