## CASE STUDY

OISD/ CS/ 2025-26/ P&E/ 10

Title: H<sub>2</sub>S exposure & fatality on external floating roof tank deck

Location: Oil Movement & Storage area of Refinery

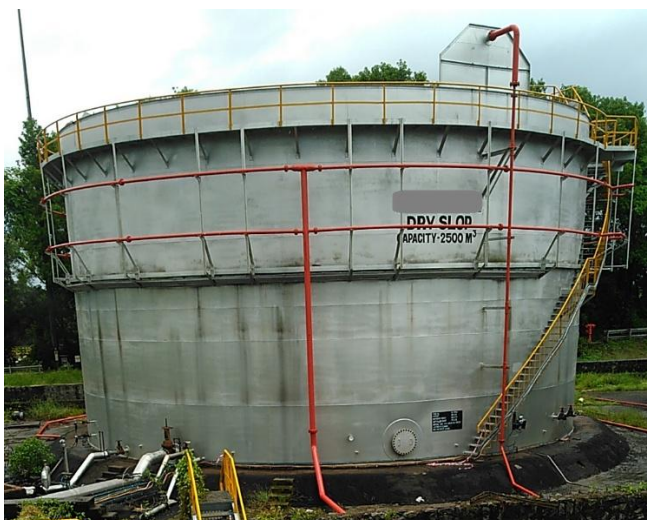
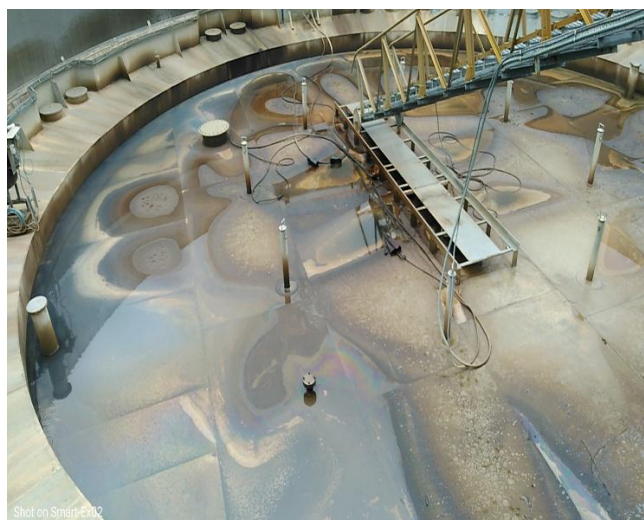
In the morning shift, an OM&S area operator was sent to inspect the slop tank roof to check for rainwater accumulation on the floating roof deck. As there was no contact from him for quite some time, another operator was sent to find him. 2<sup>nd</sup> operator informed on walkie-talkie that 1<sup>st</sup> operator has fallen on roof deck of the slop tank. He attempted to evacuate the first operator by going onto the floating roof deck. 3<sup>rd</sup> Operator, who was in near-by area, rushed to top of slop tank and saw both operators lying on the floating roof deck. He communicated the same on walkie-talkie and asked for emergency assistance.

1. The concentration of H<sub>2</sub>S on slop tank was observed to be quite high (in the range of 40 ppm at the top platform of the tank) even 48 hours post-incident.
2. Presence of oil was observed on the tank floating roof deck, indicating slippage/ escape of tank contents onto the roof floating deck upper side.

6. During the time of incident, floating roof deck was about 5 m below the top platform creating a confined space area.
7. In night shift prior to the incident, it was raining heavily. Slop tank level was observed rising and perceived to be fluctuating by OM&S panel officers.

The immediate cause of the fatalities was acute inhalation of H<sub>2</sub>S gas at concentration above immediately dangerous to life or health (IDLH). The injured person had entered the confined space without the necessary permit/ OISD standard prescribed precautions.

2. A detailed inspection of the slop tank shall be carried out to assess the integrity & healthiness of floating roof & its appurtenances in case presence of oil above the floating roof deck is observed.

4. Entry onto a floating roof tank when the roof is more than 3 meters below the top is classified as a confined space entry. Installations shall strictly enforce the Work Permit System to control an unauthorized descent onto the floating roofs deck. Prior to such entry, all safety precautions stipulated under clause no. 9.2 of OISD-STD-108 shall be complied.

5. Marking/ painting at 3-meter level (from the top of the tank) on the interior side of the tank shell shall be provided in all floating roof tanks to alert personnel about the confined space.
