## CASE STUDY

OISD/CS/2025-26/P&E/17

Title: Fire in 2" hydrocarbon drain line.

Location: Slug Catcher Area in Gas Processing Plant.

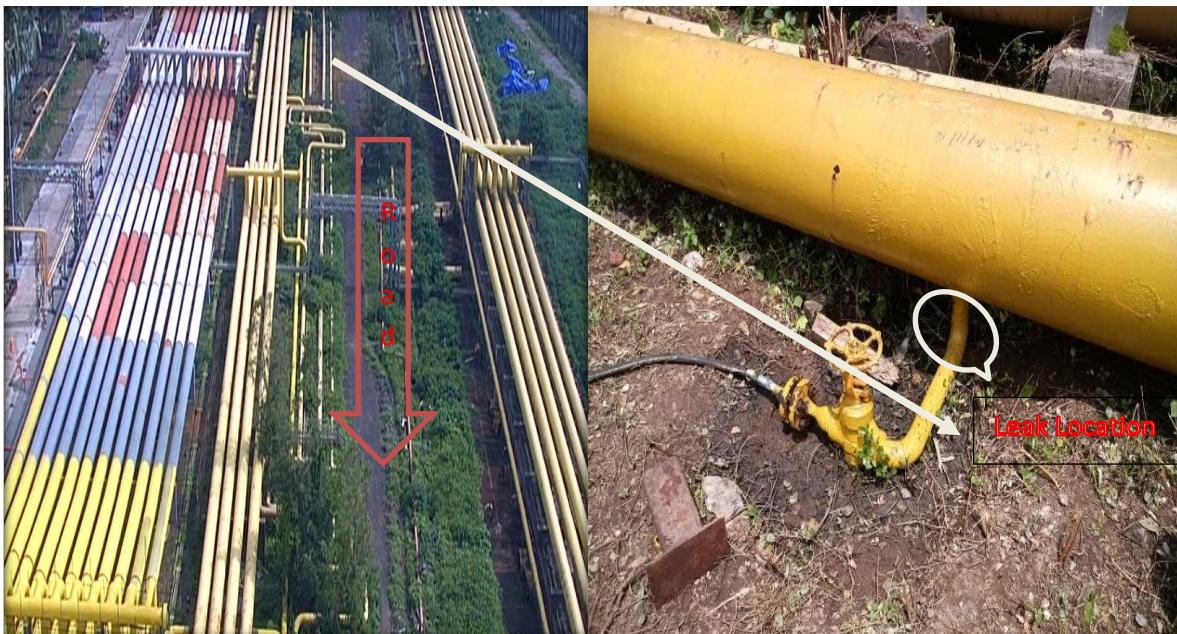
A hydrocarbon leakage occurred from elbow in a 2" drain line in a 18" gas interconnection pipeline adjacent to slug catcher area followed by a major fire. Firefighting operations were immediately initiated. The affected pipeline was isolated and adjoining sections were shutdown. Depressurisation and cooling measures were undertaken simultaneously. The fire was contained locally within 30 minutes and extinguished in around 2 hrs 40 mins. No casualties were reported in connection with the incident. Normal operations at the GPP were restored on the next day.

The cause of hydrocarbon leak was the JCB hitting the 'L' shaped 2" drain line (located at the proximity of road) of the 18" interconnection gas line in the slug catcher area during the scrapping of Road for cement surfacing work. The latent failure was absence of marking/ barricading around the protruding drain line as well as non-availability of crash barrier/ barricading on roadside to protect the pipelines.

- c. Crash Barrier or physical barricading shall be provided along the slug catchers to prevent any impact on the hydrocarbon lines.
- d. All the piping system shall be inspected (External & Comprehensive inspection) in totality as per clause 7.0 of OISD-STD-130 inclusive of small-bore piping and dead legs.
