## A CASE STUDY

OISD/CS/2026-27/E&P/03

**Title:** A minor fire incident at well site.

**Location:** On-shore Location.

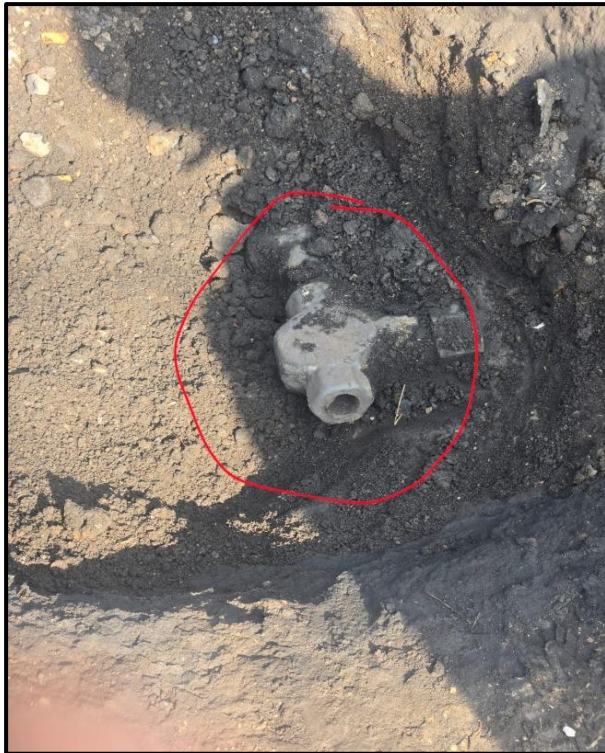
**Picture-1**

2. Cellar pit and Annulus valve with fittings were buried under the debris. Only downstream side of needle valve was found exposed from debris, which was the location from where gas had leaked.

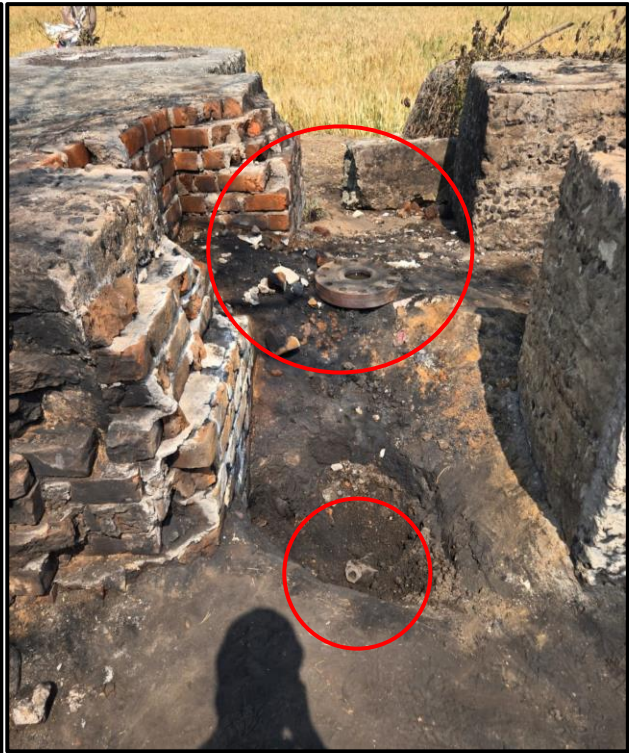
**Picture-2**

3. Cement was found inside the top flange of spool (tubing side) without blind flange.
4. Observed rusting and corrosion on annulus valve and fittings which were buried under debris. Fittings were replaced after the incident.

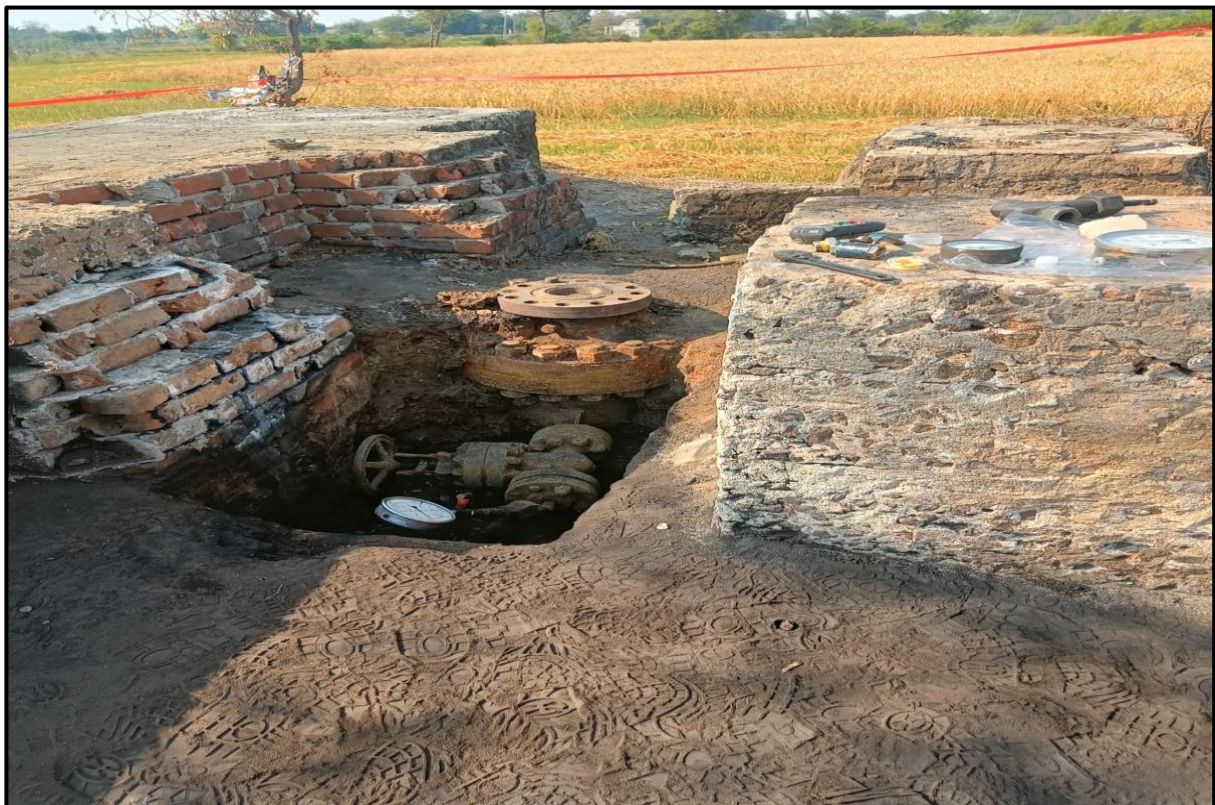
**Picture-3**

**Well site and annulus**
