# Learning from Incidents in Process Industry

**Workshop on Hazards and Safety in Oil & Gas Industries**  
**23rd – 25th February 2026**  
**Seminar Hall, IIT Delhi**

# Accidents in last 2 years (P&E)

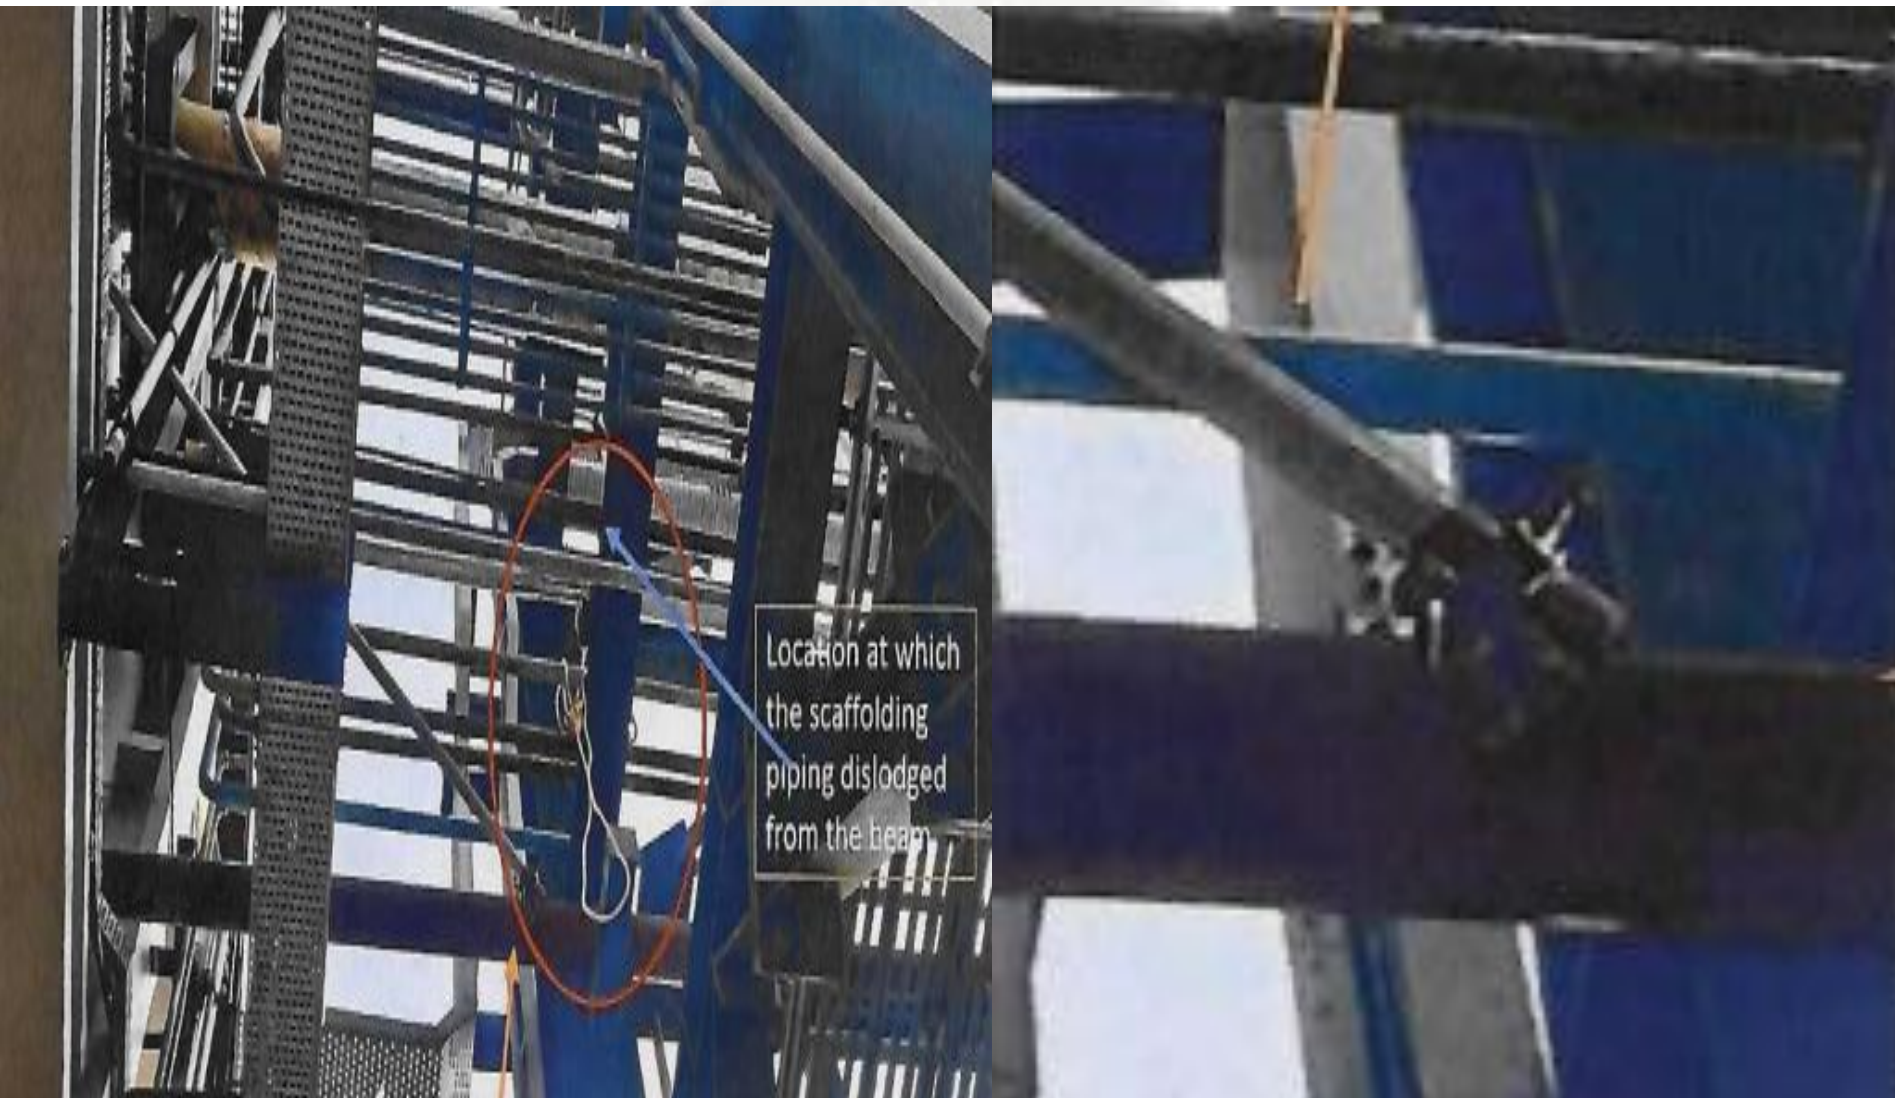
**Fatal accident due to fall from height.**

**Loss/ Outcome:** Fatality of a contract worker

- Simultaneous removal of both the hooks of lanyard or full body harness while movement.
- Slippage of support clamp of the scaffolding pipe.
- Inadequate supervision and monitoring, disregard of JSA.

- In scaffolding red tagging/ signboard should be displayed at the entry exit points and the transition location for all not fit for use scaffoldings.
- Safety net for arresting fall from height to be provided wherever it is required and feasible.
- Safe working platform and proper access to work site at height to be ensured before permit clearance.

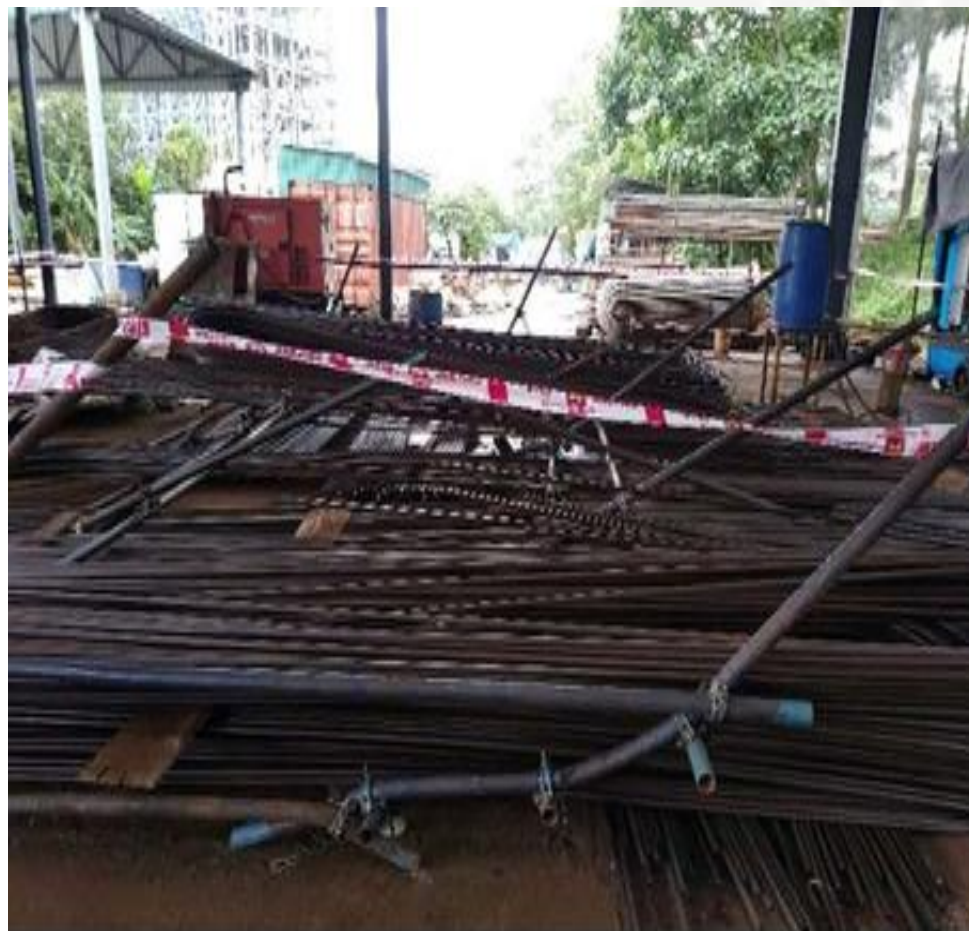
Collapsed structure without base plate, braces, safety signage

Usage of an inadequately constructed structure and the failure of system to prevent/ check the same.

- For jobs for which SOP is unavailable (for safe execution), it is mandatory to carry out JSA before issuing the work permit
- Guideline for temporary structures and its usage should be developed. The usage of the temporary structure should be restricted to the load for which it is designed.
- Rescue activities should preferably be carried out by trained personnel. Ambulance services should be preferably utilised for movement of casualty. Mock-drills for rescue should be carried out to ensure awareness to all.

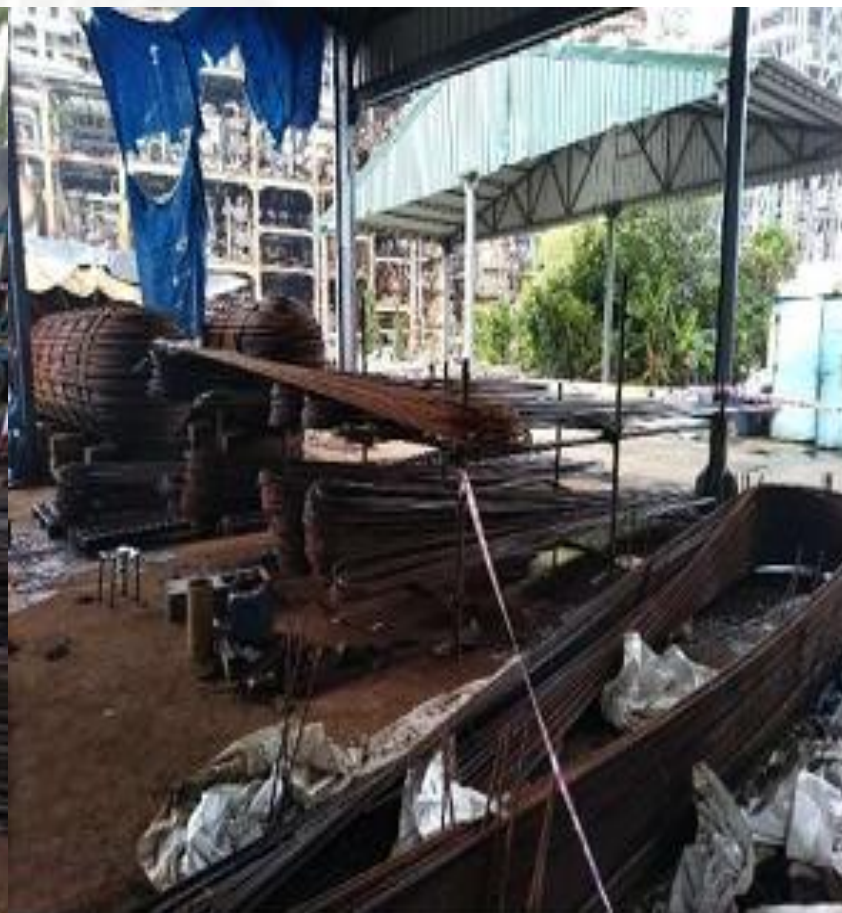
Stacking of U-Tube bundle beside the collapsed structure

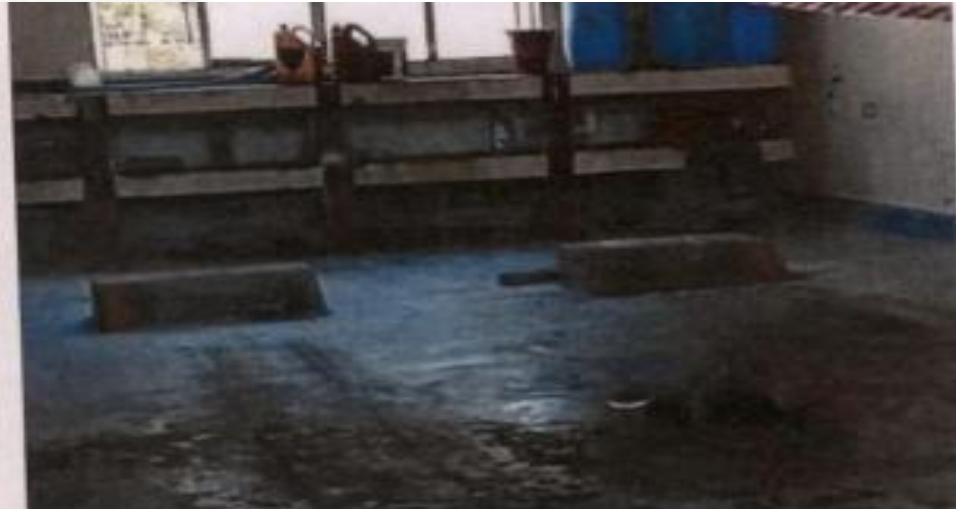
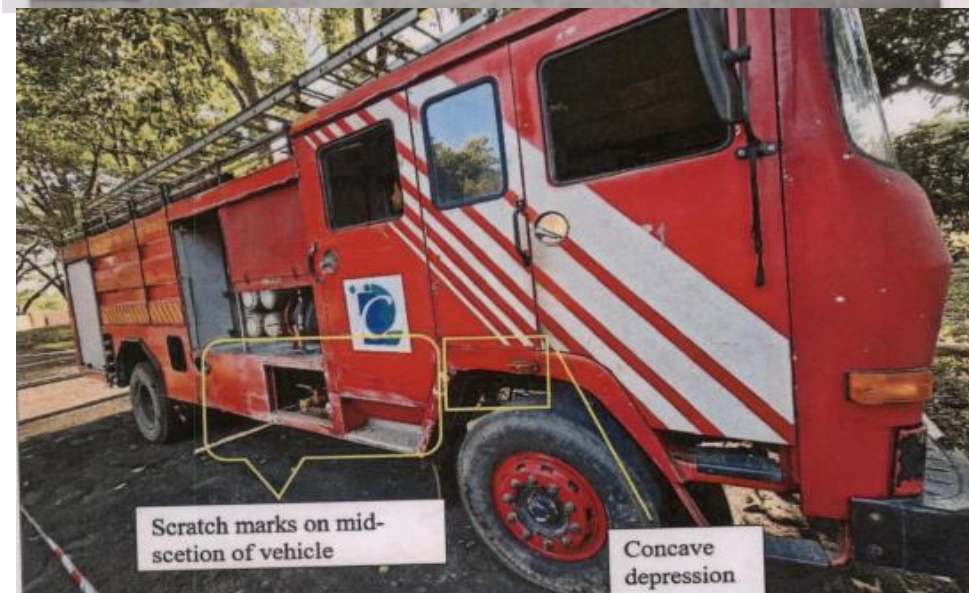
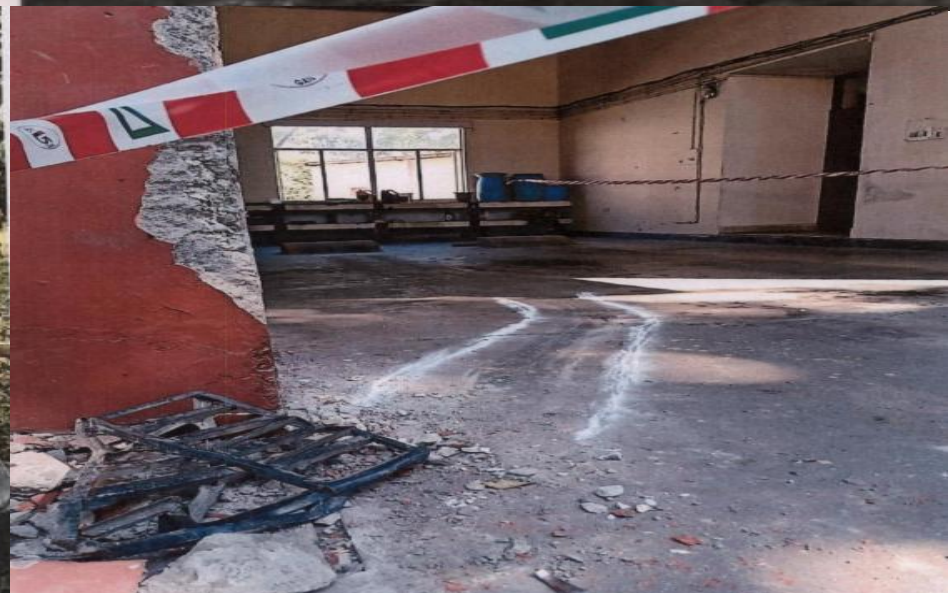
**Fatal incident during static running of fire tender.**

**Loss/ Outcome:** Fatality of fire crew.

- Most probable cause was that the tender, was started while the driver (fire crew) was standing outside of the vehicle. When the vehicle moved (probably due to gear being engaged), he was trapped between mudguard of front wheel and adjacent concrete column.
- The above action was in deviation from Standard Operating Procedure: "Start the engine with operator positioned on driver seat & run at idle speed".

- Strict adherence of Standard Operating Procedure to be ensured.
- The activity to be incorporated in HIRA (Hazard Identification & Risk Assessment) register of the company and risk rating to be revised."
- Behaviour based training to be imparted to all employees/ workers periodically.

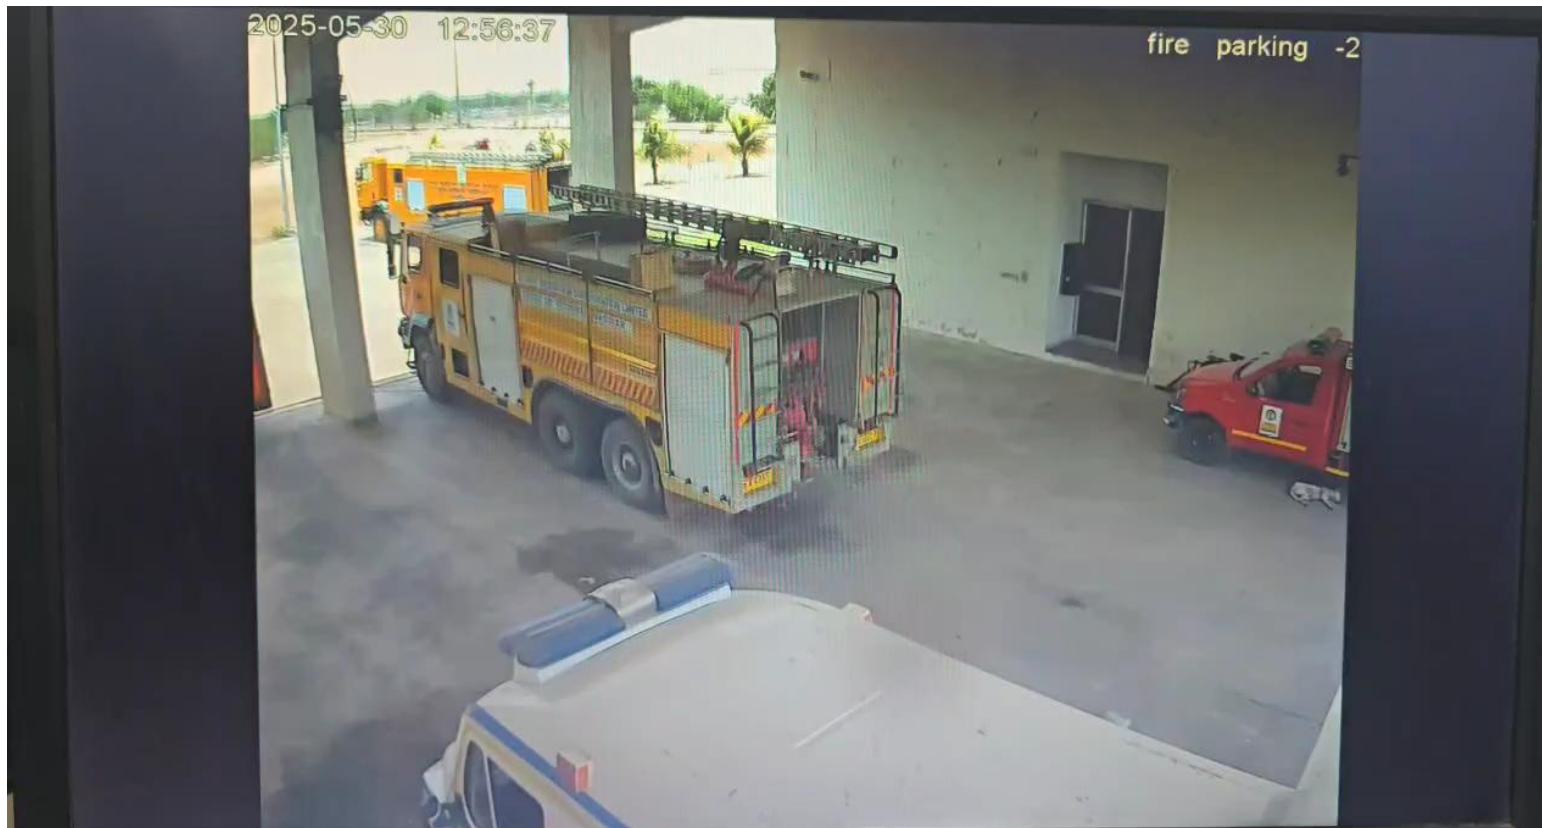
**Fatal incident during Parking of fire tender in reverse.**

**Loss/ Outcome:** Fatality of fire crew.

- Negligent/Lack of coordination between fire tender driver & Fireman while reversing of vehicle inside parking bay.
- Inadequate driving skill of the driver cum pump operator.
- Casual behaviour of deceased fireman during guiding the fire tender in parking.
- Non-availability of reverse parking sensors as mandated by The Central Motor Vehicle rules, 1989 and its amendments.
- **Learnings:**
- Reverse parking of fire tender/other heavy vehicles, especially in enclosed areas, to be avoided
- SOP should address positioning of the person guiding the tender should be visible in the rear-view mirror during parking.
- Heavy vehicles like Fire tenders, foam nursers, Mobile Oil Spill Recovery Unit (MOSRU's) etc. to be fitted with Reverse Parking sensors. It is also suggested that rear view camera may be included in specification,

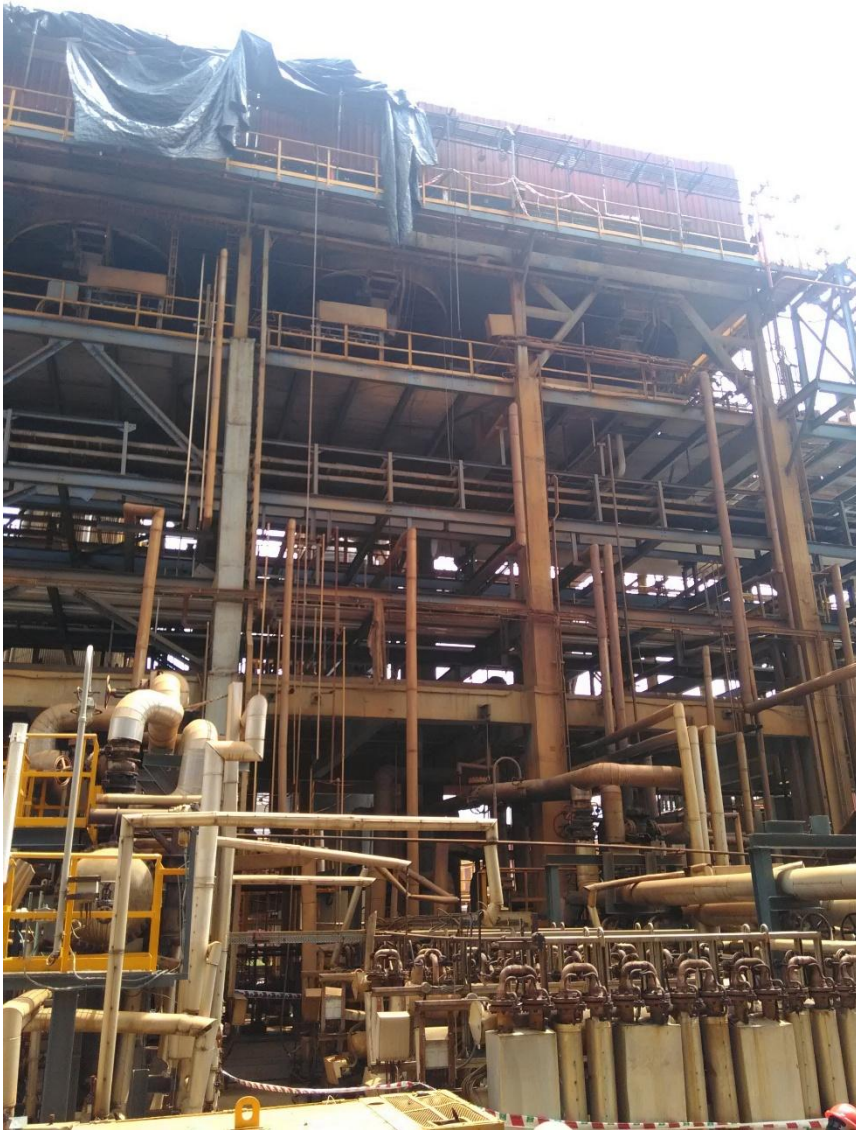
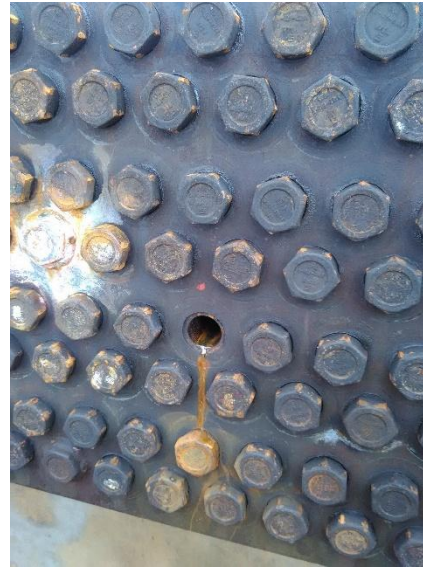
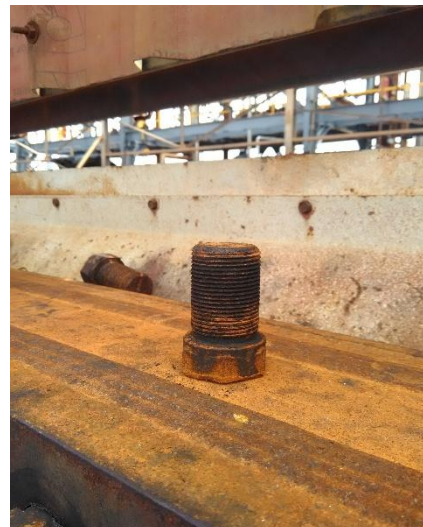
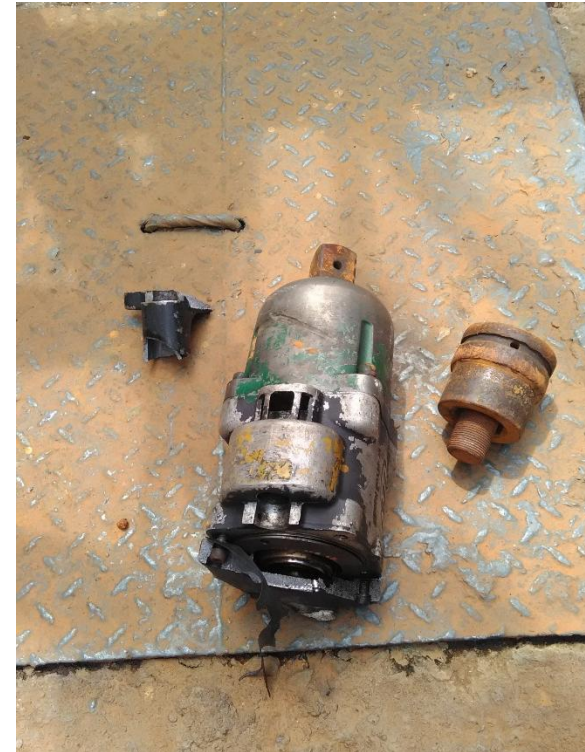
## Fatal Accident due to fall from height

**Loss/ Outcome:** 1 Fatality.

- Injured person attempted to tighten the plug to arrest the sweating (leak) and might have accidentally loosened it (The thread of the plug and the tube were intact and there was no sign of shearing) while the equipment was still in pressurized condition for hydrotesting.
- Due to the continuous work hours and resultant fatigue, IP might have thought of finishing the job by tightening the bolts.

- No repair activity shall be carried out while the equipment is pressurised for hydrotest.
- SOPs specific to the nature of job should be shared to the executing agency or the agency should be made aware of the practices/ procedures for executing the job in a safe manner.
- For critical activities like hydrotest, a competent supervision shall be ensured.
- Effective communication should be ensured between crew members.
- Tool-box talks should cover job specific actions. Precautions against all potential hazards should be reinforced through daily tool-box talks.

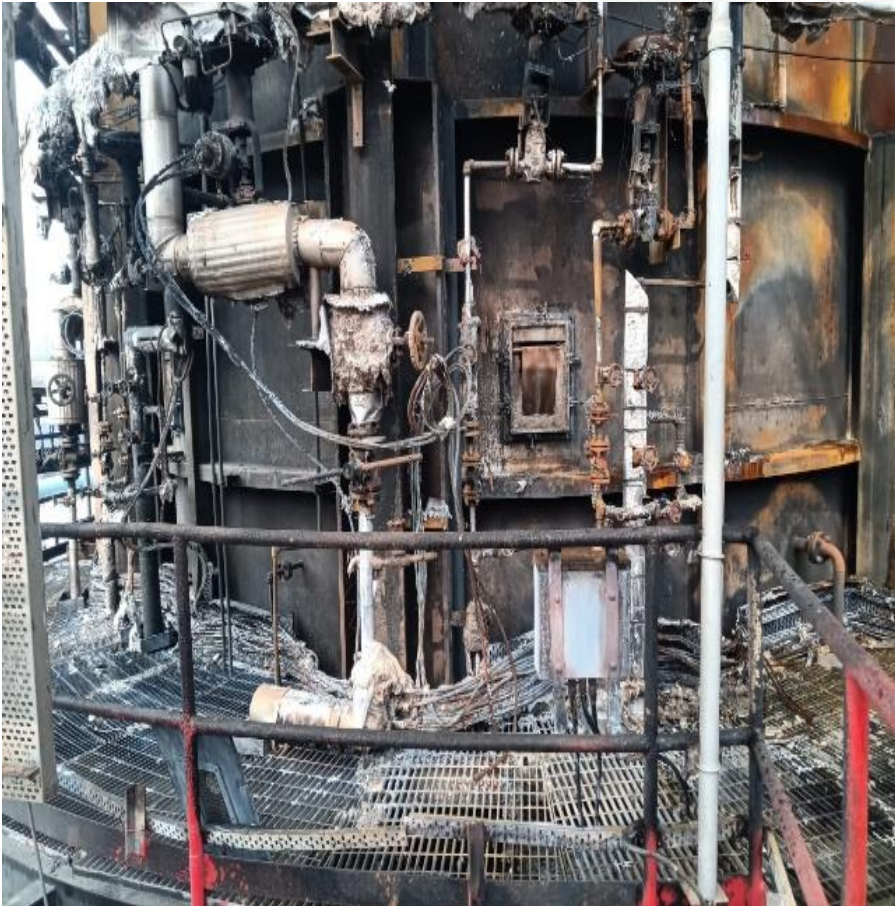
## Fire in Naphtha Splitter Reboiler Furnace

**Loss/ Outcome:** No Loss of life/ Injury.

**Root Cause:** Fire in the furnace was result of naphtha leakage from the Naphtha Splitter -1 reboiler convection bank tube. Naphtha caught fire due to the high temperature (around 720°C in arch) in the furnace. Tube failure can be attributed to high rate of corrosion .

- MOC system in line with OISD-STD-178 to be followed for all changes.
- Any scheme raised in MOC system should be drawn to its proper conclusion.
- Inspection report shall include all the observations in details.
- The monitoring of critical parameters, feed quality, etc. should be strengthened/ frequency increased for known failure cases.
- API standard 530 shall be used to calculate remaining life of heater tubes as stipulated in clause no 10.2.4 of OISD-STD-133.
- Process trip incidences should be properly investigated and record to be maintained.
- Shut Down planning of units shall be decided based on the health of the critical equipment and activities shall be taken up accordingly.

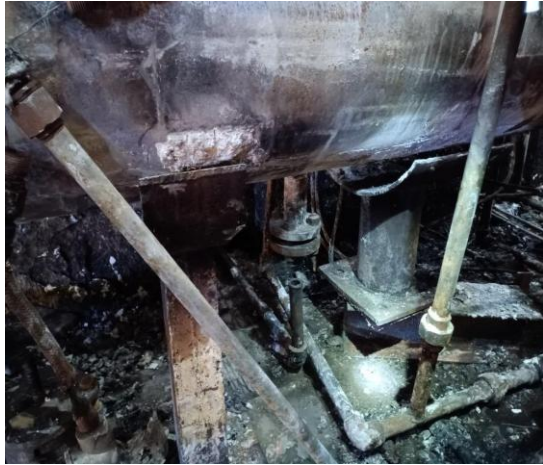
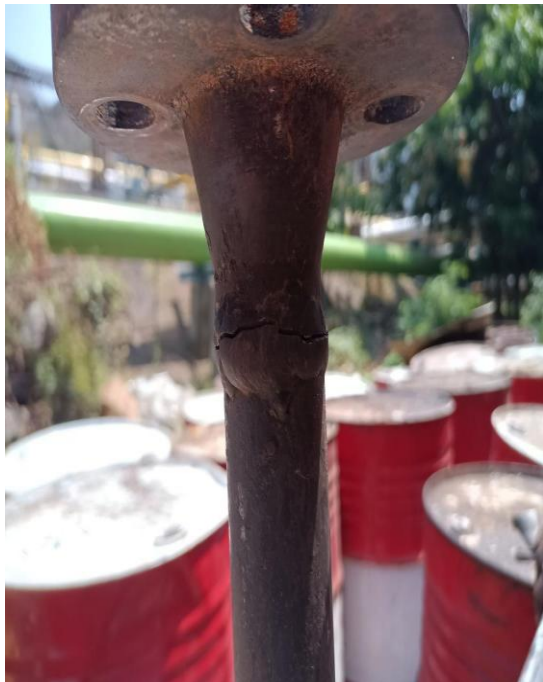
## Fire Incident in Gas Compressor House

**Loss/ Outcome:** No Loss of life/ injury.

- 1" drain line from the weld joint connected to the discharge volume bottle of the compressor snapped at the weld joint, weakened by internal corrosion & erosion. The failure was aggravated by mechanical stress due to absence of proper pipe support coupled with high vibration.

- Pipeline supports shall be provided based on detailed load calculations.
- Lack of timely response to various alarms should be properly addressed.
- Comprehensive inspection plan for small bore pipe inspection should be followed.
- Casing vibration and bearing temperature should be monitored on periodic frequency.

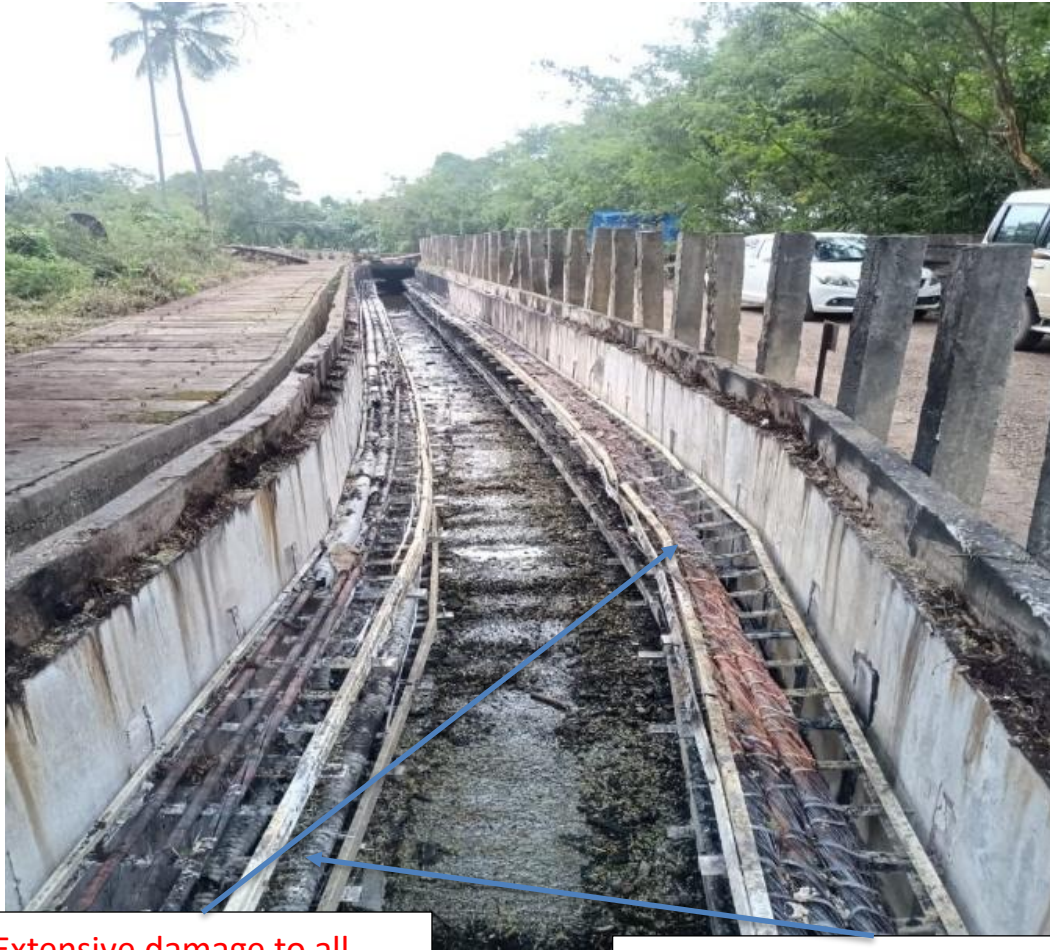
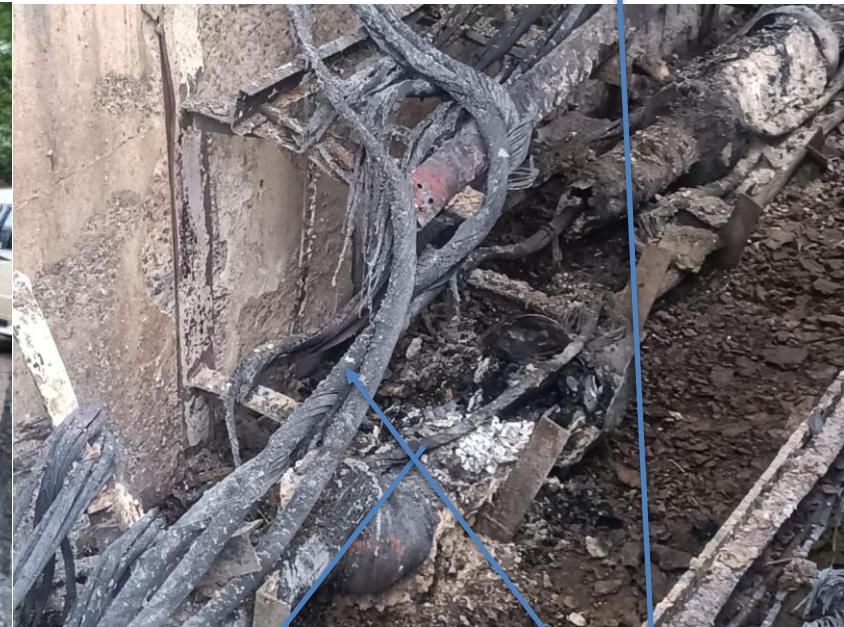
## 220 KV cable fire incident in a RCC cable trench

Extensive damage to all 12 power cables in a stretch of 175 m

Bare copper conductor with all outer covering viz XLPE insulation etc. melted away

Initiation point of the damage with extensive damage to cable trays, supports, adjacent concrete structure & melting away of copper conductor

Cable joint after explosion

**Loss/Outcome:** Complete damage of 4 nos. of 220 KV feeders in a span of 175m

- The cable joint likely deteriorated due to poor workmanship during jointing or manufacturing defects. Upon energization, switching surge triggered joint failure, causing an explosion and subsequent thermal damage to adjacent feeder cable insulations, leading to multiple cable failures.
- Absence of systemic monitoring such as Partial Discharge (PD) detection resulted in undetected deterioration. Additionally, despite availability of the Distributed Temperature Monitoring System (DTMS), early warning and preventive action could not be taken due to non-utilization and lack of monitoring.

- Ensure continuous monitoring of distributed temperature measuring system (DTMS)
- Online Partial discharge (PD) monitoring system for all EHV systems shall be provided for detecting faults at an incipient stage
- EHV Cable joints inside a cable trench should be protected against fire/explosions by suitable means like fire- and explosion-proof partitions, joint protection boxes, fire- and explosion-proof blankets, covering with sand etc.

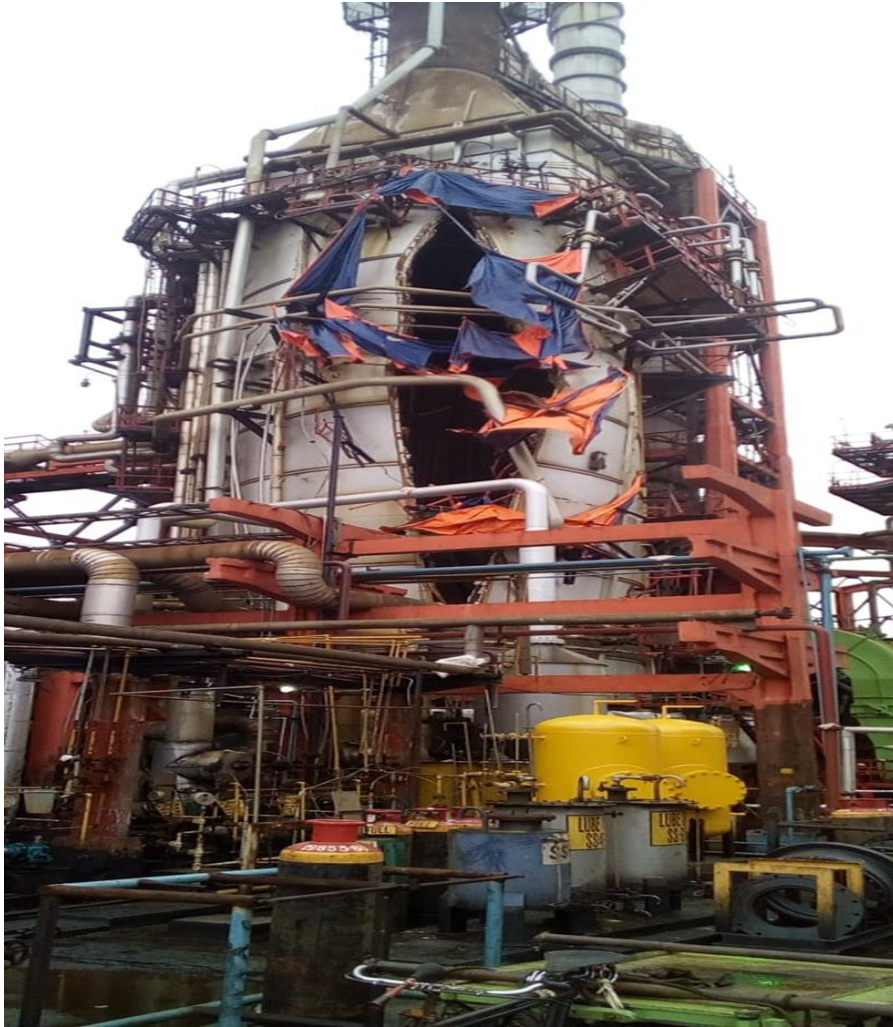
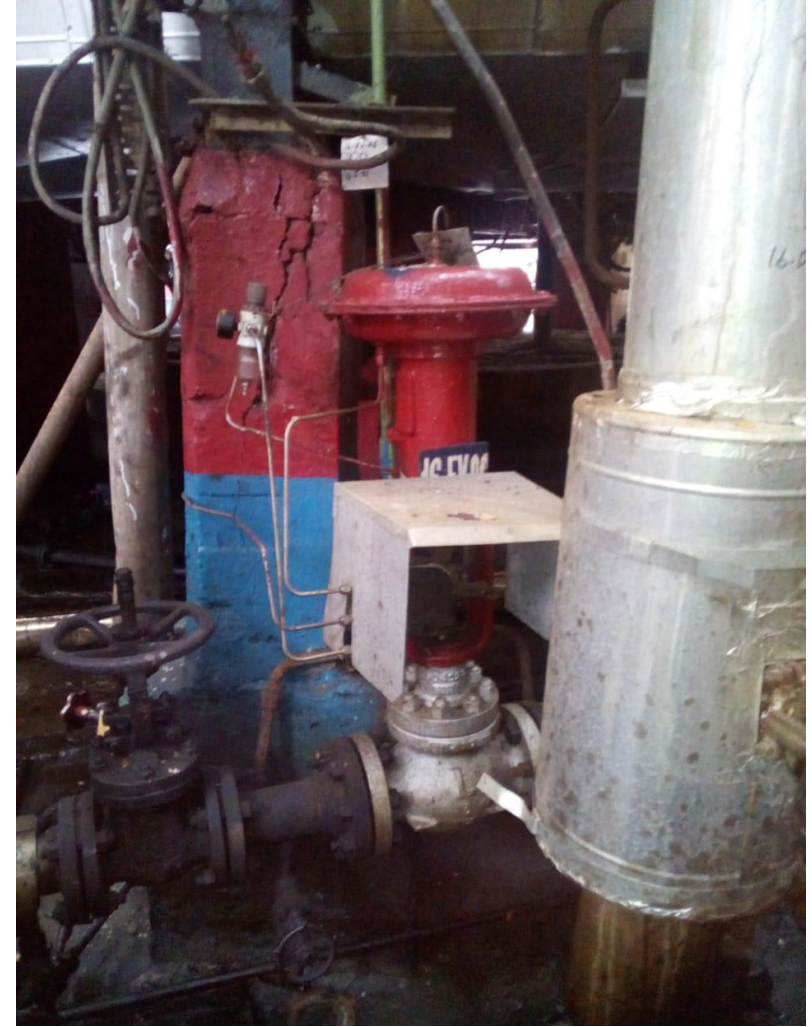
## Furnace Blast in CDU Unit

**Loss/Outcome:** Property damage & loss of production

- Resetting of the fuel gas control card led to closure of the control valve, extinguishing the burner flames. Subsequent manual opening of the valve without proper furnace purging caused accumulation of unburnt gas, which ignited upon contact with hot tubes, resulting in detonation.

- In case of flame failure/ failure of Fuel Gas/ Fuel Oil, furnace light up procedure i.e., box purging, pilot burner light up, main burner light up etc. shall be followed.
- Lapses in compliance with the work permit system, interlock bypass procedure, SOP for “Managing Exigency During Heavy Rain” to be rectified.
- Installation of Burner Management system (BMS) in furnaces

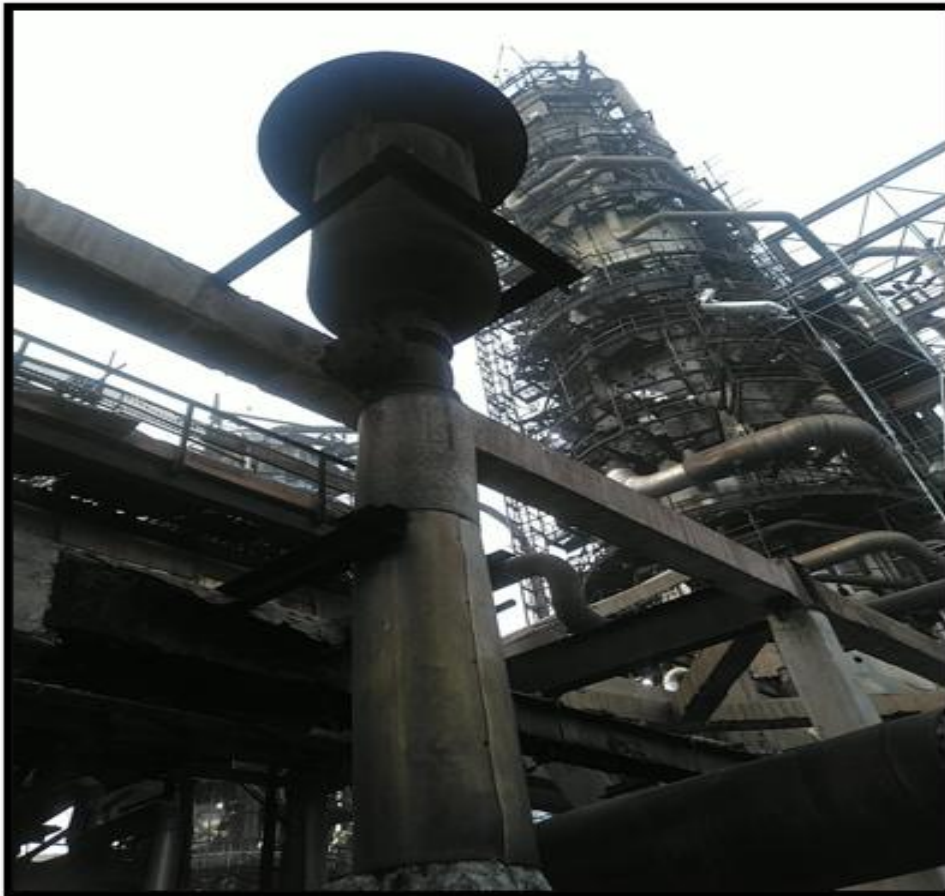
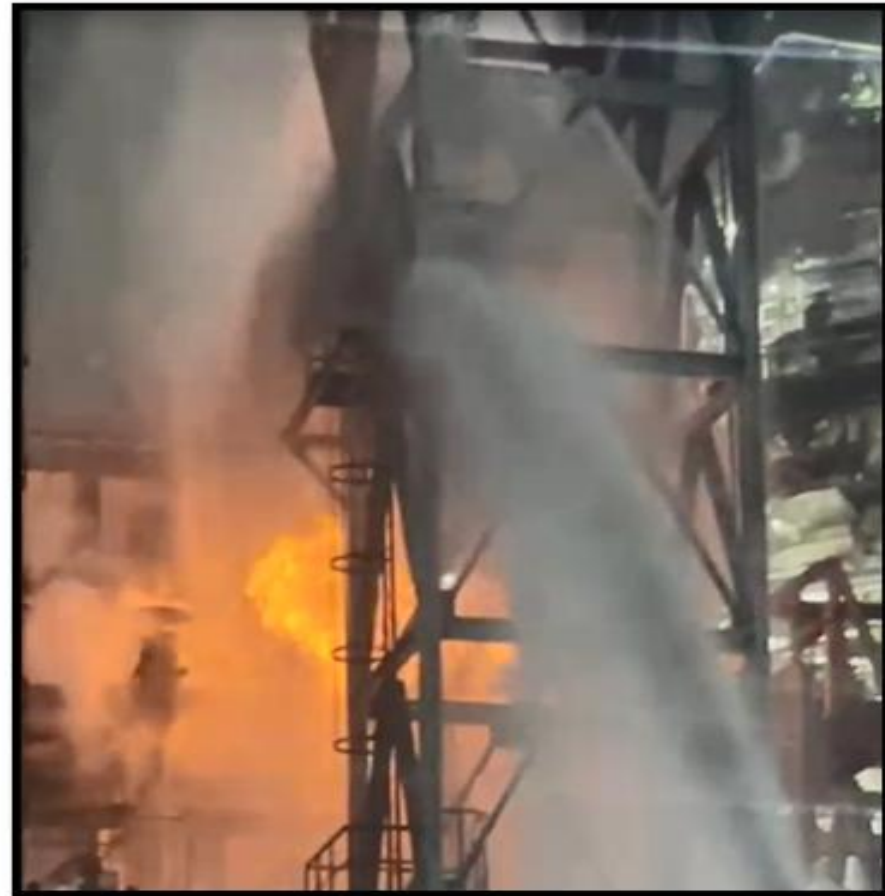
## Fire from steam silencer in Atmospheric Vacuum Unit

**Loss/Outcome:** Property damage & injury to 9 persons

- Naphtha backed up from heavy naphtha stripper (11-C-3) due to passing of isolation valves and NRV in stripping steam circuit possibly aided by high liquid level in the HN stripper. Hence, the stripping steam line up to the 6" diversion valve located at silencer platform was already full of Naphtha before the 6" diversion valve for routing steam from vent to the stripping steam header was crack opened. The liquid naphtha, when came in contact with superheated steam (320oC) vaporized and discharged through the steam silencer as in the downstream side, there was a blocked outlet condition.

- Installation of double NRV shall be reviewed in utility/ process interface circuit for enhancing system integrity.
- Method to check passing of critical NRVs should be developed. Means should be explored for online checking of such NRVs
- SOP to be developed for charging of steam headers. The same shall be known to all the concerned operating personnel.

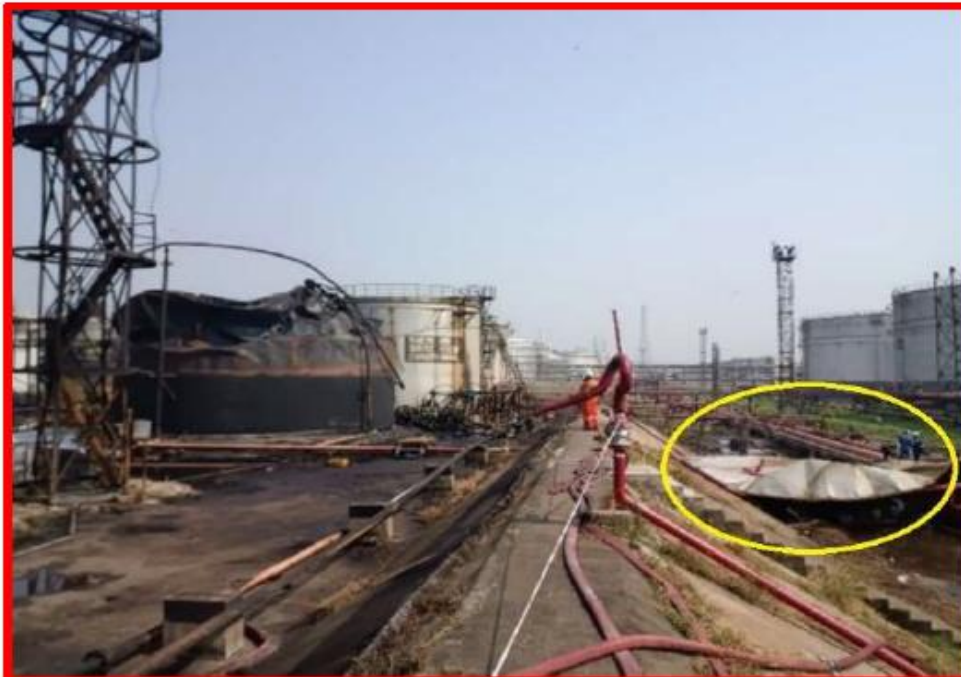
*Figure 1: Dome of the first exploded tank, outside the dyke.*

- The first explosion was caused by the confined vapor cloud explosion between the floating roof deck, and the fixed roof ignited most likely by the discharge of static charge (accumulated during the receipt of material).
- The second explosion occurred due to boiling of material in the second tank, aggravated during the foam application interruption.

- Sampling and gauging devices shall be either completely conductive or completely nonconductive.
- Review the effectiveness of conductive equipment/ earthing system associated with low-conductive flammable liquids on quarterly basis.
- Gauge hatch shall be non-sparking (or lined with non-sparking material) and self-closing type
- Nitrogen blanketing for internal floating roof tanks/ fixed roof tanks should be considered for storing products like benzene, etc.
- Anti-static additives may be added for increasing the conductivity.

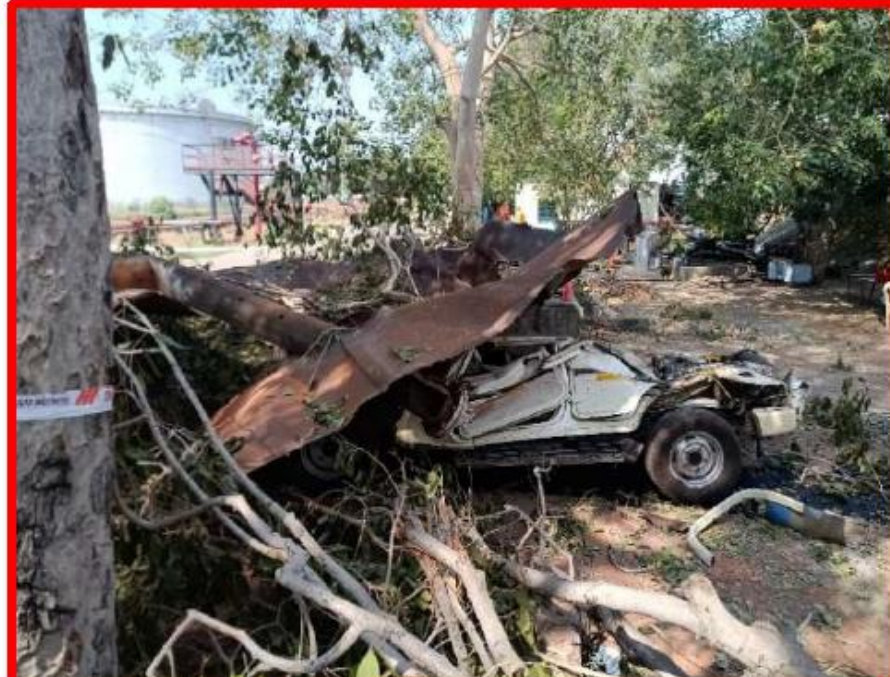
*Figure 2: Dome of the second exploded tank.*

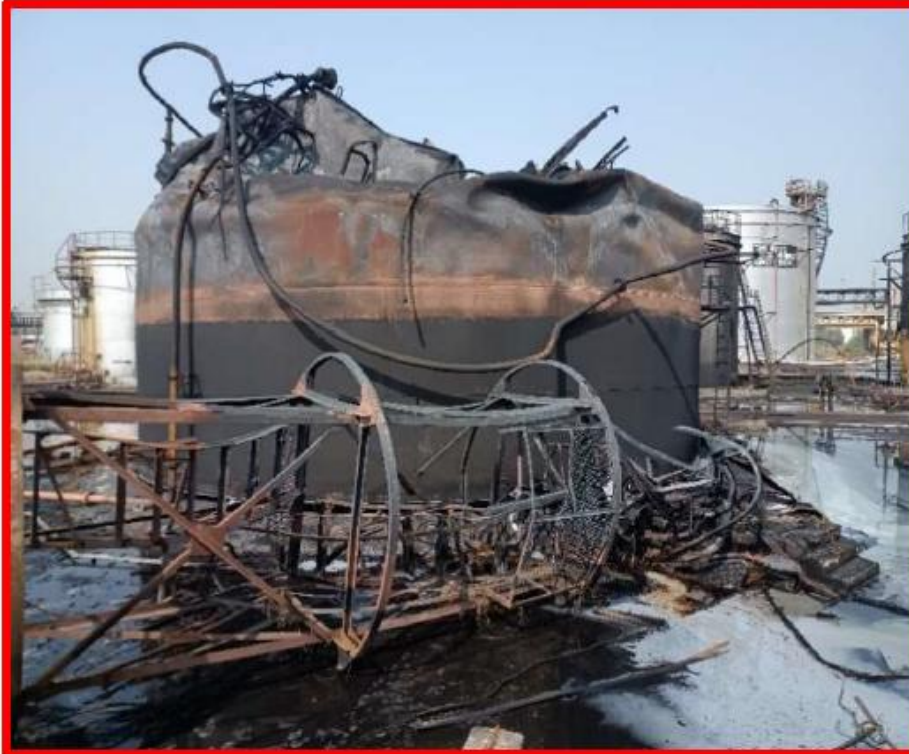
*Figure 3: Image of the first exploded tank.*

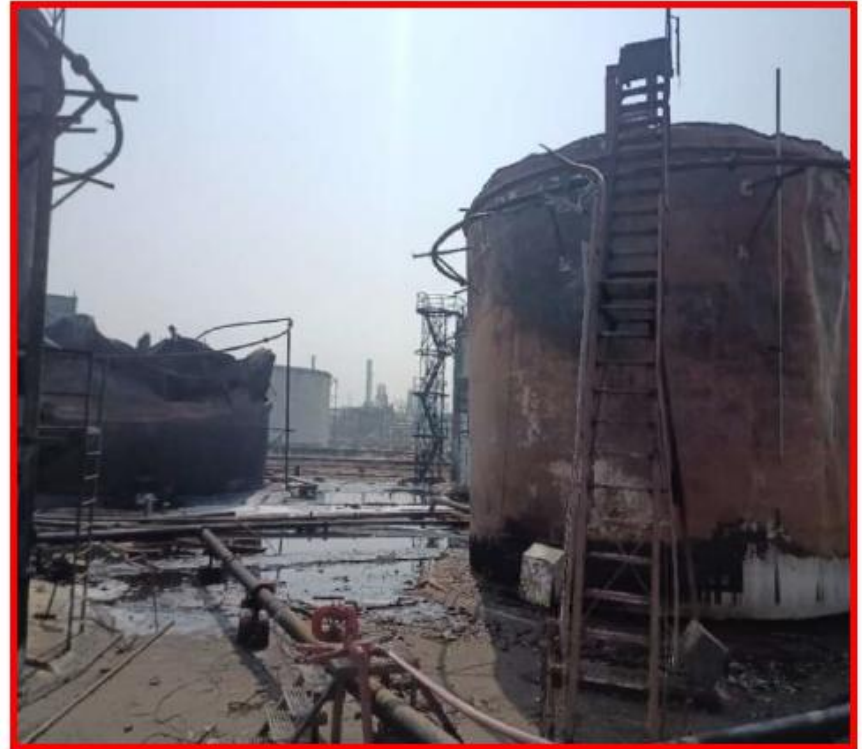
*Figure 4: Image of the second exploded tank.*

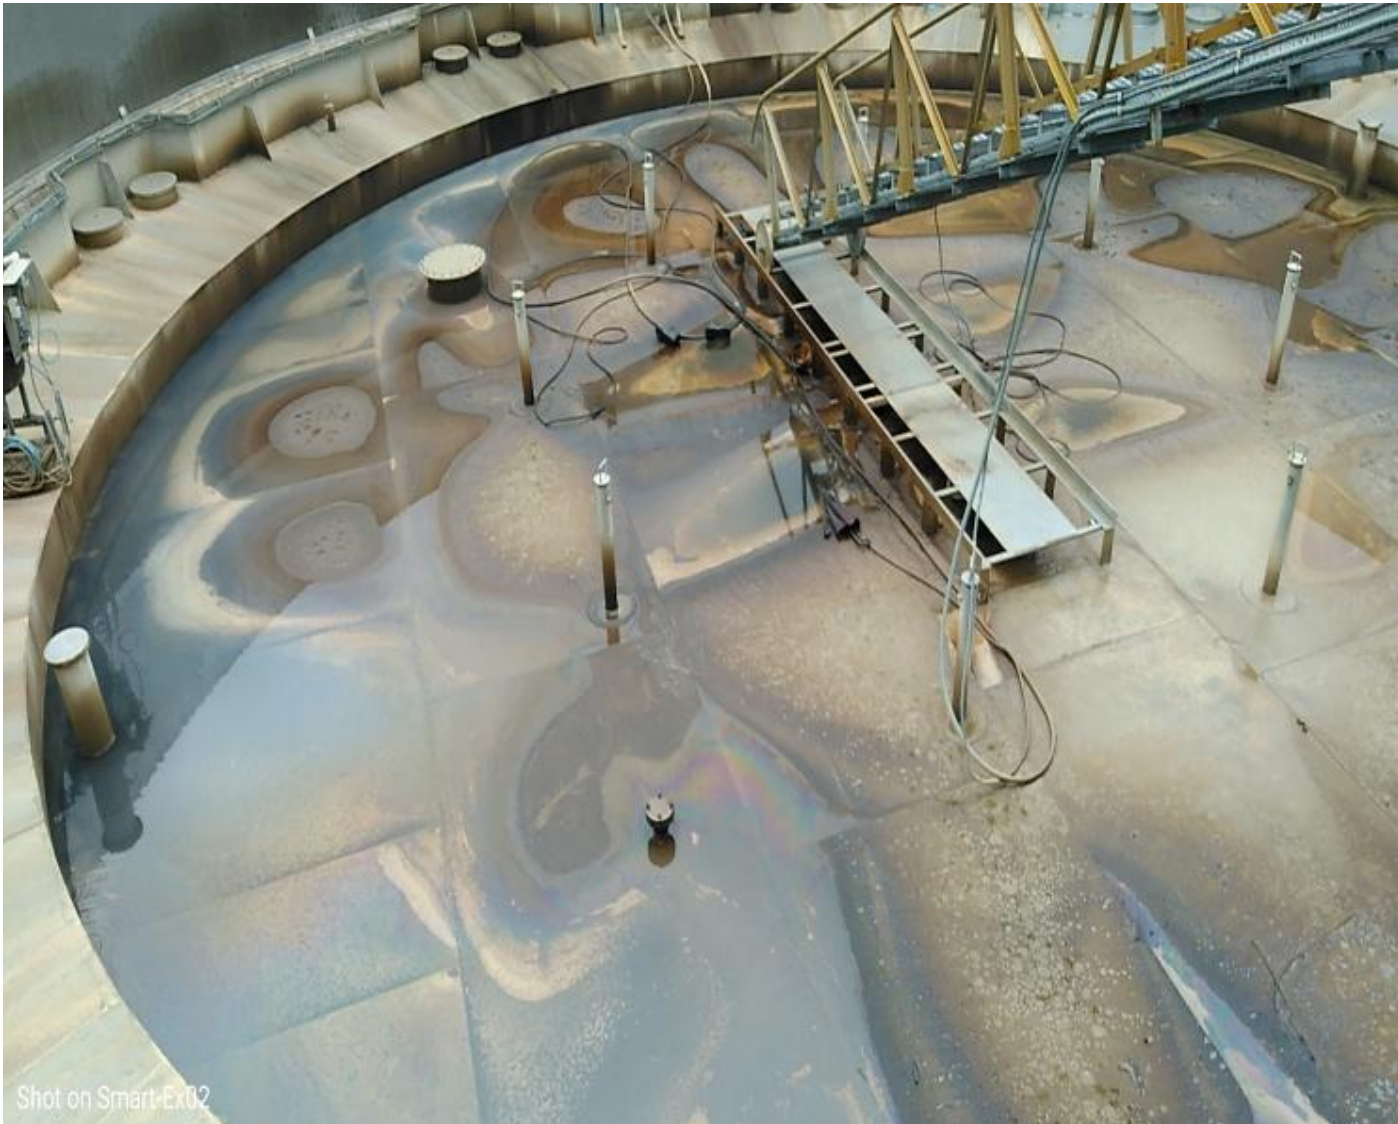
## FATAL ACCIDENT OF H<sub>2</sub>S EXPOSURE IN TANK FARM AREA

**Loss/Outcome:** 2 Fatalities

- Acute Inhalation of H<sub>2</sub>S gas at IDLH concentration
- Entering confined space without appropriate precautions
- Cognizance of prior indication of H<sub>2</sub>S in slop tank was not taken and suitable risk mitigation measures were not implemented.
- Lack of awareness amongst operators regarding potential H<sub>2</sub>S hazard in slop tank.
- Lack of supervisory actions against routine violation of entering floating roof deck without confined space permit.

- Identify and control routing of H<sub>2</sub>S-rich streams to slop tanks; implement SOPs for proper communication, monitoring, and recording of slop transfers.
- Install fixed H<sub>2</sub>S detectors with audio-visual alarms, warning signages, and provide peripheral marking at 3-m level inside tank shell to enhance hazard awareness.
- Strictly enforce the Work Permit System, conduct regular training and refresher programs, and carry out periodic rescue drills for H<sub>2</sub>S exposure scenarios
