# Learning from Incidents in Process Industry

**Workshop on Hazards and Safety in Oil & Gas Industries**  
**23rd – 25th February 2026**  
**Seminar Hall, IIT Delhi**

# Accidents in last 2 years (P&E)

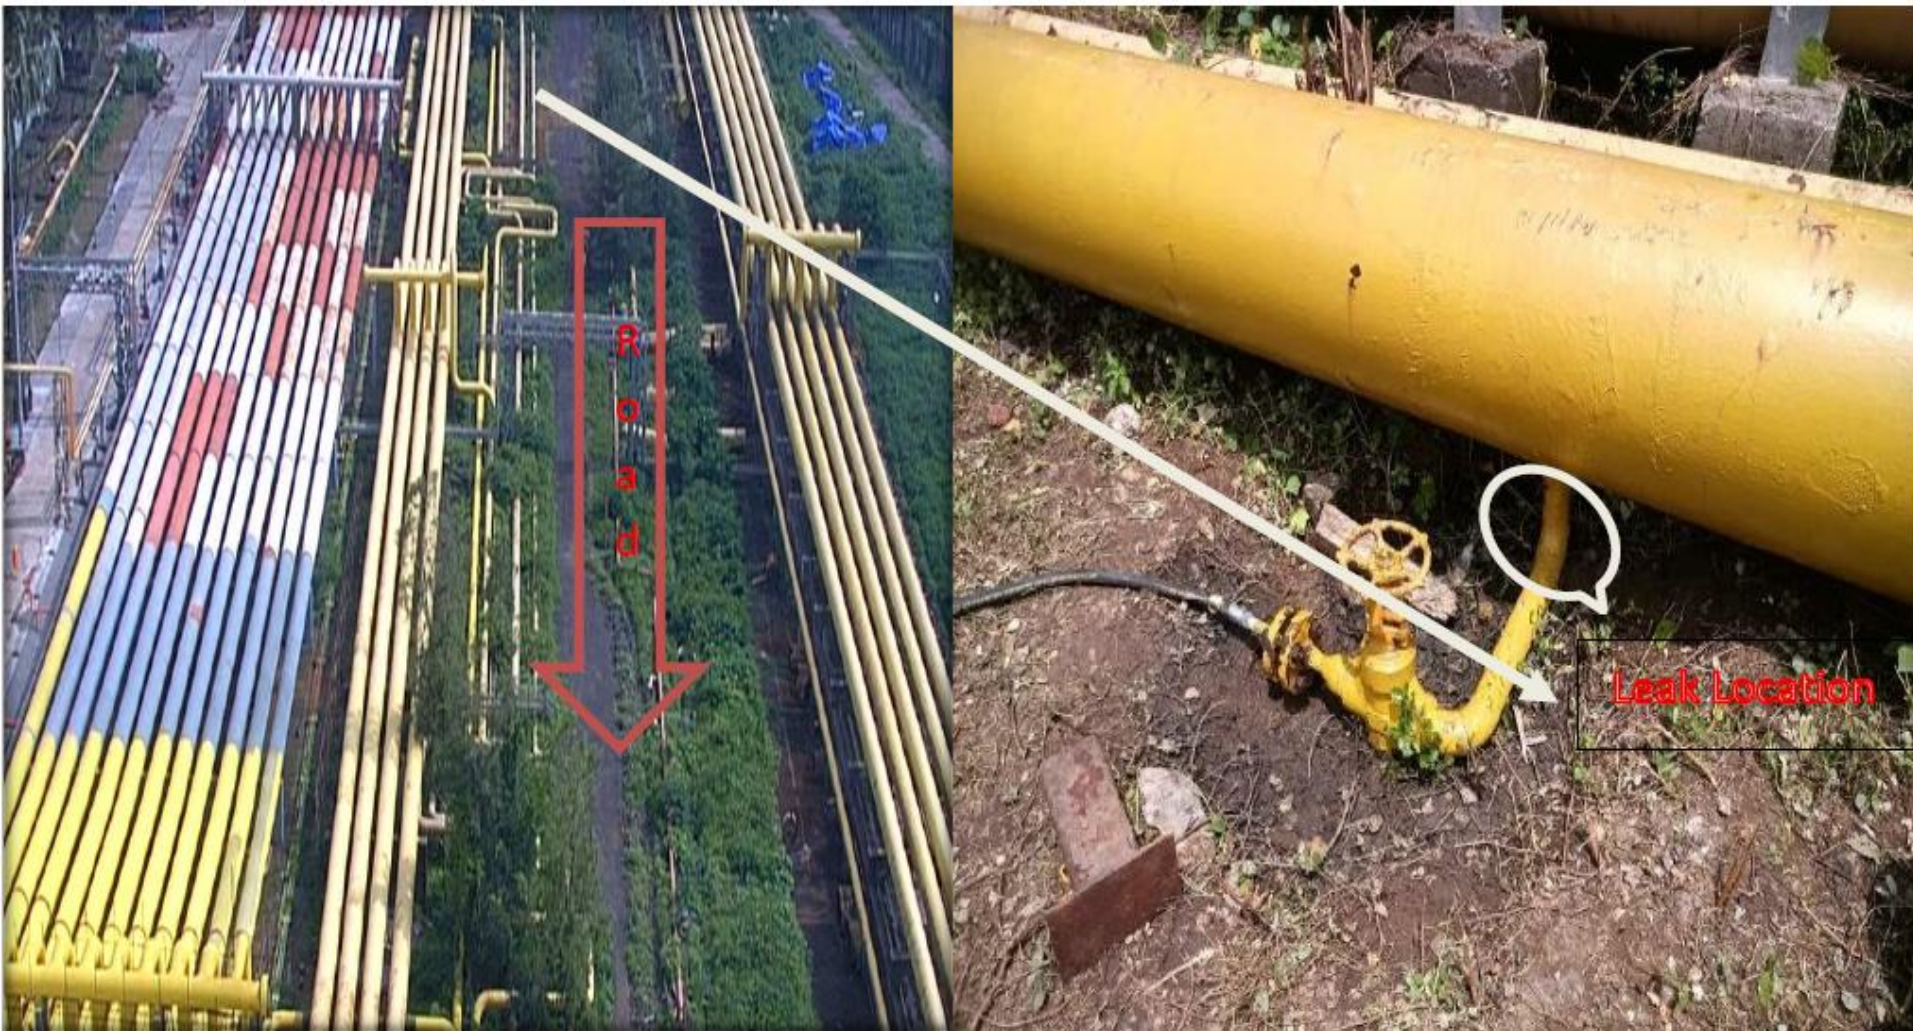
## Fire in 2" hydrocarbon drain line

**Loss/Outcome:** Unit outage & production loss,

- The cause of hydrocarbon leak was the JCB hitting the 'L' shaped 2" drain line (located at the proximity of road) of the 18" interconnection gas line in the slug catcher area during the scrapping of Road for cement surfacing work.
- The latent failure was absence of marking/ barricading around the protruding drain line as well as non-availability of crash barrier/ barricading on roadside to protect the pipelines.
- The systemic lapses included improper hazard identification, deviation in the work permit renewals, non-compliance with MOC procedures.

- Crash Barrier or physical barricading shall be provided along the slug catchers to prevent any impact on the hydrocarbon lines
- Any modification shall only be undertaken after following proper MOC procedures
- Permit should be issued/ renewed only after due diligence. Periodic audit of work permit system should be carried out
- Structured training of concerned personnel should be ensured. All potential hazards, associated with the job, should be comprehensively identified & addressed in Job Safety Analysis (JSA).
