# ARM-450 — Part-by-Part Geometry Audit

Read from the STEP B-rep, not from the source that made it and not from a mesh.

## STATUS: ALL DEFECTS FIXED — 2026-08-21

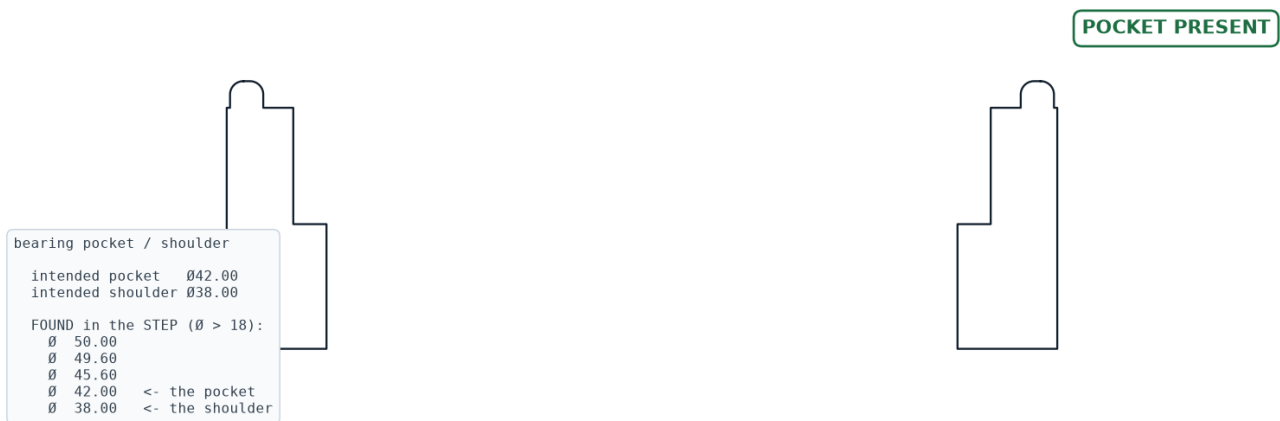
**LINK HALF (tongue) — section through the end boss the J2/J3 bearing seat**

| # | part | defect | severity |
|---|---|---|---|
| 1 | link_half_tongue | no Ø42 bearing pocket | BLOCKING |

The section is taken straight through the end boss. There is no counterbore step. The wall runs straight from the web to the seam face.

Diameters the STEP actually contains at that boss: Ø50.00, Ø49.60, Ø45.60, Ø45.20, Ø38.00. There is no Ø42.

Cause. In cad/link\_shell.py the shell is hollowed at step 2 and the pocket is cut at step 3. The hollow uses  $\text{boss}_r - \text{WALL\_FLANGE} = 25 - 2.4 = \text{Ø}45.20$  at the end boss. The pocket cut that follows is Ø42.00 — smaller than the hole it is cutting into, so it removes nothing at all. CadQuery does not complain: cutting a small cylinder out of an already-empty region is a legal no-op.

Consequence. A Ø42.00 bearing dropped into a Ø45.20 bore has 1.60 mm of radial clearance. At the 360 mm tool radius that is roughly 20 mm of tool wander — the joint has no location at all. This is the exact failure the paired-bearing redesign was written to eliminate, and it has been present in every version of the link.

| # | part | defect | fix | | --- | --- | --- | --- | | 1-2 | link halves | no Ø42 bearing pocket | solid boss ring unioned back before counterboring | | 3 | base | no Ø42 J1 seat | cable bore now stops below the seat, leaving a Ø38 shoulder | | 4 | wrist\_j6\_output | 3 of 4 tool bolts | honest 3-bolt interface at 160/250/340°, all in material | | 5 | wrist\_j5\_yoke | cheek spacing 38.02 | SPAN derived from BRG\_SPACING → 40.00 | | 6 | wrist parts | horn\_pattern() no-ops | still open — needs your decision, see §6 |
