## **Conductive Paint on Polylactic Acid 3D Printed Parts**

Michelle Thompson W5NYV 14 January 2023

This article is about the shelf life of Polylactic Acid (PLA) 3d printed parts, such as antenna prototypes for the microwave bands, after metallizing with conductive spray paint. Does the process of metallizing a 3d printed antenna reduce its shelf life? What can be done to mitigate any deterioration from the painting process?

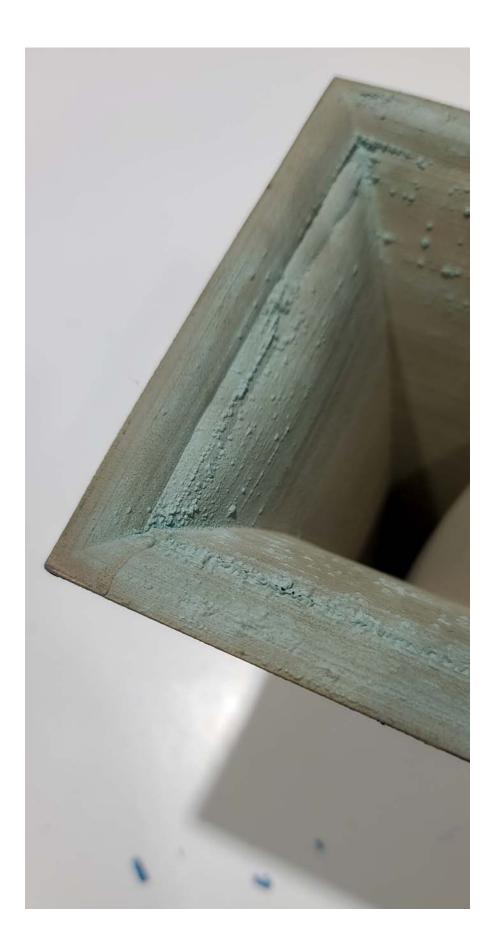
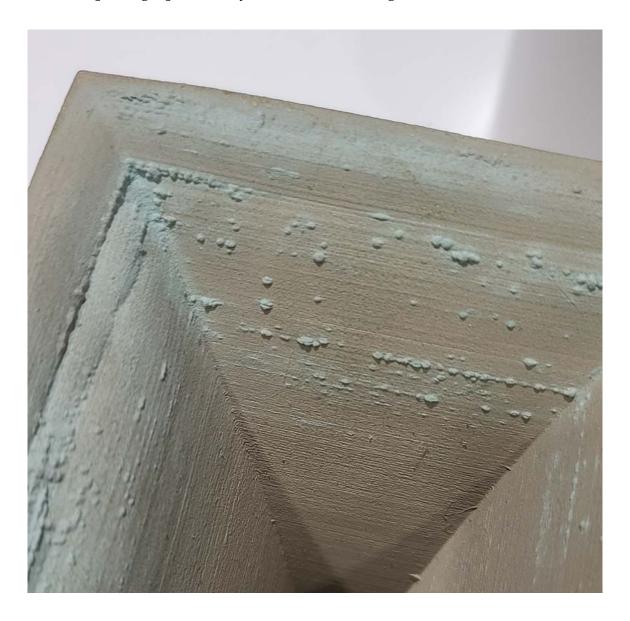
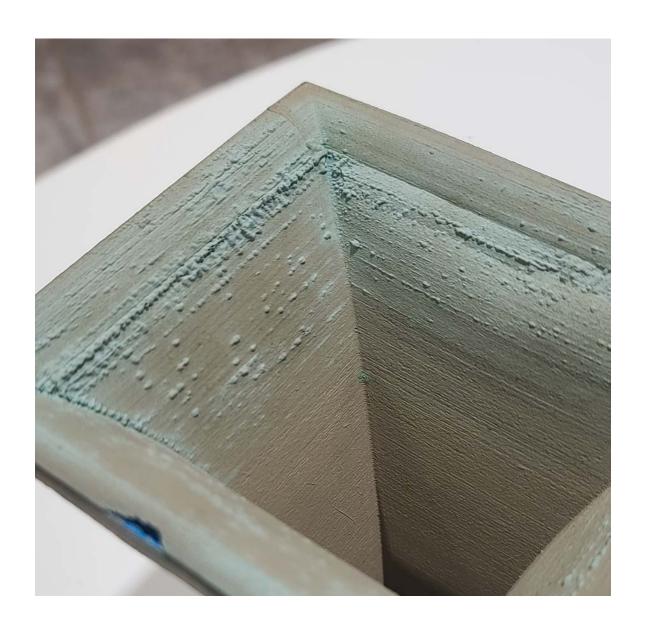
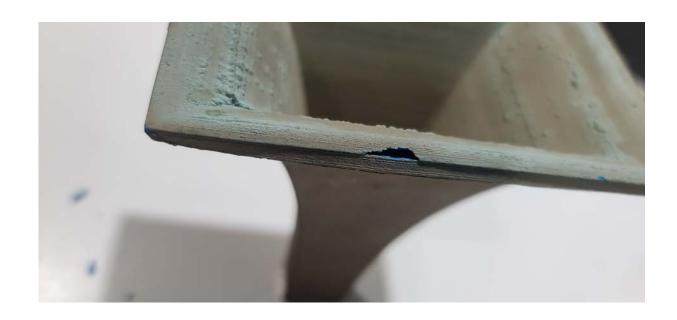
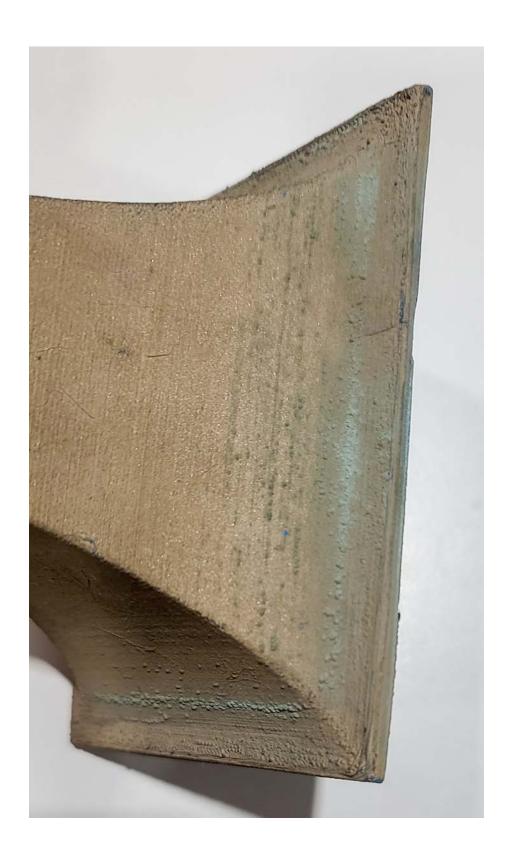
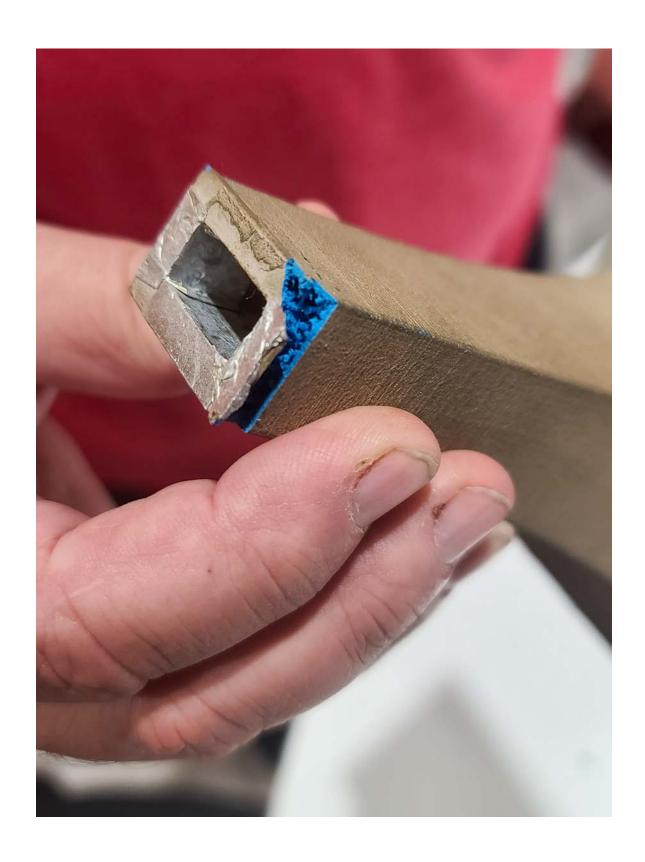
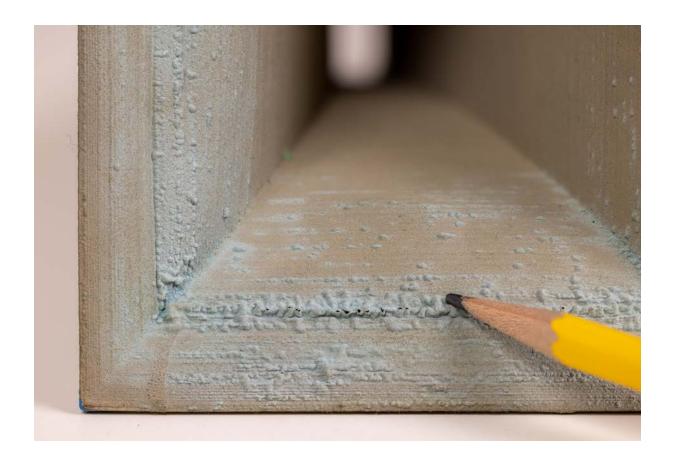
The horn has been kept inside out of direct sunlight since it was printed in 2016. These photographs clearly show some damage.

The damage to the conductive paint looks like bubbling, which is when paint doesn't adhere to the surface. Common factors in paint bubbling are 1) not using a primer and 2) moisture building up in the surface and having no where to go.

The green color could be caused by corrosion of the silver-coated copper particles in the paint. The PLA could have absorbed enough moisture to cause the paint to fail.

Using composite filaments and coating the print with waterproof epoxy are some of the recommendations for increasing the lifespan of a 3d printed PLA part. The horn antenna was not primered and was not sealed with waterproof epoxy. There were no additives in the PLA. The horn was printed and then painted with conductive spray paint (843AR). It was tested and and performed as expected, and then stored.

This is a solvent-based acrylic lacquer. ABS, PBT, PVA and ABS/PC plastics are mentioned, but PLA is not.

From the ingredients list on the material data sheet below, we can see that we've used at least one chemical directly on the surface that studies have shown weaken 3d printed objects. Namely, acetone.

3d printed antennas are extremely useful for prototyping and testing. However, the process of metallizing PLA prints directly with conductive spray paint will limit shelf life. Using a primer, then applying the conductive paint, then a waterproof epoxy sealant, can extend the shelf life of a 3d printed experimental antennas.
