## Home Inspection Report

**825 S. 22nd Street, San Jose**

Kane Howell  
May 9, 2025

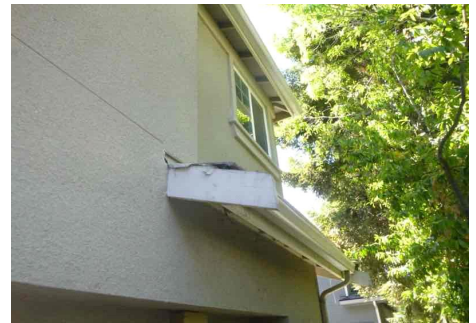
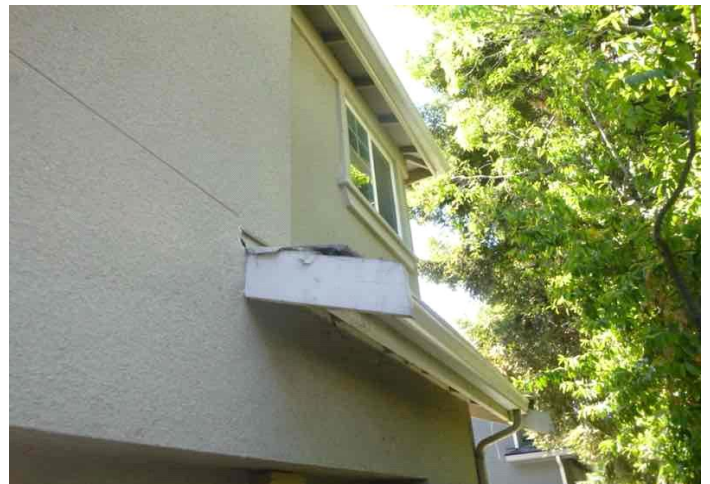
Photo 06

1. Repairs to the roof covering are recommended. Damaged, loose or missing roofing material at the field should be repaired or replaced. All roof penetrations should be examined and sealed as necessary. For further evaluation of the condition of the roof we recommend you consult a licensed roofing contractor. (See Photo 6)

- ! 1. Repairs to the roof covering are recommended. Damaged, loose or missing roofing material at the field should be repaired or replaced. All roof penetrations should be examined and sealed as necessary. For further evaluation of the condition of the roof we recommend you consult a licensed roofing contractor. (See Photo 6)

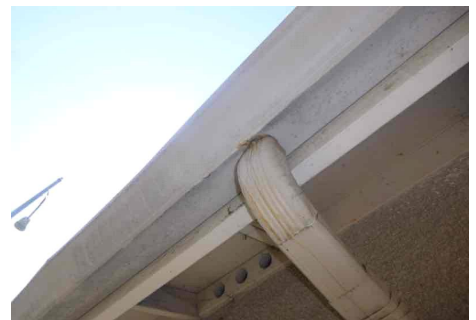
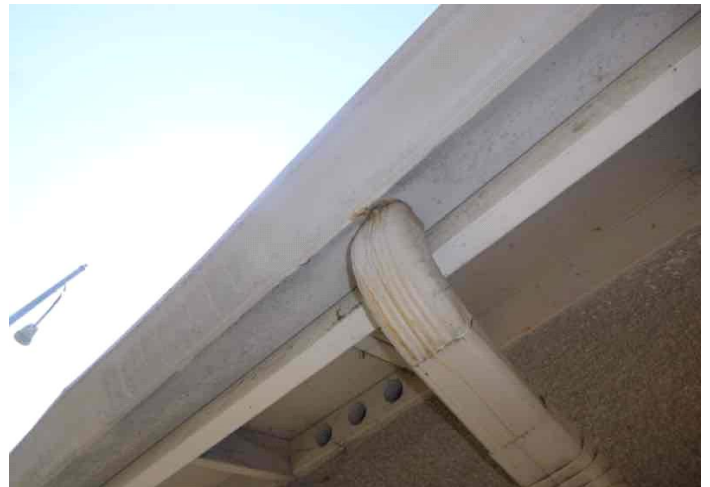
Photo 04

2. Leaks were noted in the downspouts and/or gutters at the rear. During wet weather conditions these areas are more obvious and during dry weather conditions they are noted from the stains at the areas where the leaks have occurred. We recommend all leaks be repaired. (See Illustration 2D) (See Photo 4)

- ! 2. Leaks were noted in the downspouts and/or gutters at the rear. During wet weather conditions these areas are more obvious and during dry weather conditions they are noted from the stains at the areas where the leaks have occurred. We recommend all leaks be repaired. (See Illustration 2D) (See Photo 4)

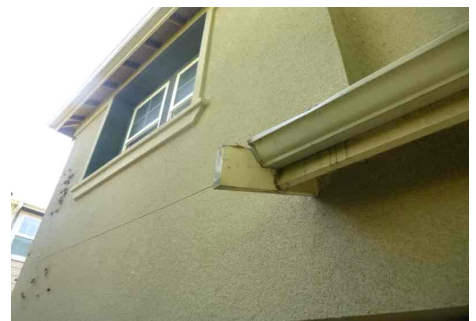
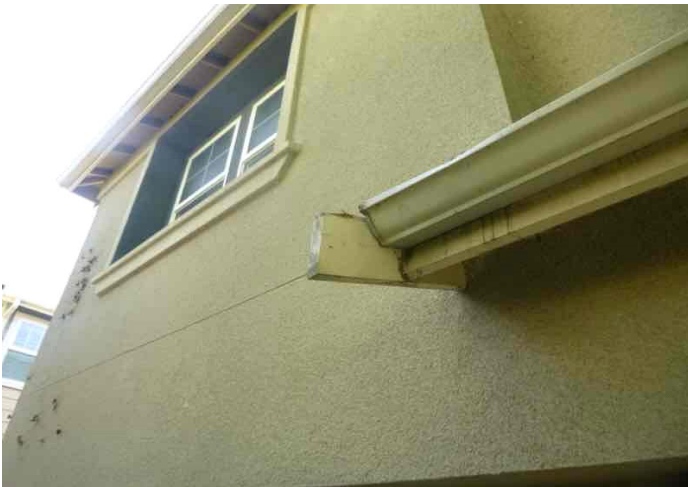
Photo 03

3. Water damage was observed to the rafters at the rear. We recommend the services of a licensed general contractor and/or structural pest control company. (See Photo 3)

- ! 1. Water damage was observed to the rafters at the rear. We recommend the services of a licensed general contractor and/or structural pest control company. (See Photo 3)

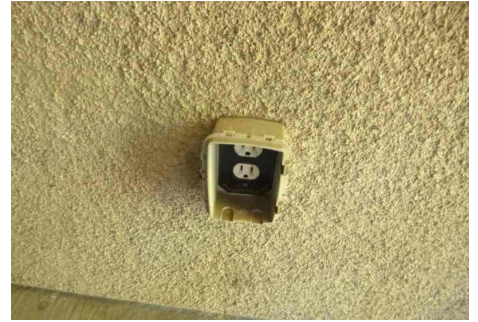
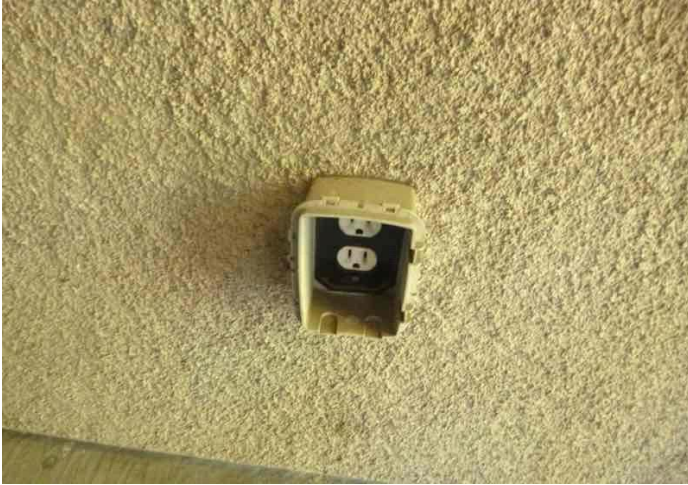
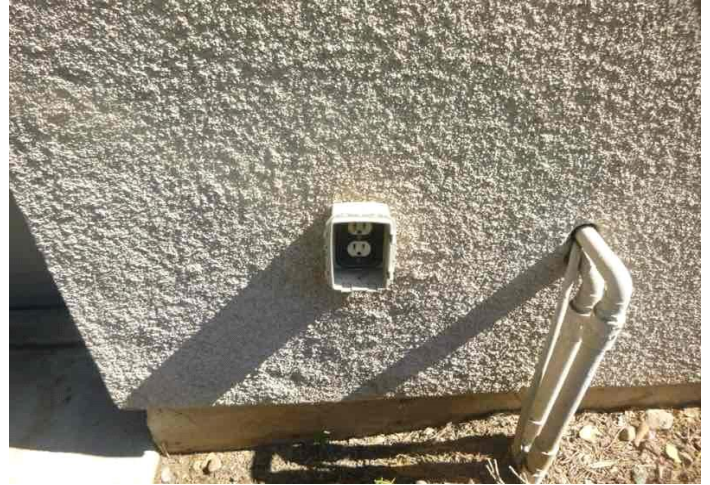
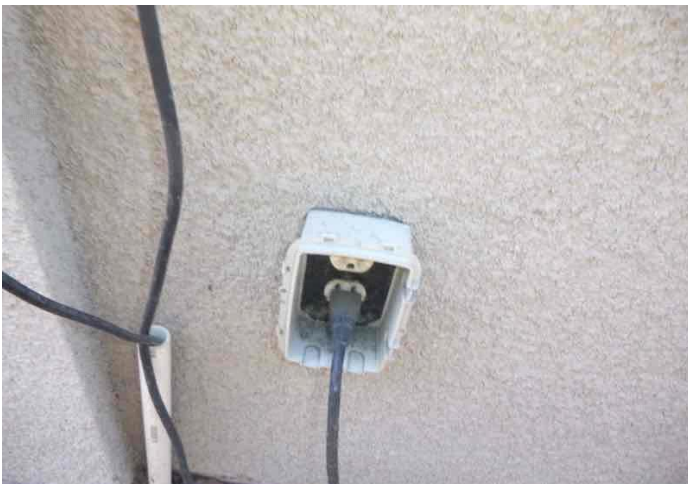
Photo 01

4. Exterior receptacles at the front porch and rear are missing a weatherproof cover plate. We recommend an approved exterior cover be installed. (See Photo 1)  
(See Photo 2) (See Photo 5)

- ! 1. Exterior receptacles at the front porch and rear are missing a weatherproof cover plate. We recommend an approved exterior cover be installed. (See Photo 1) (See Photo 2) (See Photo 5)
- ! 2. Any openings inside the electrical branch/auxiliary panel cover "Dead Front" or panel box should be covered with approved filler plates or plugs. (See Illustration 4F) (See Photo 10)
- 3. The accessible aluminum connectors inside the electrical main and/or branch panel are lacking the application of an anti-oxidant. We recommend that each accessible connection be covered with an anti-oxidant.
- 4. The missing switch cover plates at the pantry should be replaced.

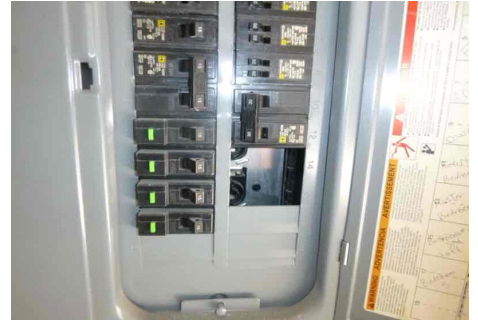
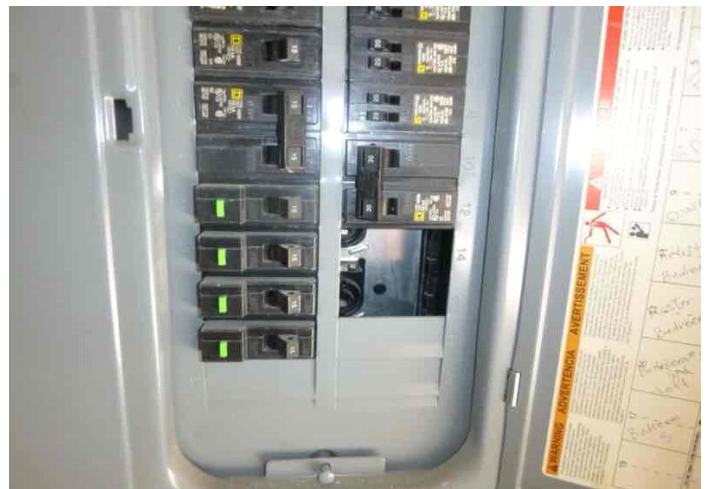
Photo 10

5. Any openings inside the electrical branch/auxiliary panel cover "Dead Front" or panel box should be covered with approved filler plates or plugs. (See Illustration 4F) (See Photo 10)

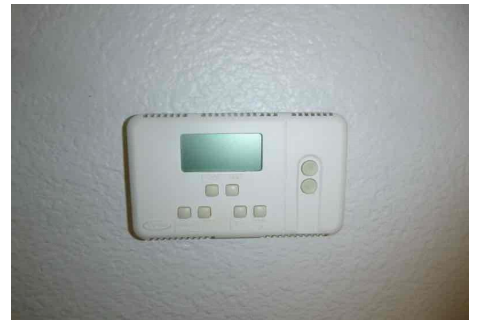
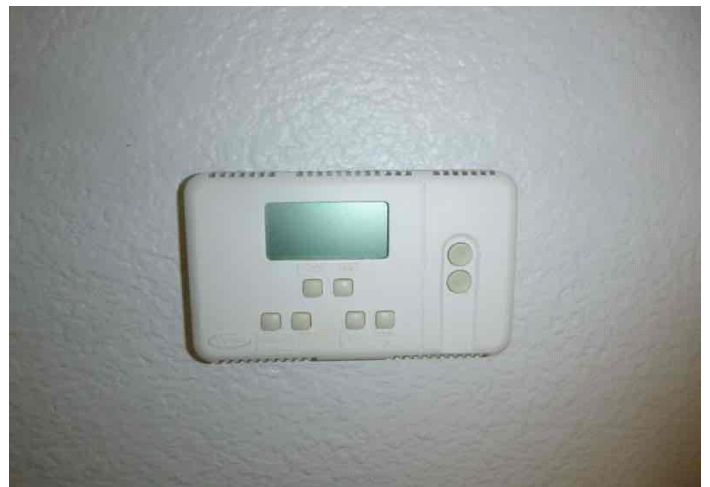
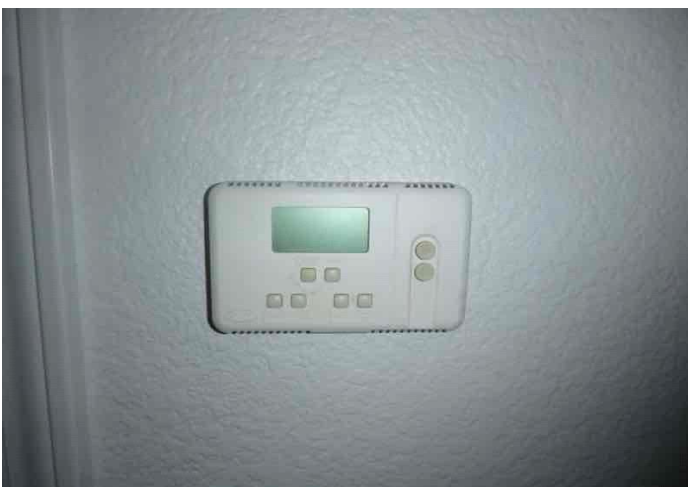
Photo 12

6. The heater thermostat was inoperable at the time of our inspection, and therefore the heater was not tested. We recommend the thermostat be repaired or replaced and proper operation of the heater verified by appropriate trades. (See Photo 12) (See Photo 17)

- !** 1. The heater thermostat was inoperable at the time of our inspection, and therefore the heater was not tested. We recommend the thermostat be repaired or replaced and proper operation of the heater verified by appropriate trades. (See Photo 12) (See Photo 17)

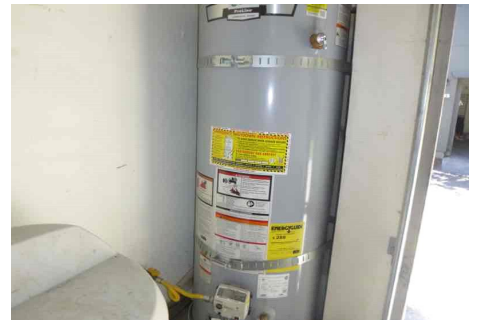
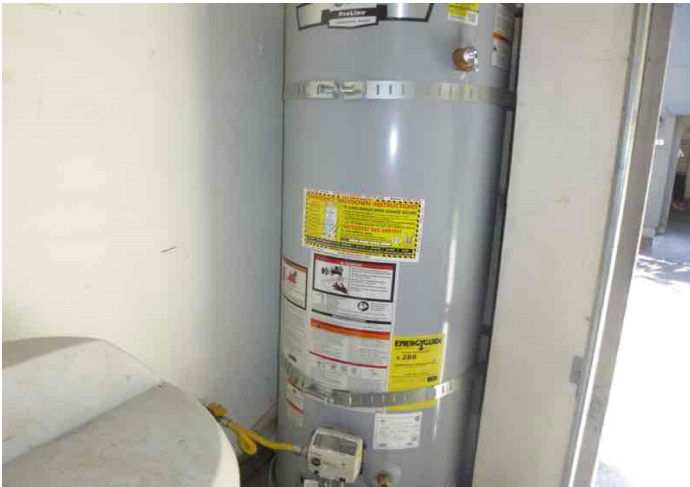
Photo 07

7. The water heater seismic straps are loose, this will allow movement of the tank in an earthquake. We recommend tightening the straps and/or adding bracing between the tank and wall to improve safety. (See Photo 7)

- ! 1. The water heater seismic straps are loose, this will allow movement of the tank in an earthquake. We recommend tightening the straps and/or adding bracing between the tank and wall to improve safety. (See Photo 7)

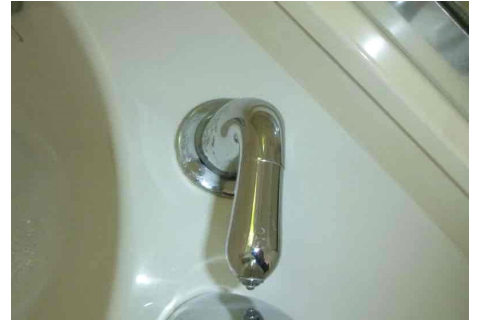
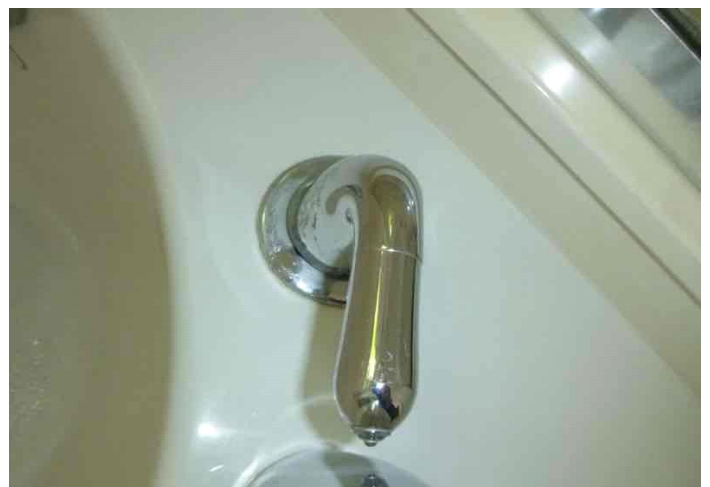
Photo 18

8. The tub faucet and/or handles are leaking at the master bathroom. We recommend all leaks be repaired. (See Photo 18)

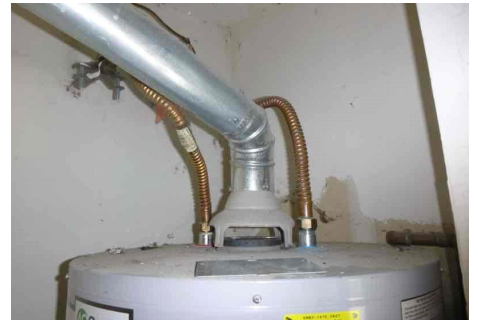
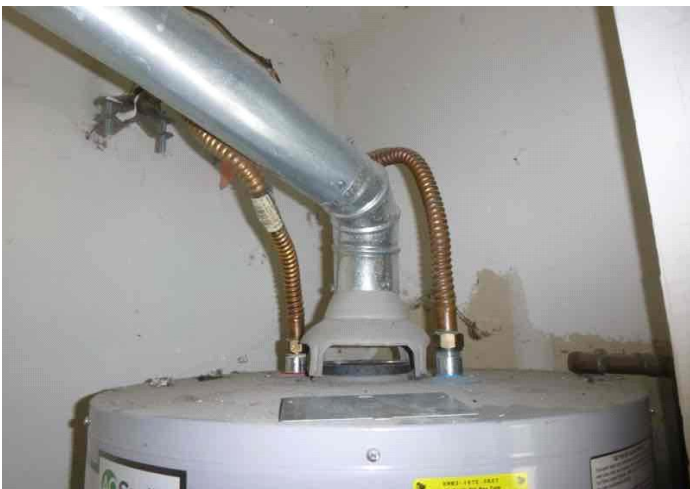
Photo 09

10. For enhanced safety, it is recommended that the loose or damaged connections of the water heater venting system be improved. A minimum of 3 screws at each section of the duct is recommended. (See Illustration 8M) (See Photo 9)

- ! 2. For enhanced safety, it is recommended that the loose or damaged connections of the water heater venting system be improved. A minimum of 3 screws at each section of the duct is recommended. (See Illustration 8M) (See Photo 9)

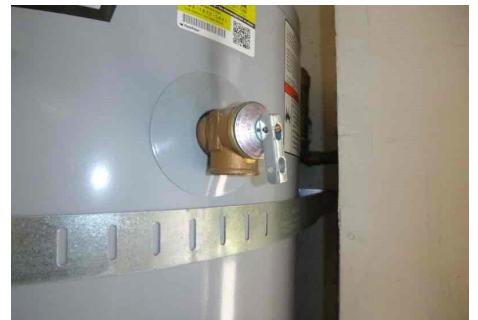
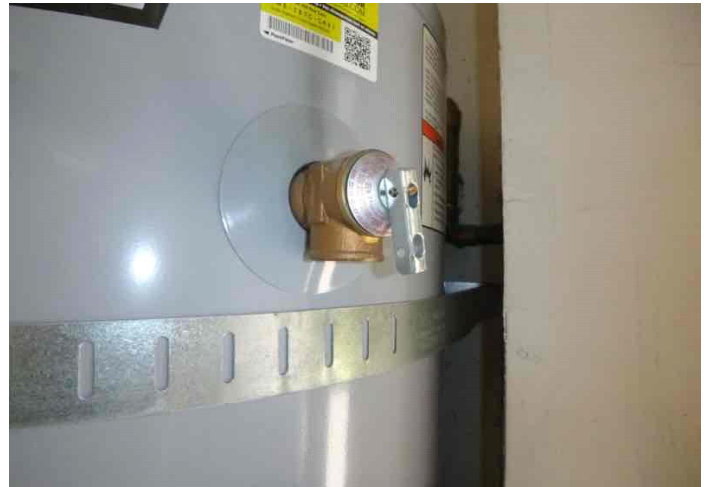
Photo 08

11. The temperature and pressure relief valve for the water heater lacks a proper discharge pipe. We recommend the installation of approved piping to an approved location. (See Photo 8)

- ! 3. The temperature and pressure relief valve for the water heater lacks a proper discharge pipe. We recommend the installation of approved piping to an approved location. (See Photo 8)

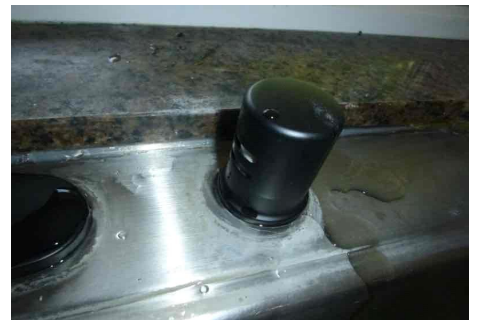
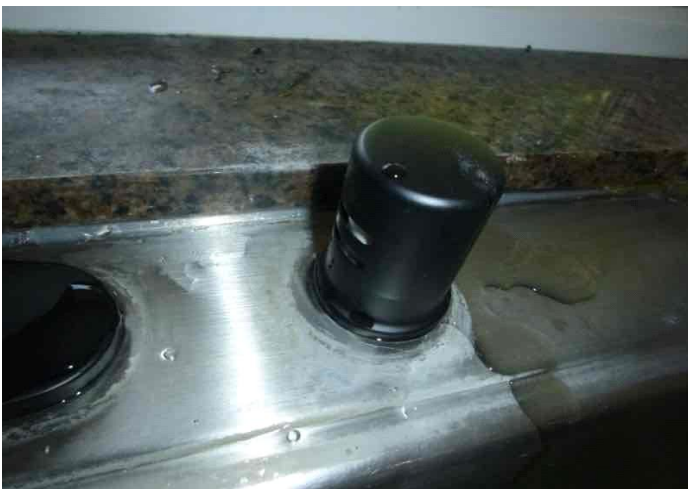
Photo 15

12. The air-gap or its connection to the disposal, appears to be restricted, causing water to flow out of the air-gap during the drain cycle of the dishwasher. We recommend that the drain system be cleaned or modified to correct this deficiency. (See Illustration 9F) (See Photo 15)

- ! 9. The air-gap or its connection to the disposal, appears to be restricted, causing water to flow out of the air-gap during the drain cycle of the dishwasher. We recommend that the drain system be cleaned or modified to correct this deficiency. (See Illustration 9F) (See Photo 15)

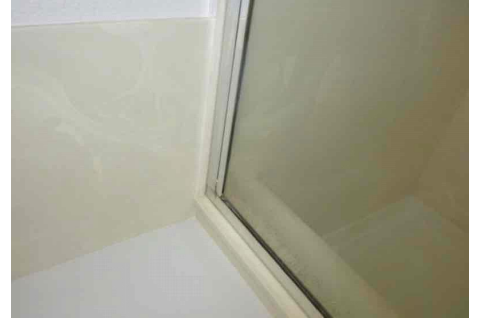
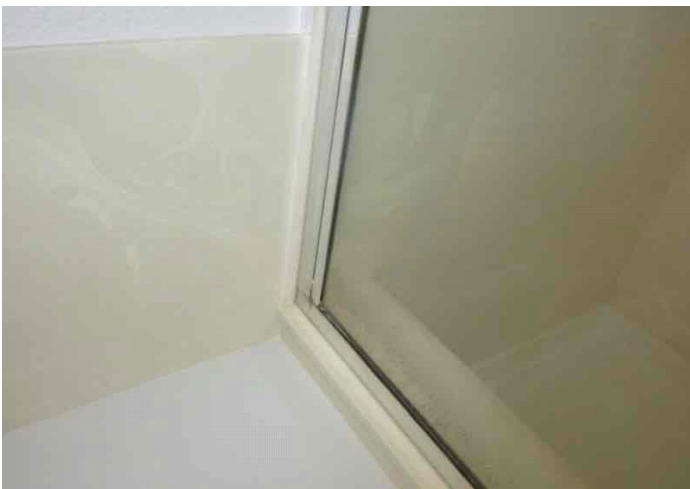
Photo 21

13. Cracked, deteriorated and/or missing tub/shower enclosure caulk in the master bathroom should be replaced. Water leaking through non-sealed areas can cause damage. Damage caused by water seepage cannot be determined by this visual observation. (See Photo 21)

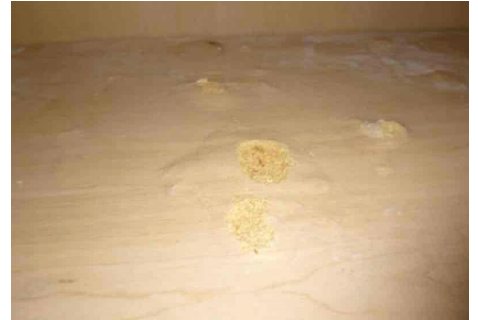
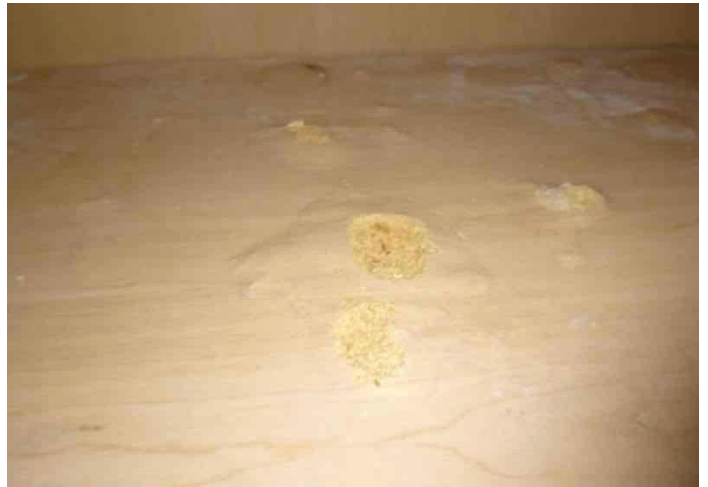
Photo 20

14. The base and/or side of the master bathroom sink cabinet sink shelf is deteriorated. We recommend the advice and services of a licensed pest control operator for investigation and possible repair of this condition. (See Photo 20)

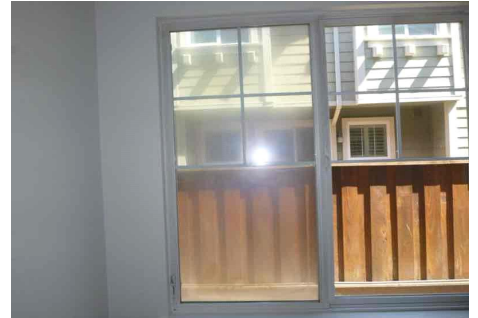
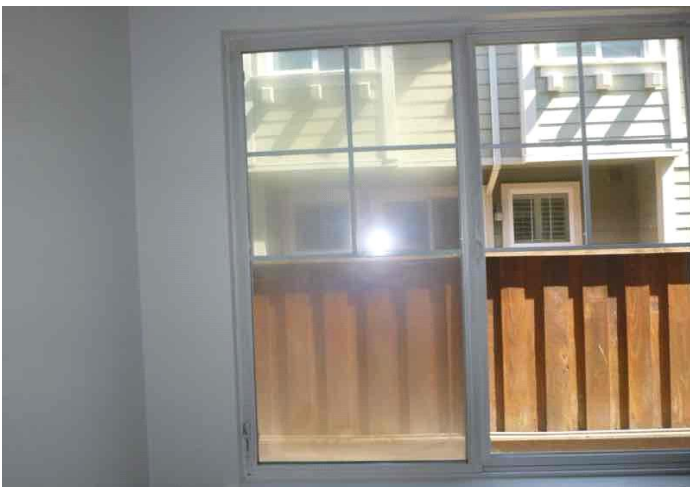
Photo 11

15. The interior windows at the downstairs bedroom are inoperable, stuck, or painted shut. We recommend repair or replacement to restore functional use of these areas. (See Photo 11)

- ! 1. The interior windows at the downstairs bedroom are inoperable, stuck, or painted shut. We recommend repair or replacement to restore functional use of these areas. (See Photo 11)

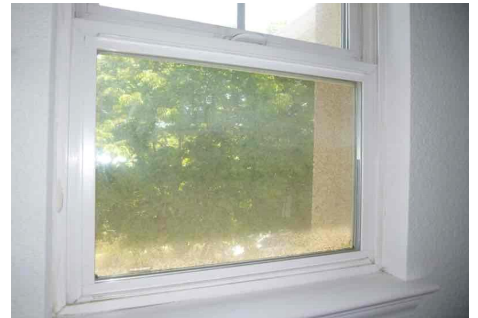
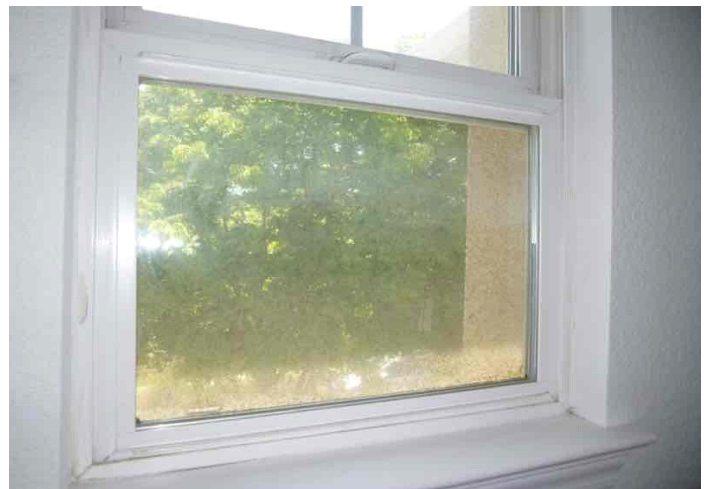
Photo 16

16. One or more of the windows are not fully serviceable because their lift mechanism sash cords or springs are missing or damaged. We recommend these windows be repaired and their full functional use restored. (See Photo 16)

- ! 2. One or more of the windows are not fully serviceable because their lift mechanism sash cords or springs are missing or damaged. We recommend these windows be repaired and their full functional use restored. (See Photo 16)

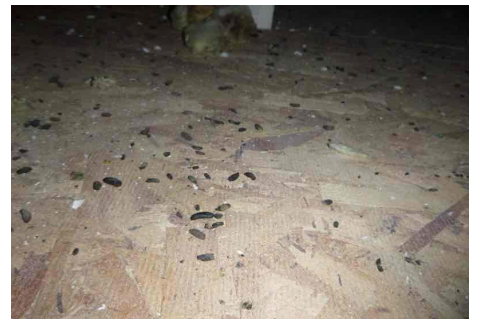
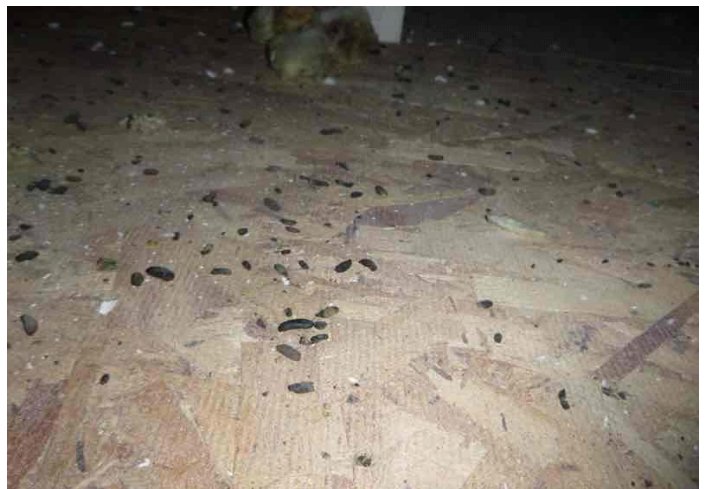
Photo 22

17. Evidence of vermin activity was observed within the structure. It is likely this evidence will extend into inaccessible areas. The owner is advised to contact the appropriate trade for further evaluation and remedial measures if necessary. (See Photo 22)

- ! 3. Evidence of vermin activity was observed within the structure. It is likely this evidence will extend into inaccessible areas. The owner is advised to contact the appropriate trade for further evaluation and remedial measures if necessary. (See Photo 22)

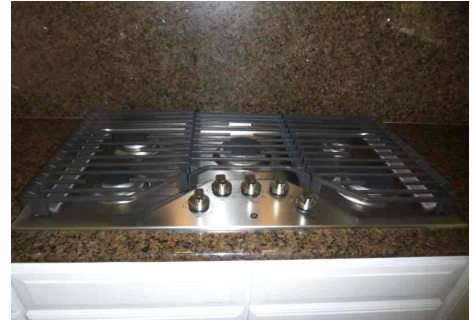
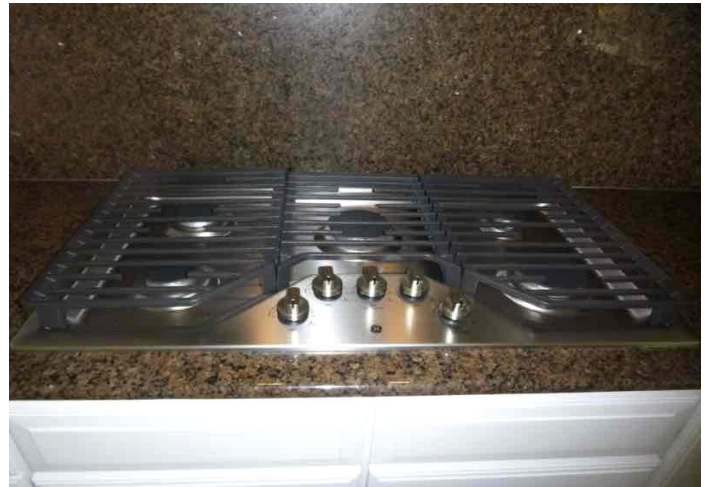
Photo 14

18. The gas was off at the time of our inspection, therefore the kitchen gas appliances were not tested. We recommend operation of the appliances by interested parties when all services have been restored. (See Photo 14)

The gas was off at the time of our inspection, therefore the kitchen gas appliances were not tested. We recommend operation of the appliances by interested parties when all services have been restored. (See Photo 14)
