Anomaly Report – Loose Connection

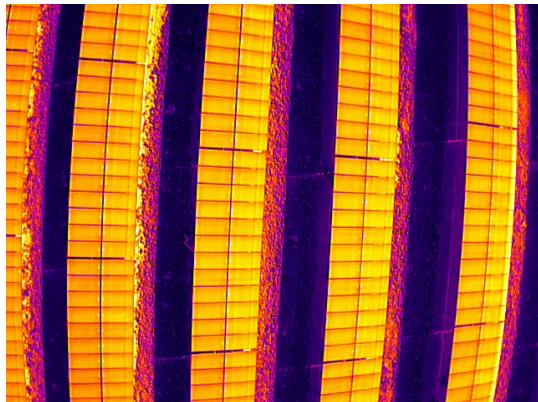
DJI_20241219111517_0901_T.JPG

Category	Priority	Size	Loss
Loose Connection	Low	Large	24.08 kW

Temperature	Parameters	Remedial Action	Comment
74.38 °C	Voltage: 351V Current: 26A	Auto-generated action	Auto-detected anomaly

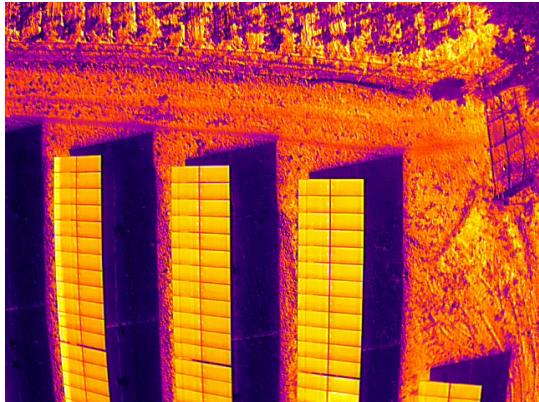
DJI_20241219110453_0110_T.JPG

Category	Priority	Size	Loss
Damaged Conductor	Critical	Medium	40.79 kW

Temperature	Parameters	Remedial Action	Comment
117.75 °C	Voltage: 321V Current: 13A	Auto-generated action	Auto-detected anomaly

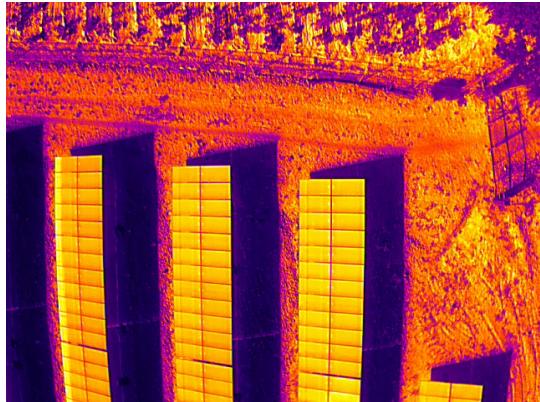
DJI_20241219110453_0110_T.JPG

Category	Priority	Size	Loss
Damaged Conductor	Low	Small	24.13 kW

Temperature	Parameters	Remedial Action	Comment
63.33 °C	Voltage: 278V Current: 6A	Auto-generated action	Auto-detected anomaly

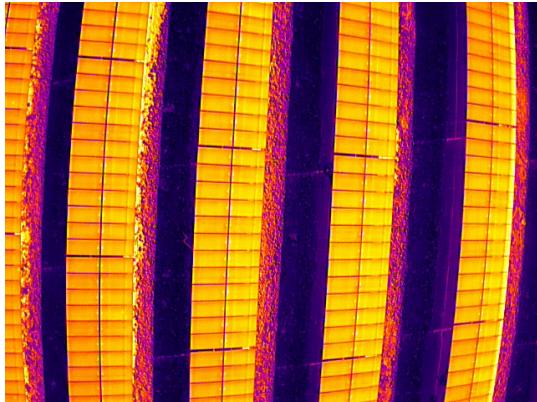
DJI_20241219111517_0901_T.JPG

Category	Priority	Size	Loss
Damaged Conductor	Medium	Small	25.27 kW

Temperature	Parameters	Remedial Action	Comment
86.32 °C	Voltage: 288V Current: 13A	Auto-generated action	Auto-detected anomaly
