Anomaly Report – Damaged Conductor

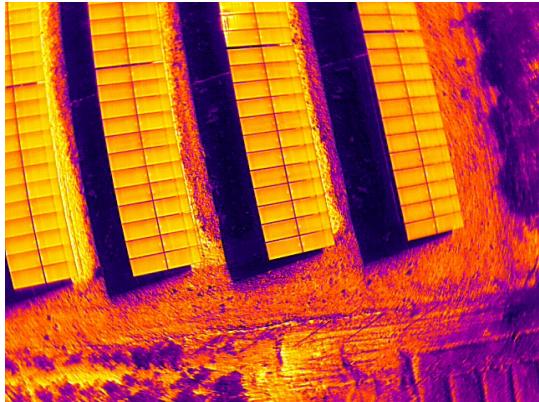
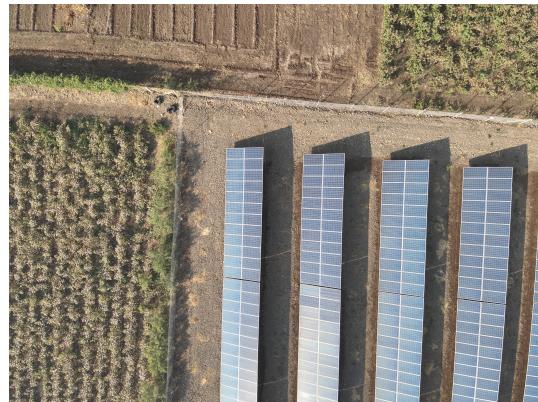
DJI_20241219112408_1575_T.JPG

Category	Priority	Size	Loss
Damaged Conductor	Medium	Large	5.86 kW

Temperature	Parameters	Remedial Action	Comment
47.22 °C	Voltage: 370V Current: 27A	Auto-generated action	Auto-detected anomaly

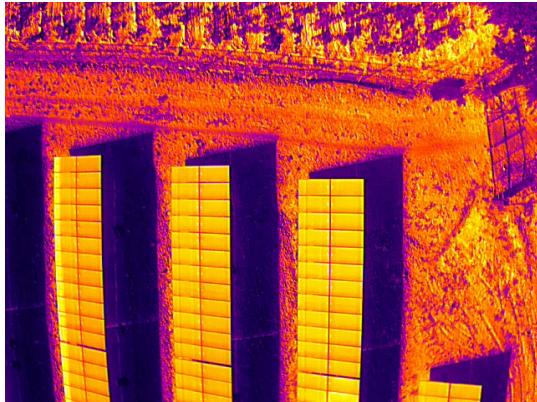
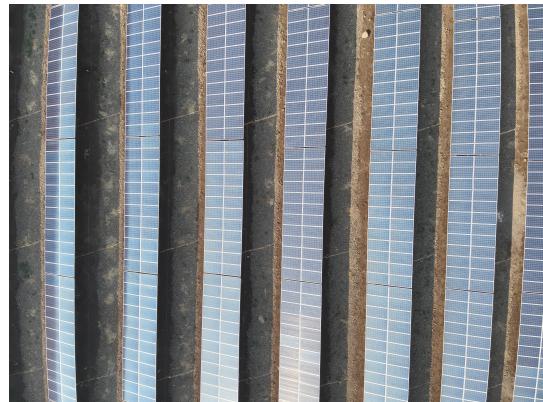
DJI_20241219110453_0110_T.JPG

Anomaly Report – Loose Connection

Category	Priority	Size	Loss
Loose Connection	Critical	Medium	12.64 kW

Temperature	Parameters	Remedial Action	Comment
53.31 °C	Voltage: 204V Current: 31A	Auto-generated action	Auto-detected anomaly

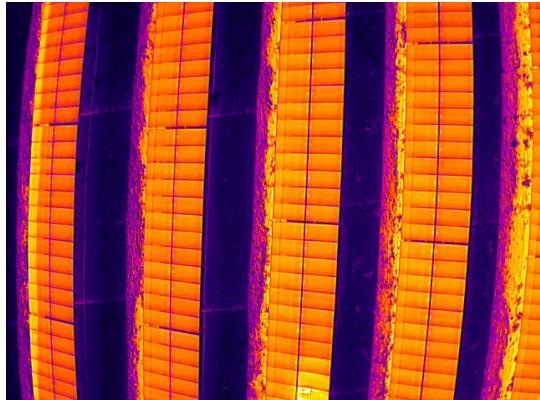
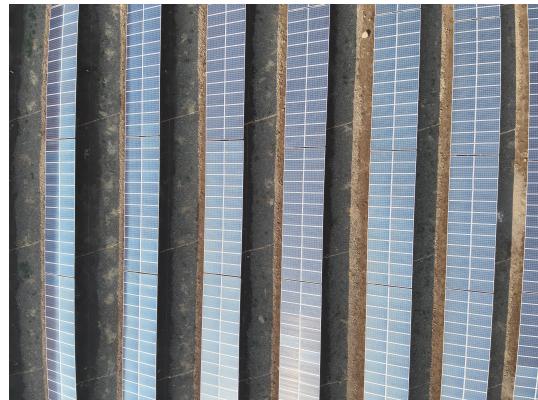
DJI_20241219111447_0862_T.JPG

Anomaly Report – Damaged Conductor

Category	Priority	Size	Loss
Damaged Conductor	Low	Large	5.66 kW

Temperature	Parameters	Remedial Action	Comment
41.58 °C	Voltage: 203V Current: 20A	Auto-generated action	Auto-detected anomaly
