# AI VEHICLE DEFECT INSPECTION

INSPECTION ID: #RPT-9999

COMMERCIAL DAMAGE ASSESSMENT REPORT

| Vehicle Profile: | Tesla Model Y | Digital Health Score: | 100/100 (Excellent) |

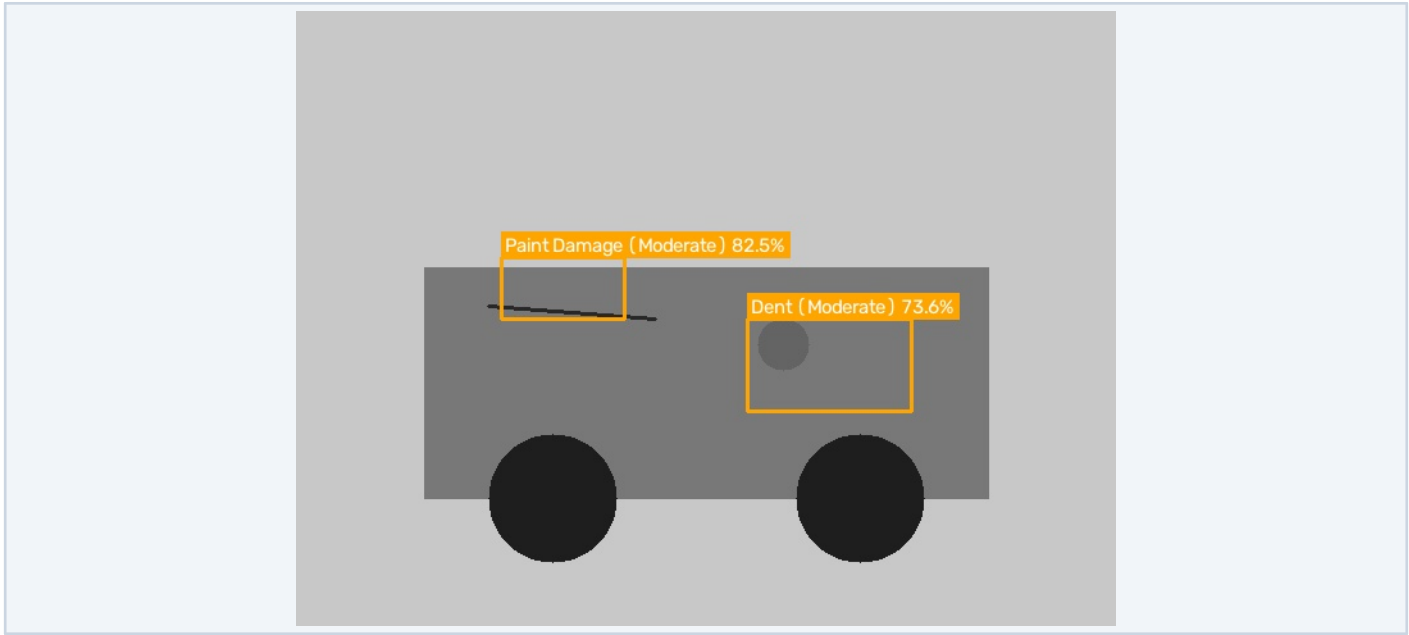
| Defect / Damage Type | Affected Part | Severity | Confidence | Estimated Repair Cost Range |
|---|---|---|---|---|
| Paint Damage | Side Panel | Moderate | 82.5% | \$350 - \$750 |
| Dent | Side Panel | Moderate | 73.6% | \$400 - \$800 |

- **Paint Damage (Side Panel):** Sanding and multi-coat respraying of affected panels.
- **Dent (Side Panel):** Paintless Dent Repair (PDR) or panel reshaping needed.
