# Attic Mould Remediation

Before-and-after photographic evidence for remediation required to enable safe installation of a central ducted heat pump.

| ADDRESS | 27 Cedar Ridge Road, Port Hardy, BC V0N 2P0 |

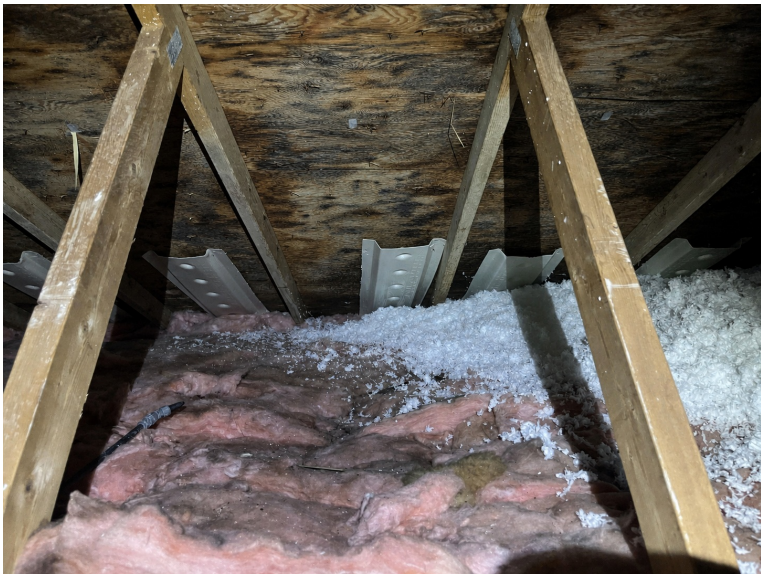
The pre-existing issue was localized mould and moisture staining on attic roof sheathing and adjacent insulation around the planned air-handler platform and duct-access route. Remediation was required before, and completed in direct association with, the eligible central ducted heat-pump installation on the same invoice.

**BEFORE - July 7, 2026.** Attic roof sheathing shows irregular dark mould staining and moisture discoloration above the planned HVAC work area. Adjacent insulation shows localized damp staining. Photograph captured before containment or treatment.

- Isolated the affected attic work zone and protected the occupied space below.
- HEPA vacuumed loose debris and surface growth from roof sheathing and framing.
- Applied approved fungicidal cleaner to localized affected surfaces and removed visibly affected loose insulation debris.
- Allowed treated surfaces to dry and completed a final visual inspection before HVAC installation.
- Released the air-handler platform and duct route for safe heat-pump installation.

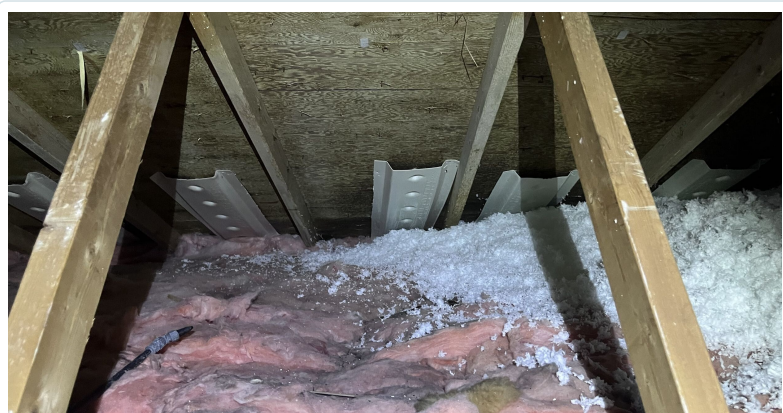
**AFTER VIEW A - July 22, 2026.** Treated sheathing and cleaned work area after HEPA vacuuming, fungicidal treatment and drying verification. View faces the planned air-handler platform.

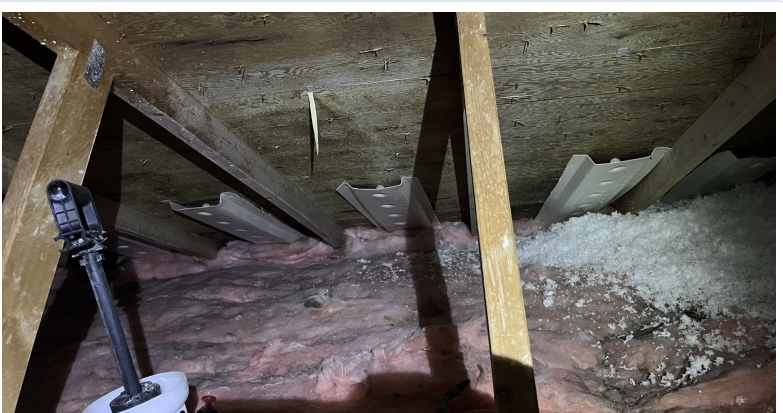
**AFTER VIEW B - July 22, 2026.** Adjacent bay and duct route after treatment. No visible active surface growth remains in the remediated work area.
