# Front Wing Repair

### Root Cause Analysis: Front Wing Failure

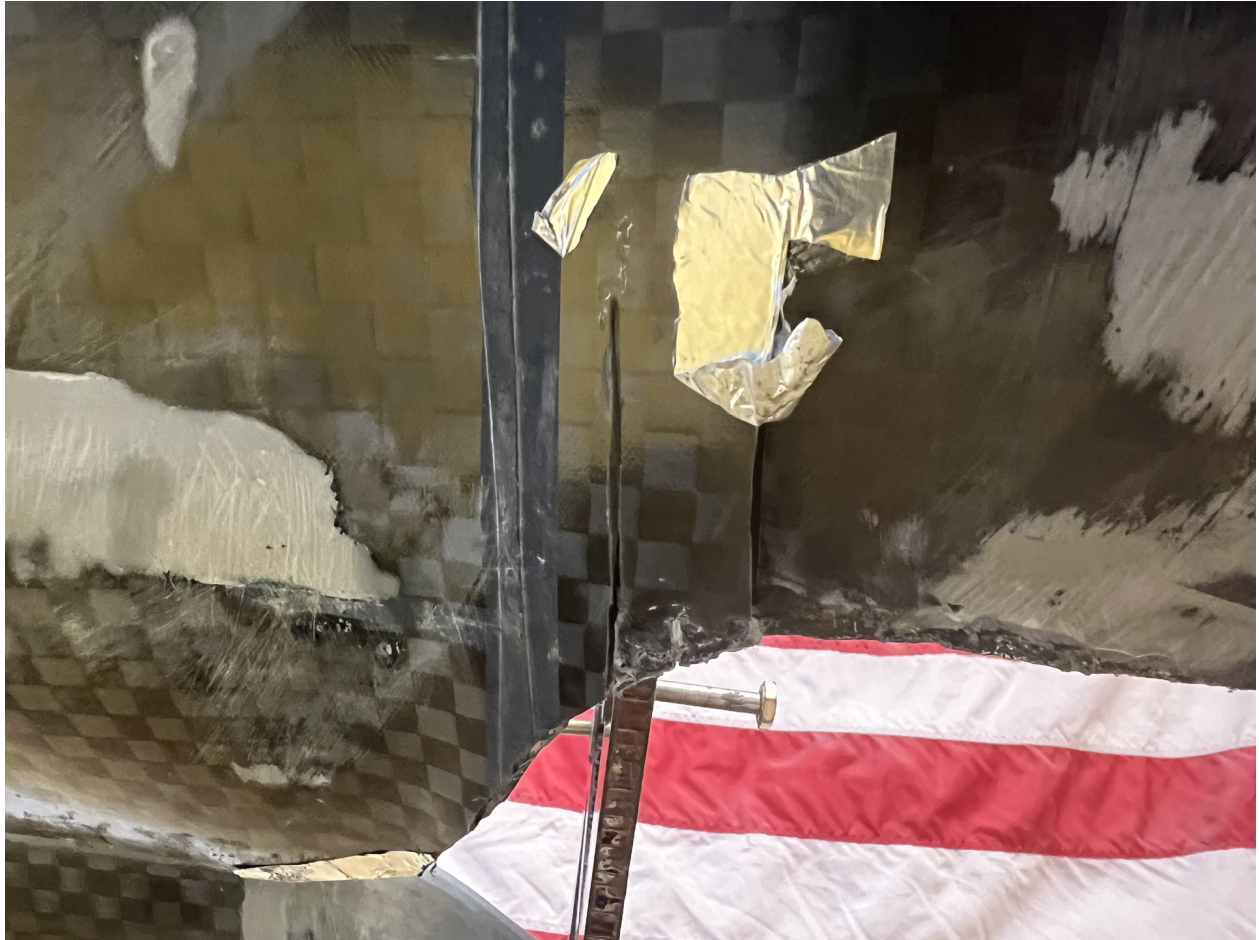
Figure 1: Relief cuts made in front wing, possible point failure

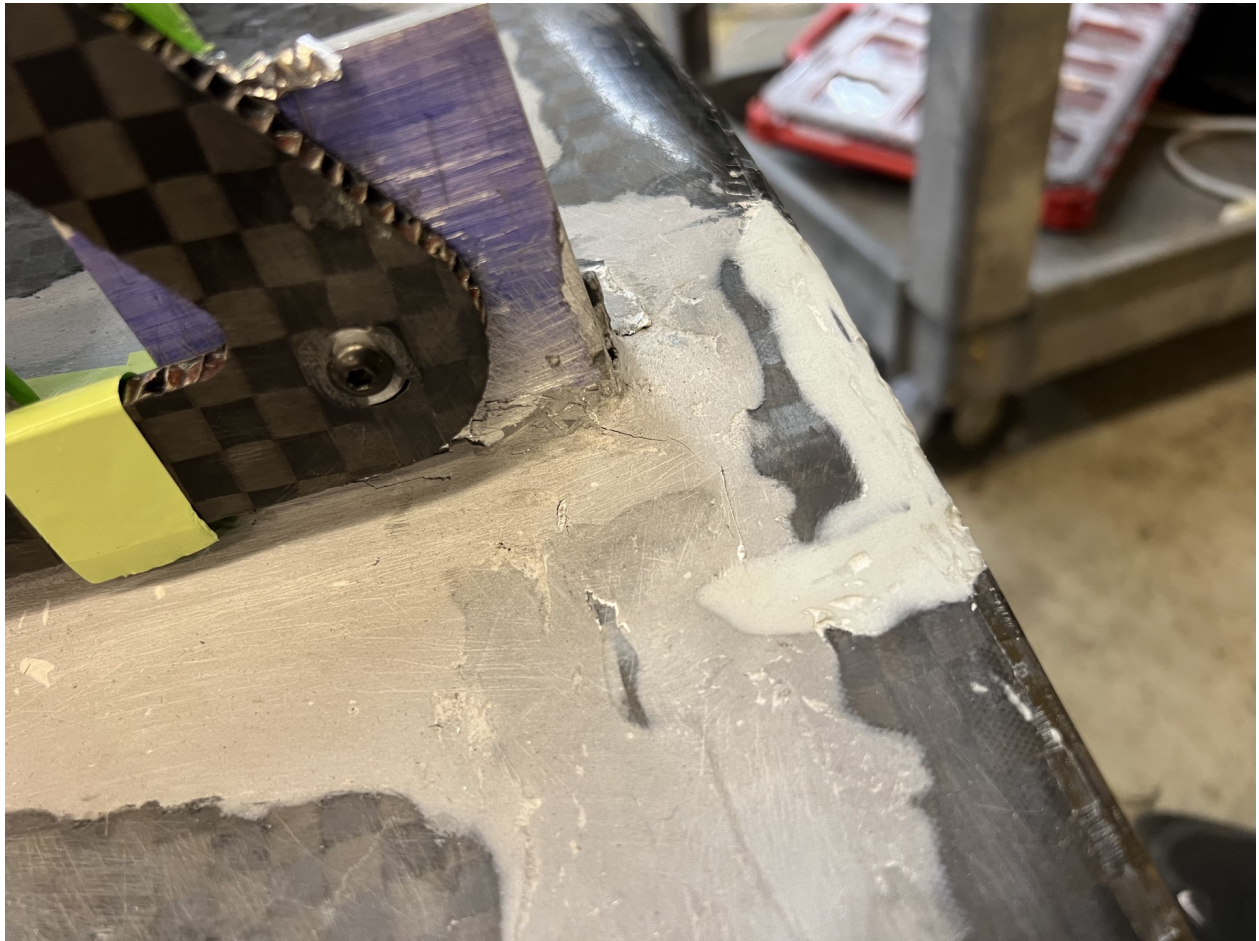
After reaching around 150lbs of downforce during wind tunnel testing (\_\_\_ mph airspeed), the front wing ribs deflected enough to strain the bond between the outer sections of the mainplane, causing a fracture in the filler, along with some separation/fracture in the leading edge. As the mainplane ribs are only constrained by their hardpoints to the front wing struts, which in turn is mounted to the monocoque, it is reasonable to assume that when loading both sides of the mainplane downwards, there is nothing to react the moment incurred besides the stiffness of the rib and strut, which leads to most of the plies /filler taking the load and deflecting.

Figure 2: Small crack located in the filler, rightmost of the left center mainplane rib

- Waterjet spar
- weld plates to middle section
- Cut open fw
- match drill spar and rib
- tap and bolt spar in
- reseal fw

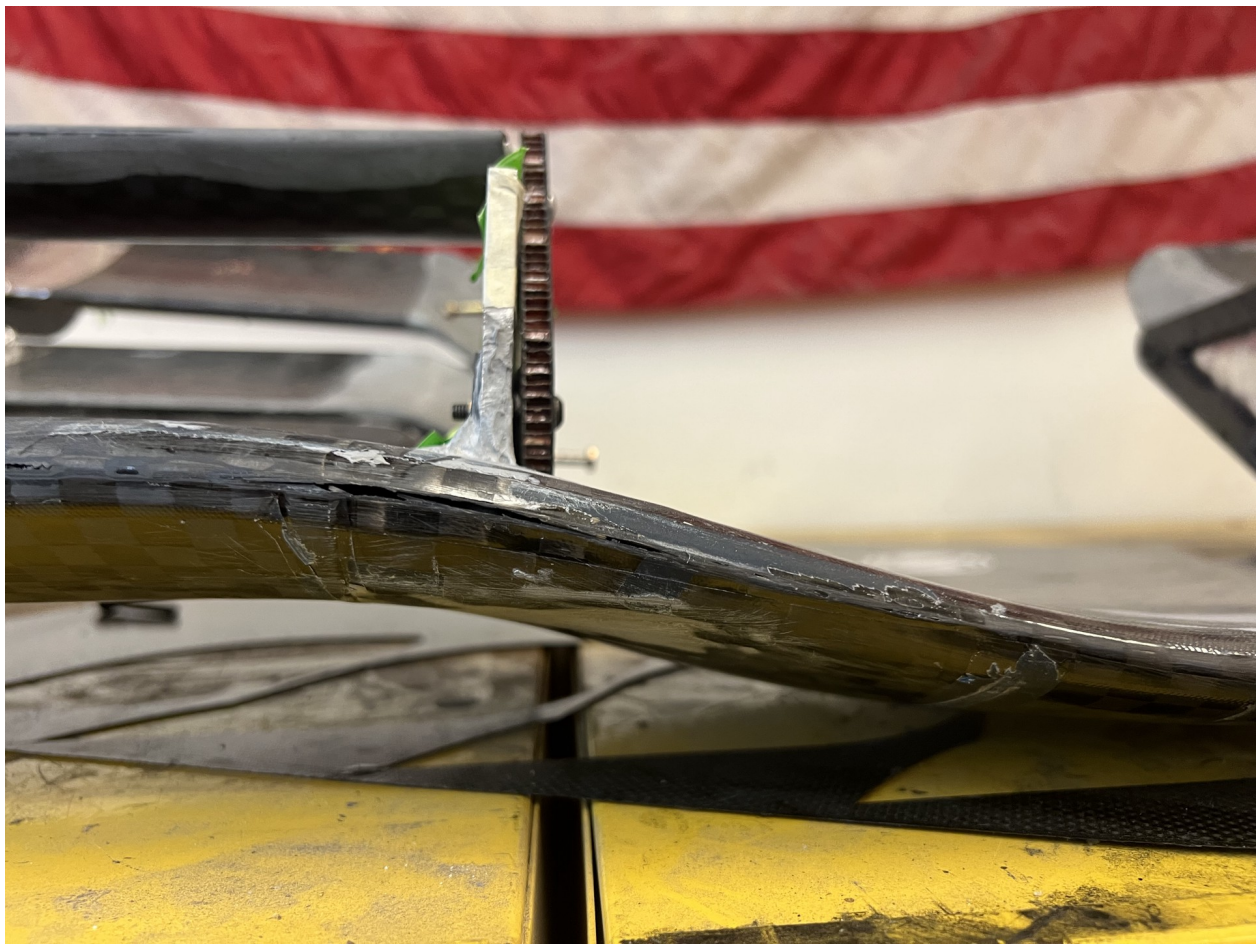
Figure 3: Separation at the leading edge between each "half" of the mainplane. When loaded downwards, the gap increases before returning back to depicted state.

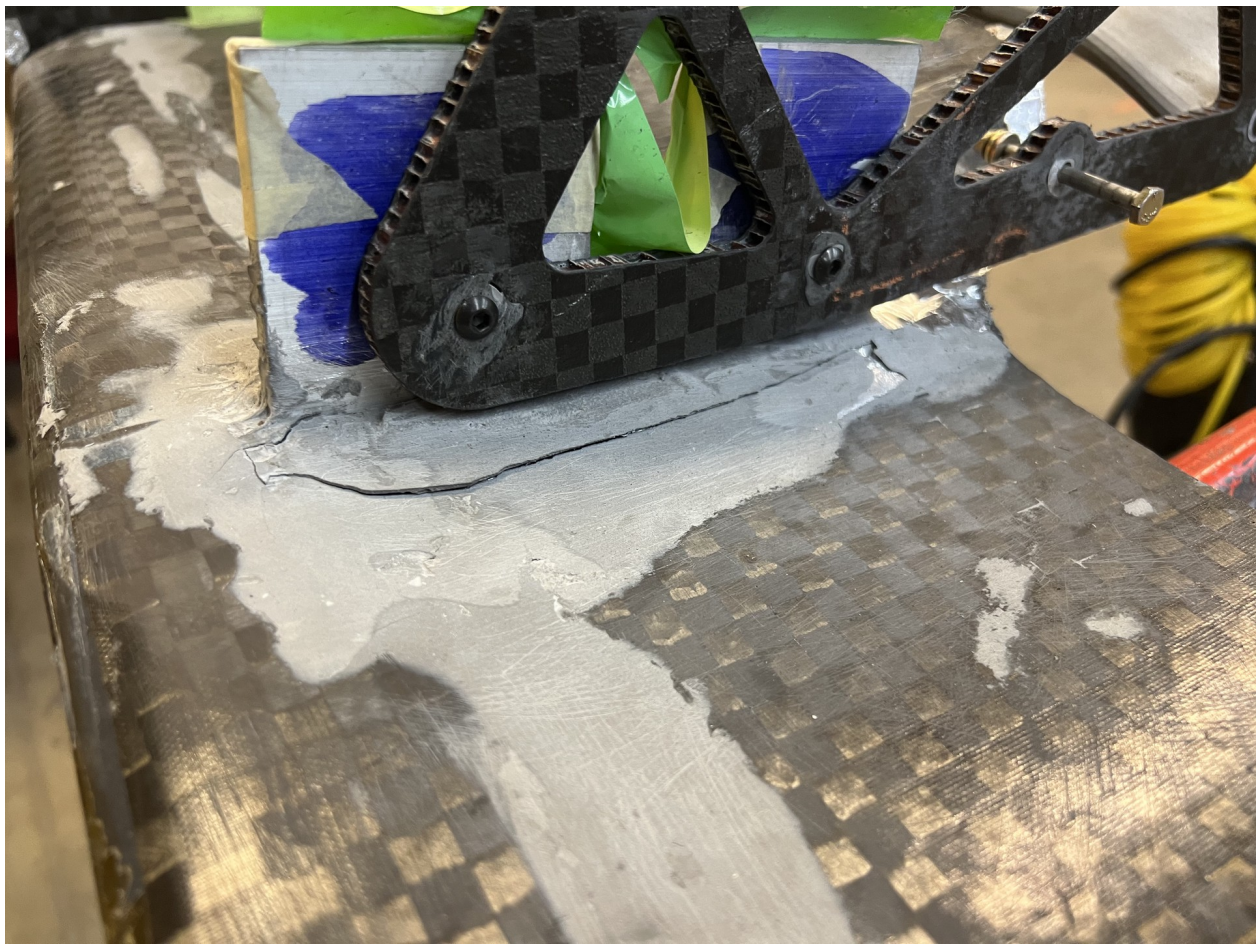
Figure 4: Noticeable crack in the filler located at the right center mainplane rib
