RECOMMENDATIONS FROM THE BOARD OF INQUIRY INTO THE GROUNDING OF **HMS SUPERB**

BOARD OF INQUIRY REPORT INTO THE CIRCUMSTANCES SURROUNDING THE GROUNDING OF HMS SUPERB ON 26 MAY 2008

BOARD OF INQUIRY REPORT INTO THE CIRCUMSTANCES SURROUNDING THE **GROUNDING OF HMS SUPERB ON 26 MAY 2008**

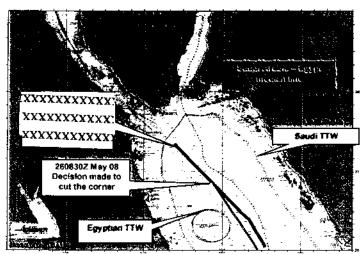
- 7. **Conduct.** Having exited the Gulf of Suez on the morning of the 26 May the boat dived at the northern end of the Red Sea, in accordance with its SUBNOTE, at XXXXX The Tactical and Sonar Officer (TASO), XXXXXXXXXXXXXXXX conducted this evolution taking Charge⁷ of the submarine at XXXXXXX when he brought the OOW below. An overview of SUPERB's navigational plan is shown in Figure 1.

Figure 1 – Overview of HMS SUPERB's navigational plan.

11. At XXXXXIII order to assist with the SOA, TASO instructed the LO to shape the course to starboard, cutting the comer of the planned navtrack, iot reduce the distance to run, whilst at the

required. The LO then plotted a course of XXXXXXX after the alteration, which was then cursorily checked by TASO¹²; this course ran directly over the XXXX shoal.
