1 L/s Plant Testing, Spring 2017

May 15, 2017

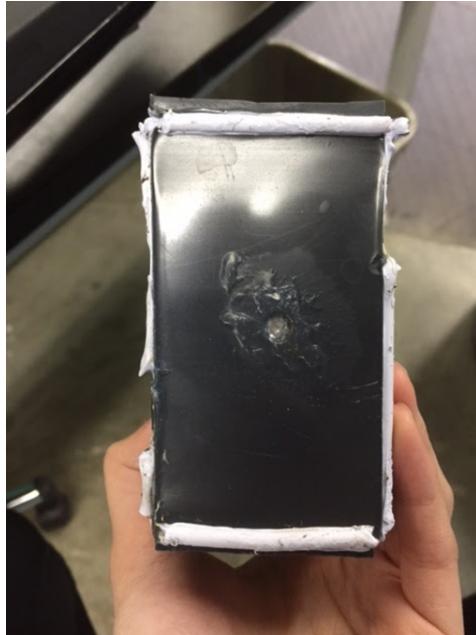
Eventually, the processes of re-welding and tacking the joints proved fruitless, and the process of solvent welding was adopted. The team built a small-scale rectangular tank, welded it poorly, and patched holes in the welded plastic by solvent welding. The solvent welding proved very effective and quickly patched the leaks. In order to further confirm the effectiveness of solvent welding, the team drilled a hole in the bottom of the tank and patched it with PVC glue as seen in Figure 2. The tank was tested once again for watertightness and was successful. After the solvent welding technique was adopted, leaks in the sedimentation tank were quickly absolved.

Figure 2: Solvent welding test

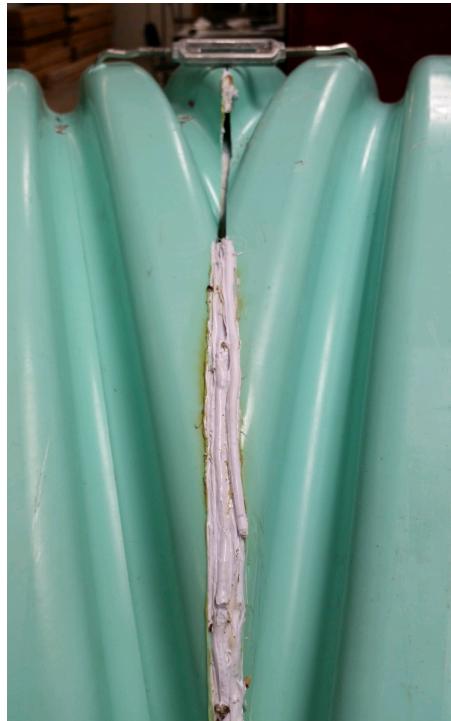
In order to place the turn buckles, the team carefully drilled two holes on the top and bottom section of the sedimentation tank corrugations, respectively, without puncturing the inside. These two turn buckle holes were drilled on either side of the sedimentation tank cut for security. Despite aligning the cut of the sedimentation tank (Herrera et al., 2016), the cut was not perfect and resulted in a few large gaps. The team had rotated welding over the gaps and was able to start water testing. (shown in 6).

Figure 6: Welding to Fill in Gaps

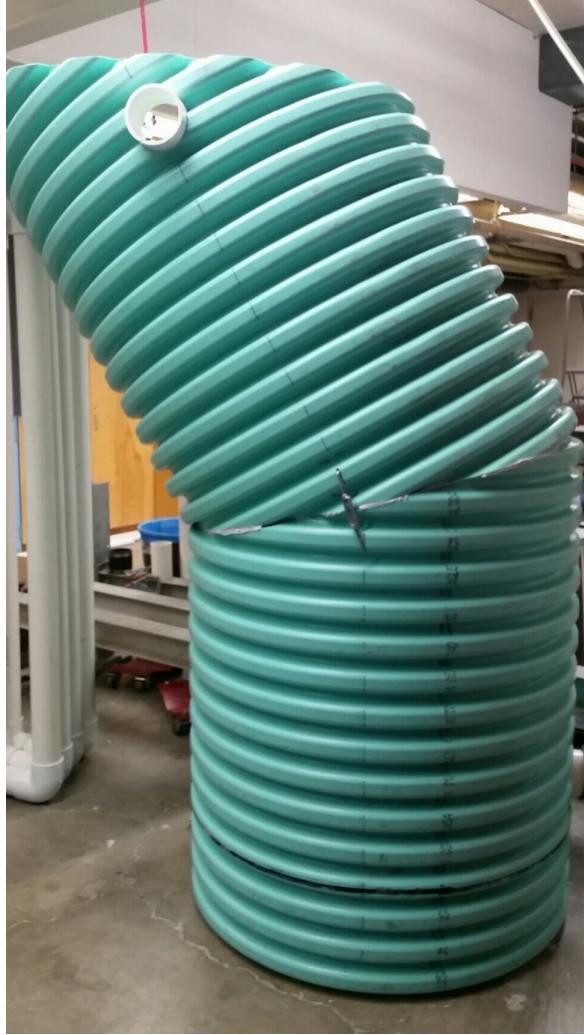
Figure 7: Sedimentation Tank upright for Water Testing

It took the team roughly an hour to fill up the sedimentation tank with water past the seam where the bottom and top parts of the tank were welded together. There were two leaks that were found near the welded seams of the tank. The tank was drained of water and when the tank was dried, the team solvent welded over the plastic welded area and water tested. During the second round of water testing, there were an additional two leaks directly in the area where the turnbuckles were attached. Because the turnbuckles were attached on the top and bottom of the cross sectional area of the sedimentation tank, the area around the turnbuckles were difficult to weld over. The team removed the turnbuckles and welded over. Before water testing again, the team solvent welded over the outside and inside of the main welds. These methods proved successful in making the sedimentation tank water tight.

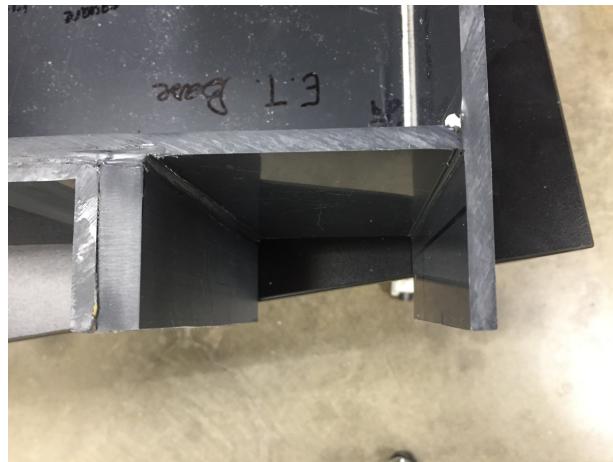
However, there were still issues with the construction of the entrance tank. One of the first problem areas was the section where the entrance tank would be attached to a wooden pole support (shown in Figure 9). The team did not realize the colloquial term "4-by-4" for a wooden pole does not allude to a 10.16 cm (4 in) by 10.16 cm (4 in) cross section of the wooden pole. In fact, this term refers to a wooden pole with a 7.62 cm (3.5 in) by 7.62 cm (3.5 in) cross section. Therefore, the team created enough space for a 10.16 cm (4 in) width pole rather than a 7.62 cm (3.5 in) width pole. This issue was resolved by solvent welding a 1.27 cm (0.5 in) PVC sheet to the inside of the space (shown in Figure 8).

Figure 8: The 0.5 inch PVC sheet is glued to the inside of the space.

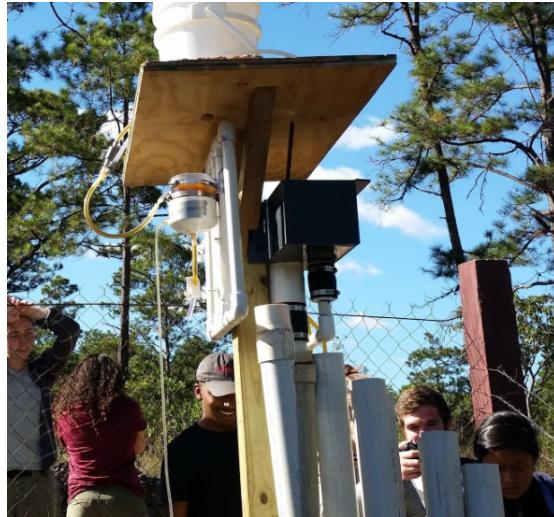
The third issue addressed was the problem of having the first pipe of the tapered flocculator too close to the wooden pole. In the original design, the wooden pole is directly next to the first pipe of the flocculator. This first pipe had a diameter of 7.62 cm (3 in), which made it feasible for it to fit next to the pole. However, the tapered flocculator will have a first pipe with a diameter of 20.32 cm (8 in). As shown in Figure 9, the 7.62 cm (3 in) pipe only barely fit next to the pole, so it would be impossible for a 20.32 cm (8 in) pipe to fit in that same space. To address this issue, the team decided to shift the positions of the Linear Flow Orifice Meter (LFOM) and the entrance pipe to the entrance tank itself. The LFOM is attached to the entrance to the flocculator to ensure linear flow into the first leg of the pipe. Both the LFOM and the entrance pipe were to be attached to the entrance tank as shown in the layout in Figure 10.

Figure 9: This is a photo of the entrance tank attached to the wooden pole in Honduras. The first pipe of the flocculator is shown pressed up against the wooden pole.
