## Health and Safety Windsor Report

Generated By: John McGann Generated On: 03/03/2010 - February

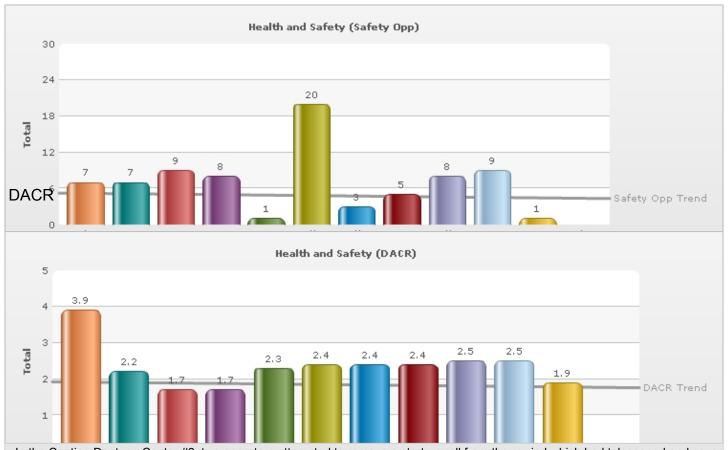
## Safety Opportunities

In the Coating Dept. on Coater #2, two operators attempted to remove a start-up roll from the rewind which had telescoped and covered over the roll shaft extension on one end.

The operators rigged 2 narrow lifting slings and speader bar to lift the large roll, and the sling on the telescoped paper side slipped, causing the roll to drop from the hoist.  $\Box$

Potential for severe injury to employees if struck by falling roll.  $\square$   $\square$   $\square$   $\square$   $\square$

The Department group reviewed this event and it's causes at Dept. Safety Tool Box Talk briefing.

Management counseled all operators to use wide body fabric lifting sling to fully support large rolls if roll shafts are not completely exposed and roll shaft ends cannot be securely held with narrow slings, when removing rolls with ovehead chain hoist.
