QC TEST REPORT

SCAPA Complaint n:

100315

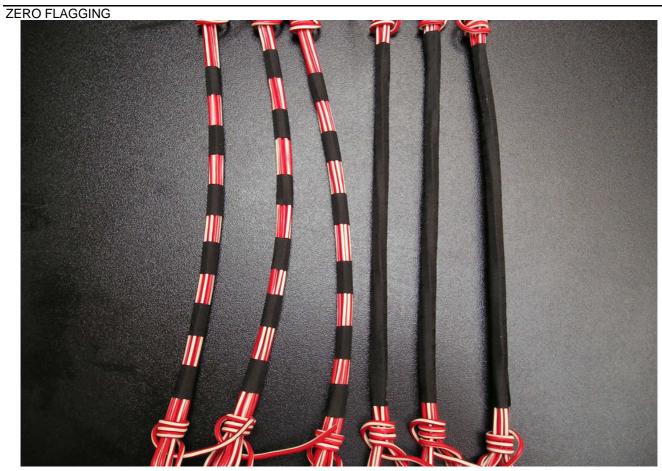
Adesion to back

SAMPLE	Average values (SCAPA spec ≥ 2 N/cm)
1	5,73
2	4,82
