NATIONAL TRANSPORTATION SAFETY BOARD

US Army PAT25, Sikorsky UH-60L and

PSA Airlines flight 5342

Midair Collision in Washington, DC

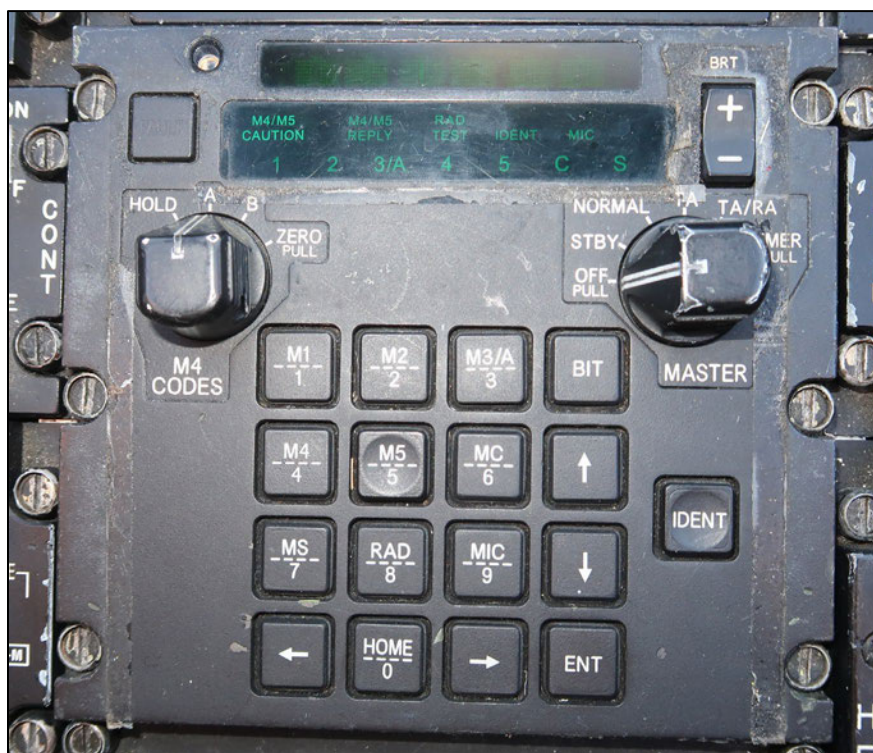
TCAS was not installed in the helicopter, hence the TA and TA/RA functions were inoperative.

**Figure 20.** AN-123(V) Transponder control head as installed in the Blackhawk.

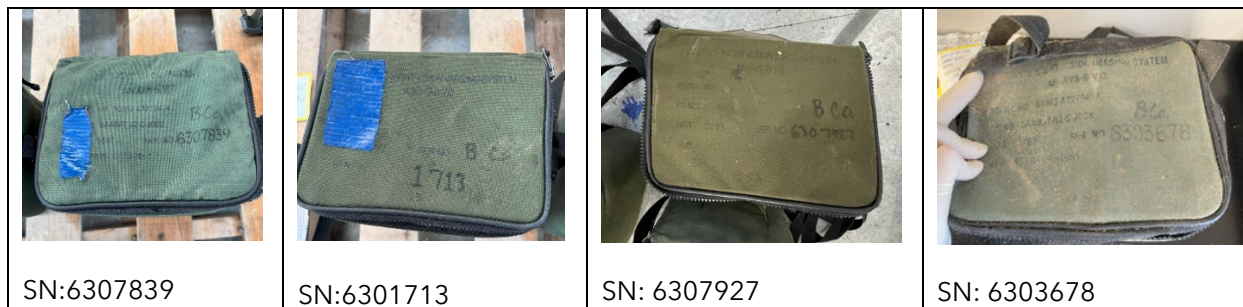
**Figure 31.** Empty NVG cases recovered from the wreckage.

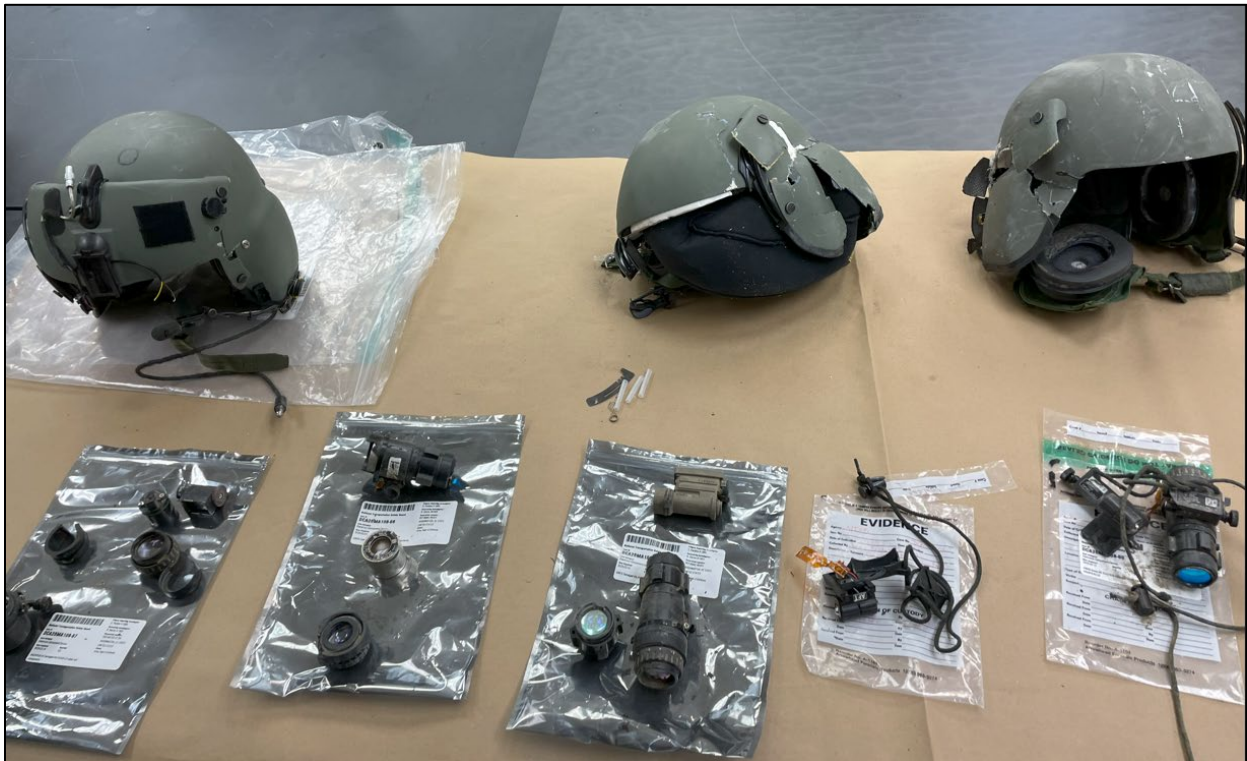
The group also collected three crew helmets (figure 32) and multiple broken NVG components from the wreckage area. Although the group was able to identify which helmets belonged to which crew members, and although some of the NVG components bore serial numbers matching the numbers for the devices that were checked out by the IP and the numbers on the NVG cases, investigators were unable to determine which NVGs had been mounted on which helmets because there were no matching broken wires or fracture surfaces (Attachment 12).

**Figure 32.** Crew helmets, NVG components, and other electronic components from the wreckage.

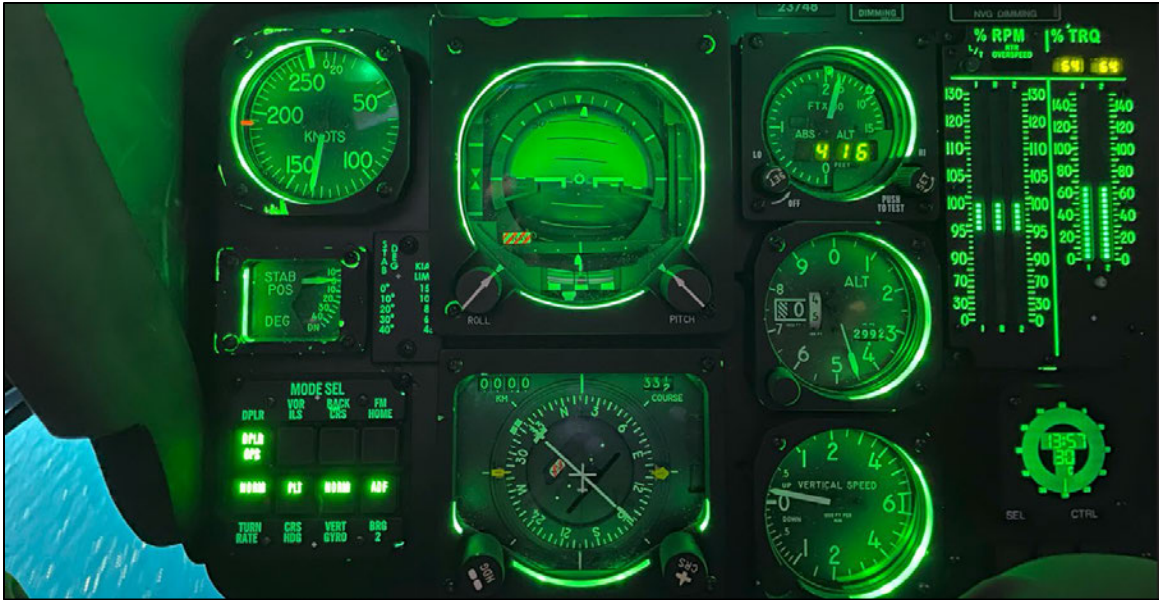
The group member was able shift their gaze from looking at the external scene through the NVGs to looking at the flight instruments below the NVGs without head movement. The portion of instrument panel that was visible below the goggles is shown in figure 36. A photo was taken from the group member's goggle position, and the group member used computer software to sketch the approximate field of view through the NVGs when looking straight ahead through them (figure 37).

**Figure 35.** View of the instrument panel when looking below the NVG's with the seat full aft and the eyepiece 54mm in front of the wearer's eye.

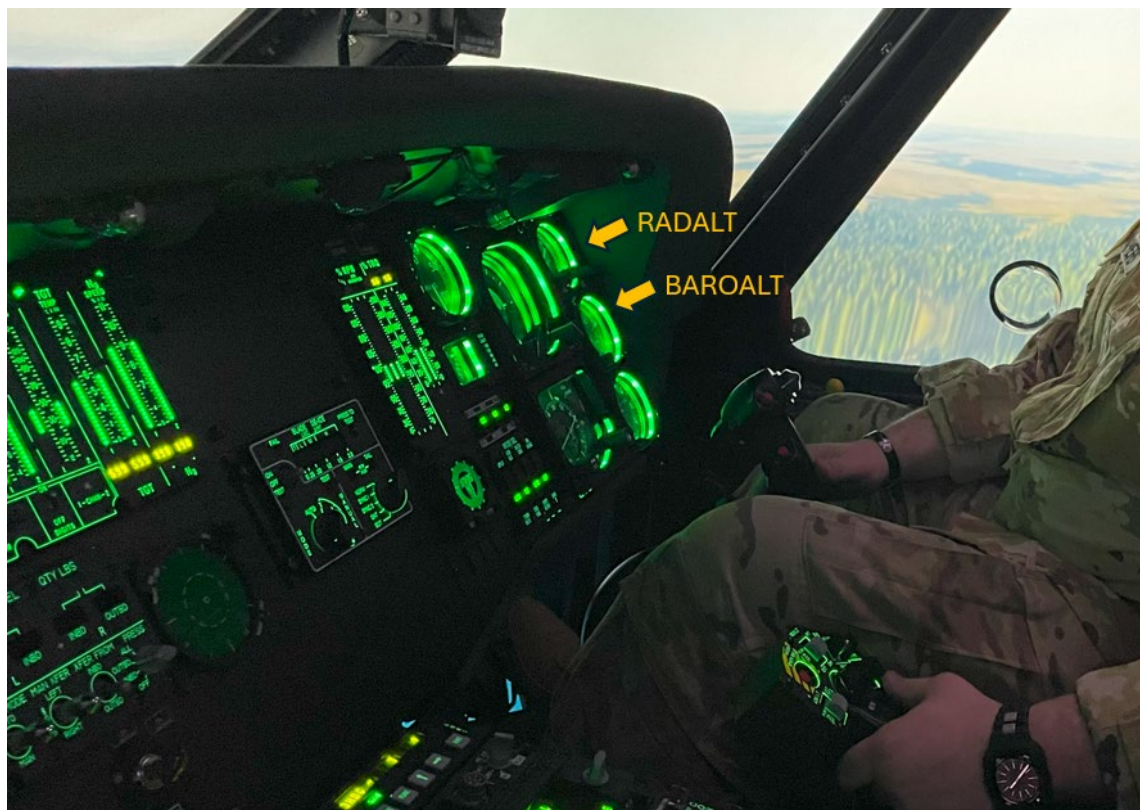
**Figure 38.** Left-seat pilot's view of right seat altimeters.

A view of the right seat altimeters from the point of view of the left seat pilot is shown in figure 39. The left seat pilot could not easily observe altitude indications on the opposite side of the cockpit. Head rotation and leaning were required. The left seat altimeters were closer to the center of the cockpit, which made it somewhat easier for the right seat pilot to observe the left-seat altimeter indications.

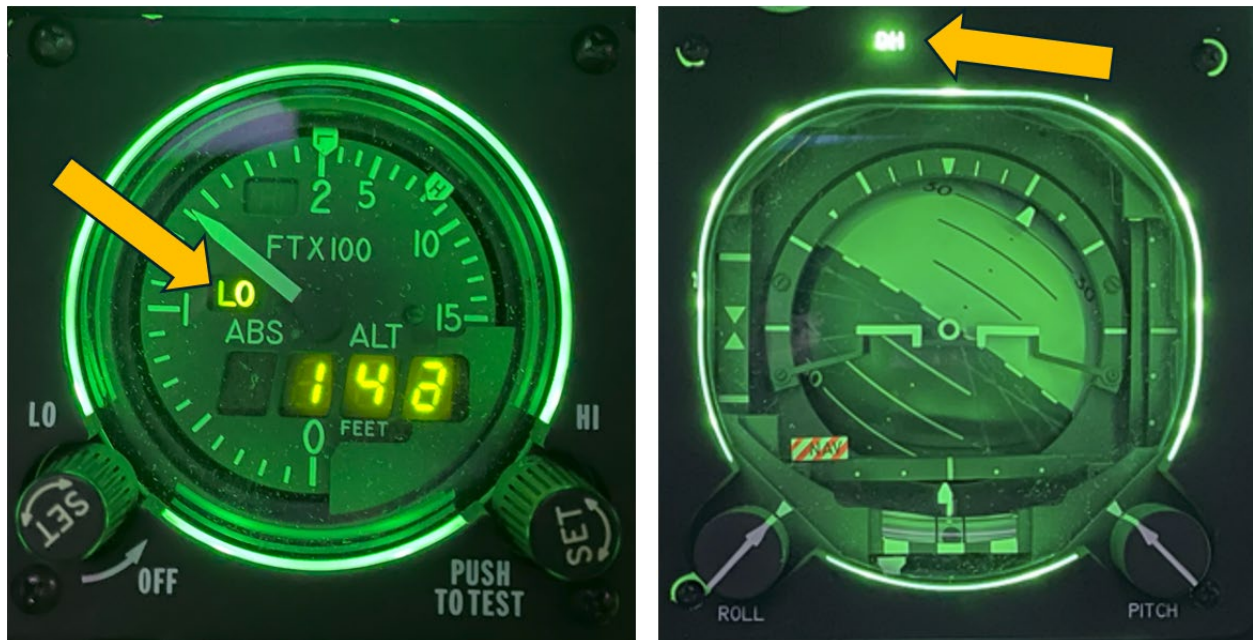
The UH-60L radar altimeter was equipped with adjustable upper and lower altitude bugs. Investigators observed in a UH-60L simulator that when the radar altitude dropped below the lower bug, an amber "LO" indication illuminated on the face of the radar altimeter, and a green "DH" indication illuminated above the vertical situation indicator (VSI), as shown in figures 40 and 41.

**Figure 39.** "LO" and "DH" indications (yellow arrows) that appeared when radio altitude decreased below the radar altimeter's lower altitude bug.

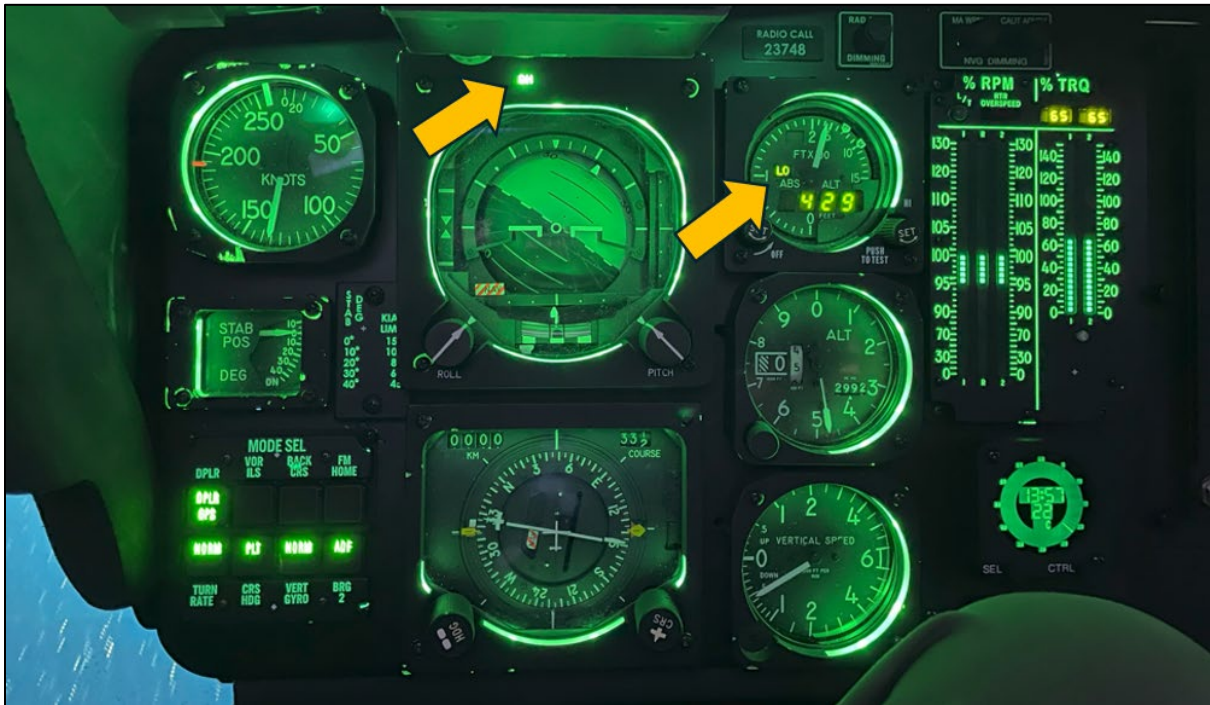
**Figure 40.** Location of the "LO" and "DH" indications on the left instrument panel.

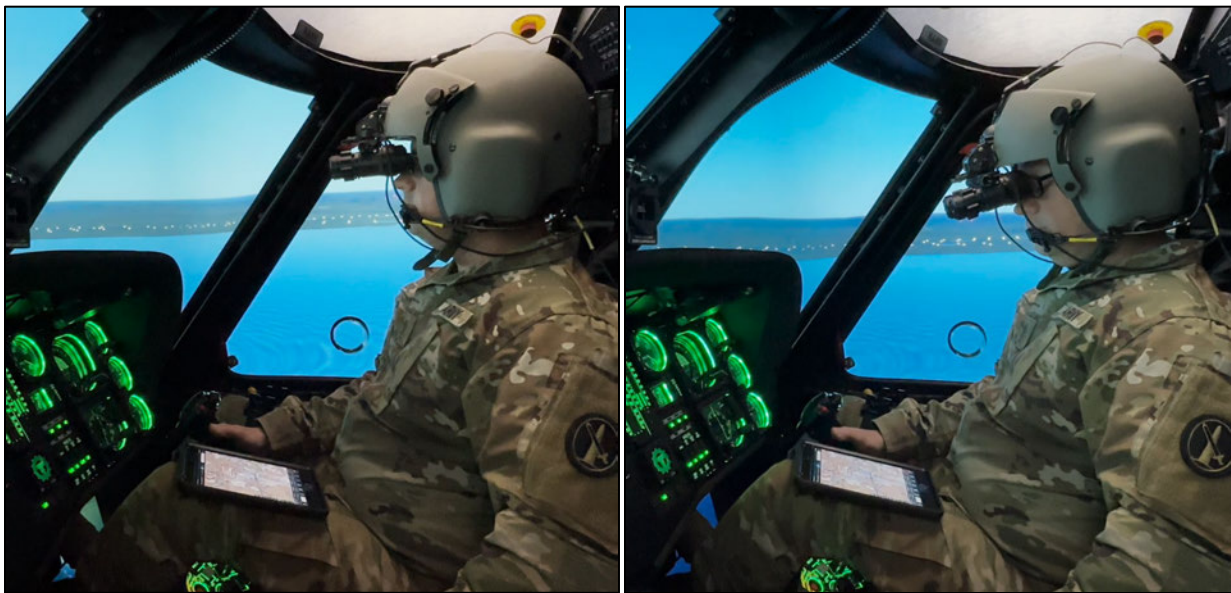
Video revealed that the pilot tilted his head down each time he viewed the iPad (figure 43). The group's human performance investigator sat in a chair with the same iPad on his thigh while looking straight ahead and confirmed that it was necessary to tilt one's head down to look at the iPad because it was outside the range of eye movement when looking straight ahead.

**Figure 42.** Pilot's head tilt when acquiring traffic on the iPad.

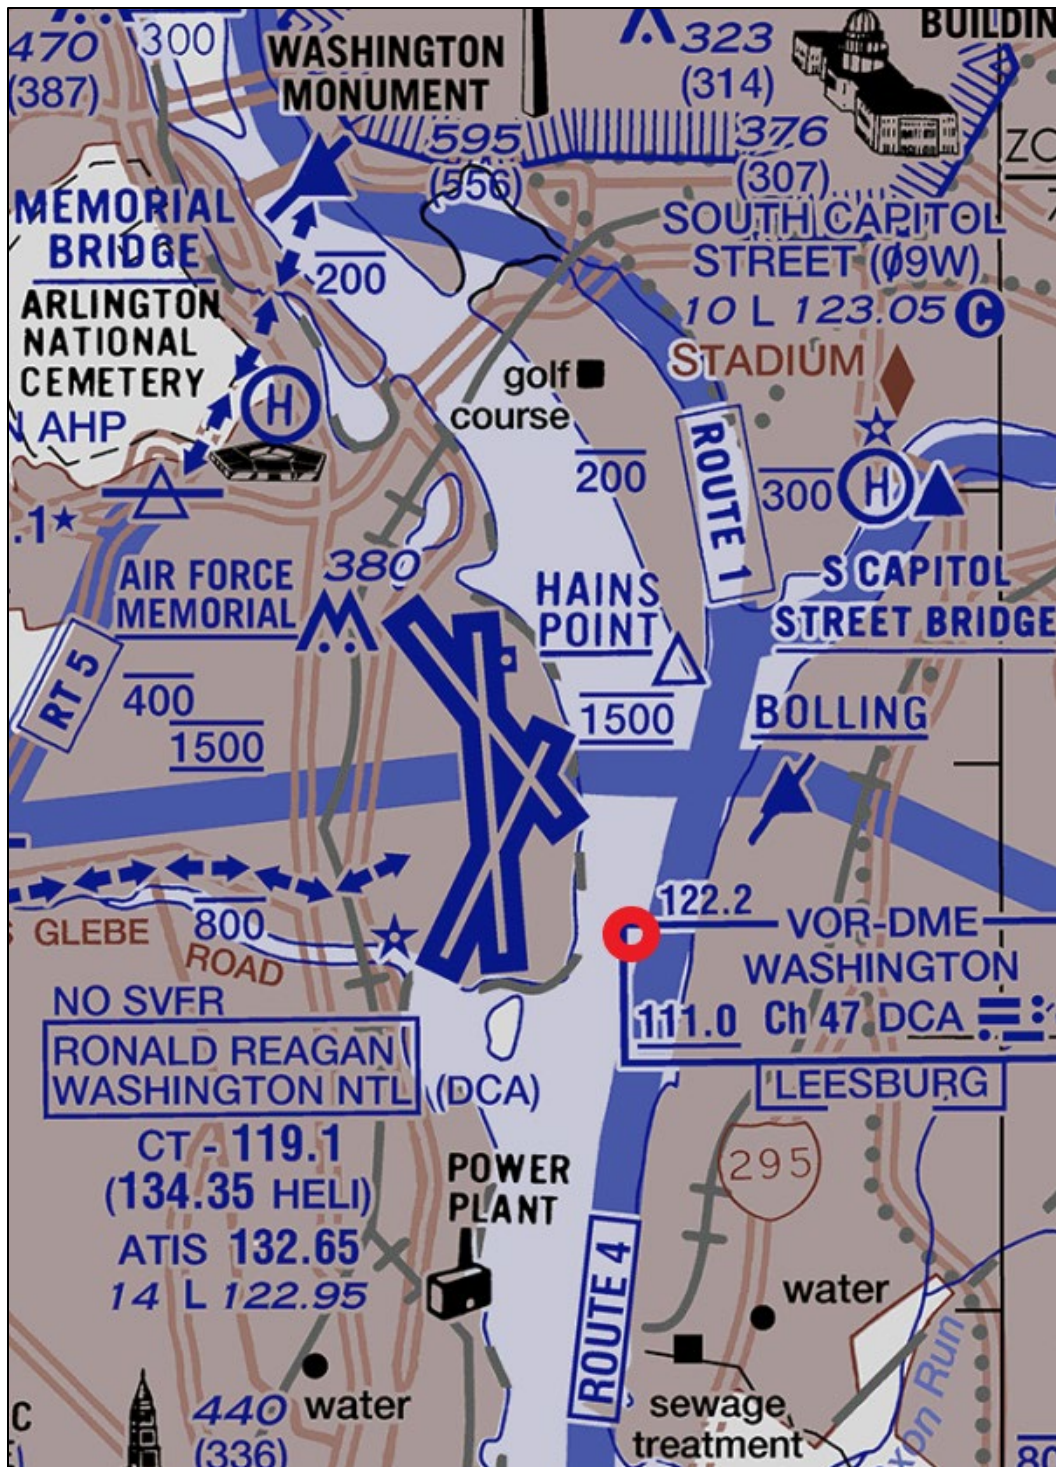
**Figure 45.** Approximate location of the accident crash depicted in red circle over the Helicopter Route  
Chart: Baltimore-Washington
