**PRELIMINARY PROJECT REPORT**

**RESTORATION OF  
ST. MARY'S CHURCH, AJMER,  
RAJASTHAN**

**MAY 2024**

**ARCHITECTURAL HERITAGE DIVISION  
INDIAN NATIONAL TRUST FOR ART AND CULTURAL HERITAGE  
(INTACH)  
NEW DELHI**

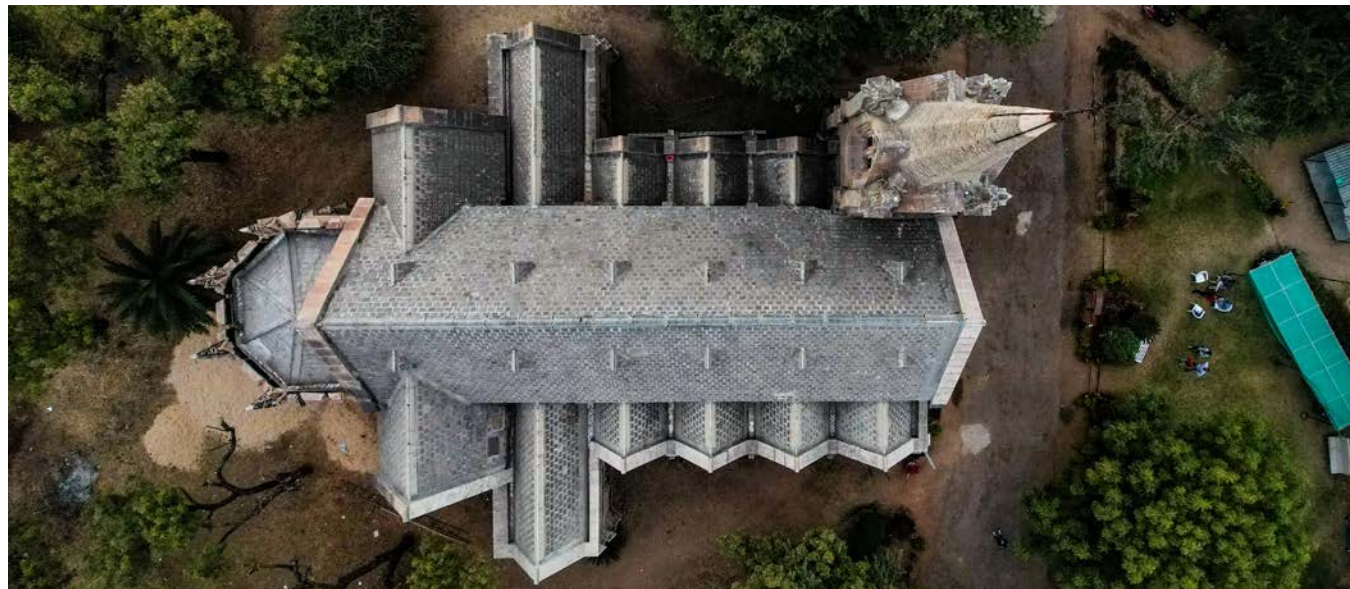
Fig. 16 - Drone view of site before fire incident  
Source -St. Mary's Church Trust

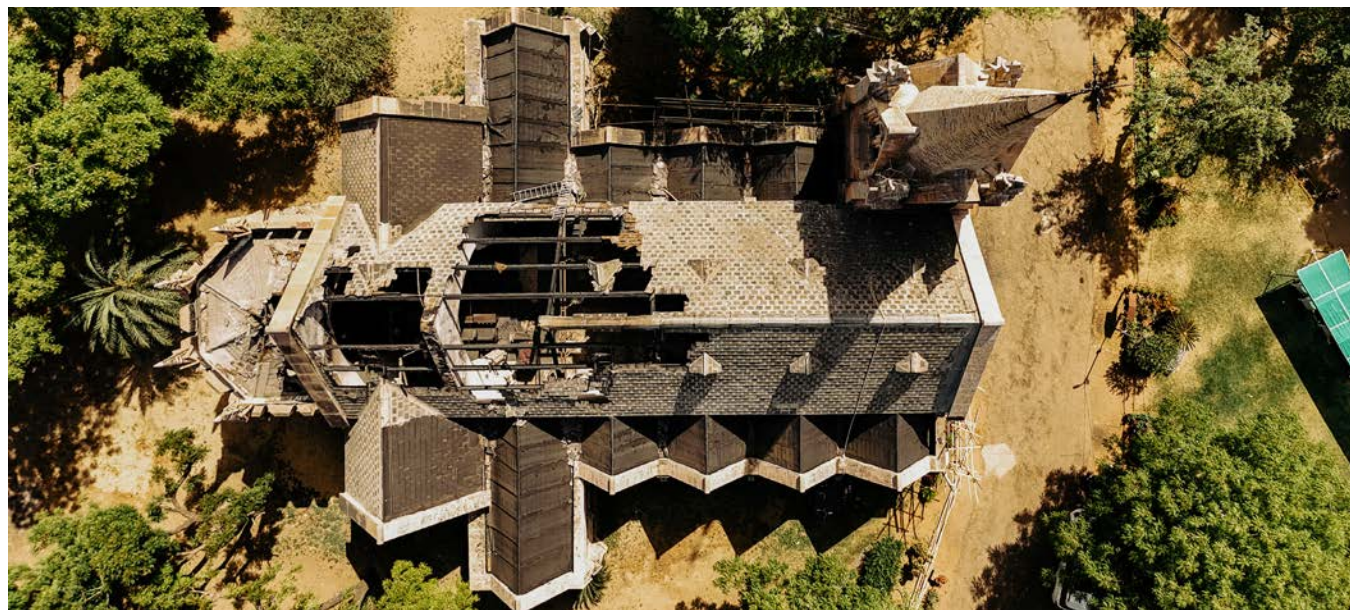
The fire has caused extensive damage to the Church, with over 50% of the roof destroyed. Three out of four timber trusses are completely lost, and the collapse of the roof has severely damaged the items below, including historic furnitures, electrical fixtures and fittings. the fallen roof has shattered all the historic materials it contained, making them irreparable and unsuitable for reuse. Additionally, the fire has left deposits on the Church's interiors, including stained glass windows, compromising their historic and aesthetic value.

Fig. 17 - Drone view of site after fire incident showing the damaged roof  
Source -St. Mary's Church Trust

1. **Scaffolding and Propping:** Erect necessary scaffolding and supports to ensure safety and stability during the roof repair process.
2. **Dismantling:** Carefully dismantle the entire roof, documenting and recording each layer to guide the restoration.
3. **Restoration and Structural Strengthening:** Reconstruct the roof based on the documented layers, including the truss. Add a waterproofing layer to enhance protection.
4. **Timber Treatment:** Treat Timber for termite and polish all timber members to restore their historic appearance and conserve their condition.
5. **Waterproofing:** Apply a layer of compatible waterproofing membrane to the restored roof to replace the historic lead-based sheeting.
6. **Rainwater Drainage:** Restore the rainwater drainage pipes using materials compatible with the historic structure.

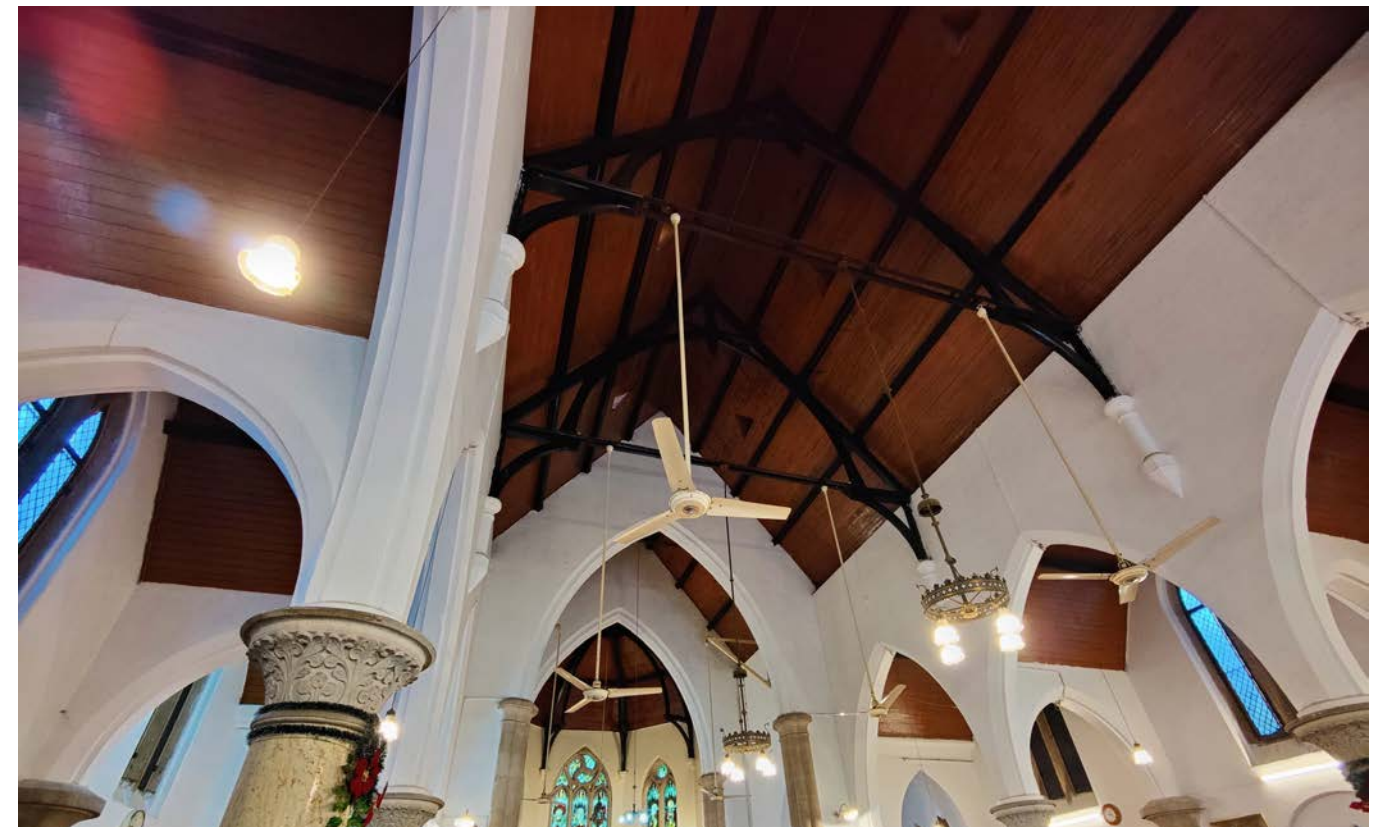
Fig. 18 - The wooden false ceiling before the fire incident  
Source -St. Mary's Church Trust

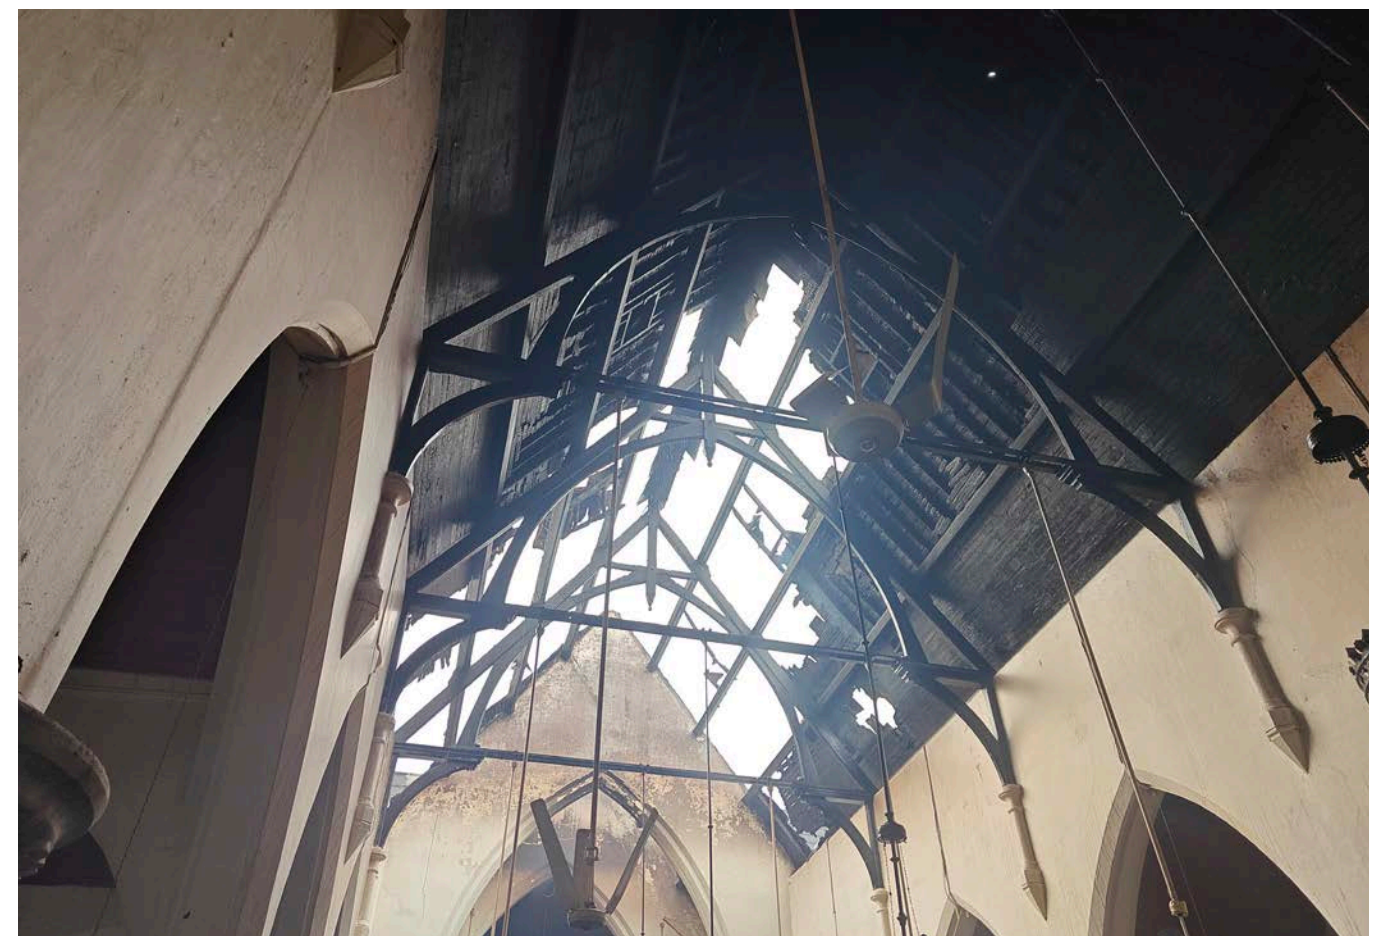
Fig. 19 - The damaged wooden false ceiling before the fire incident  
Source -St. Mary's Church Trust

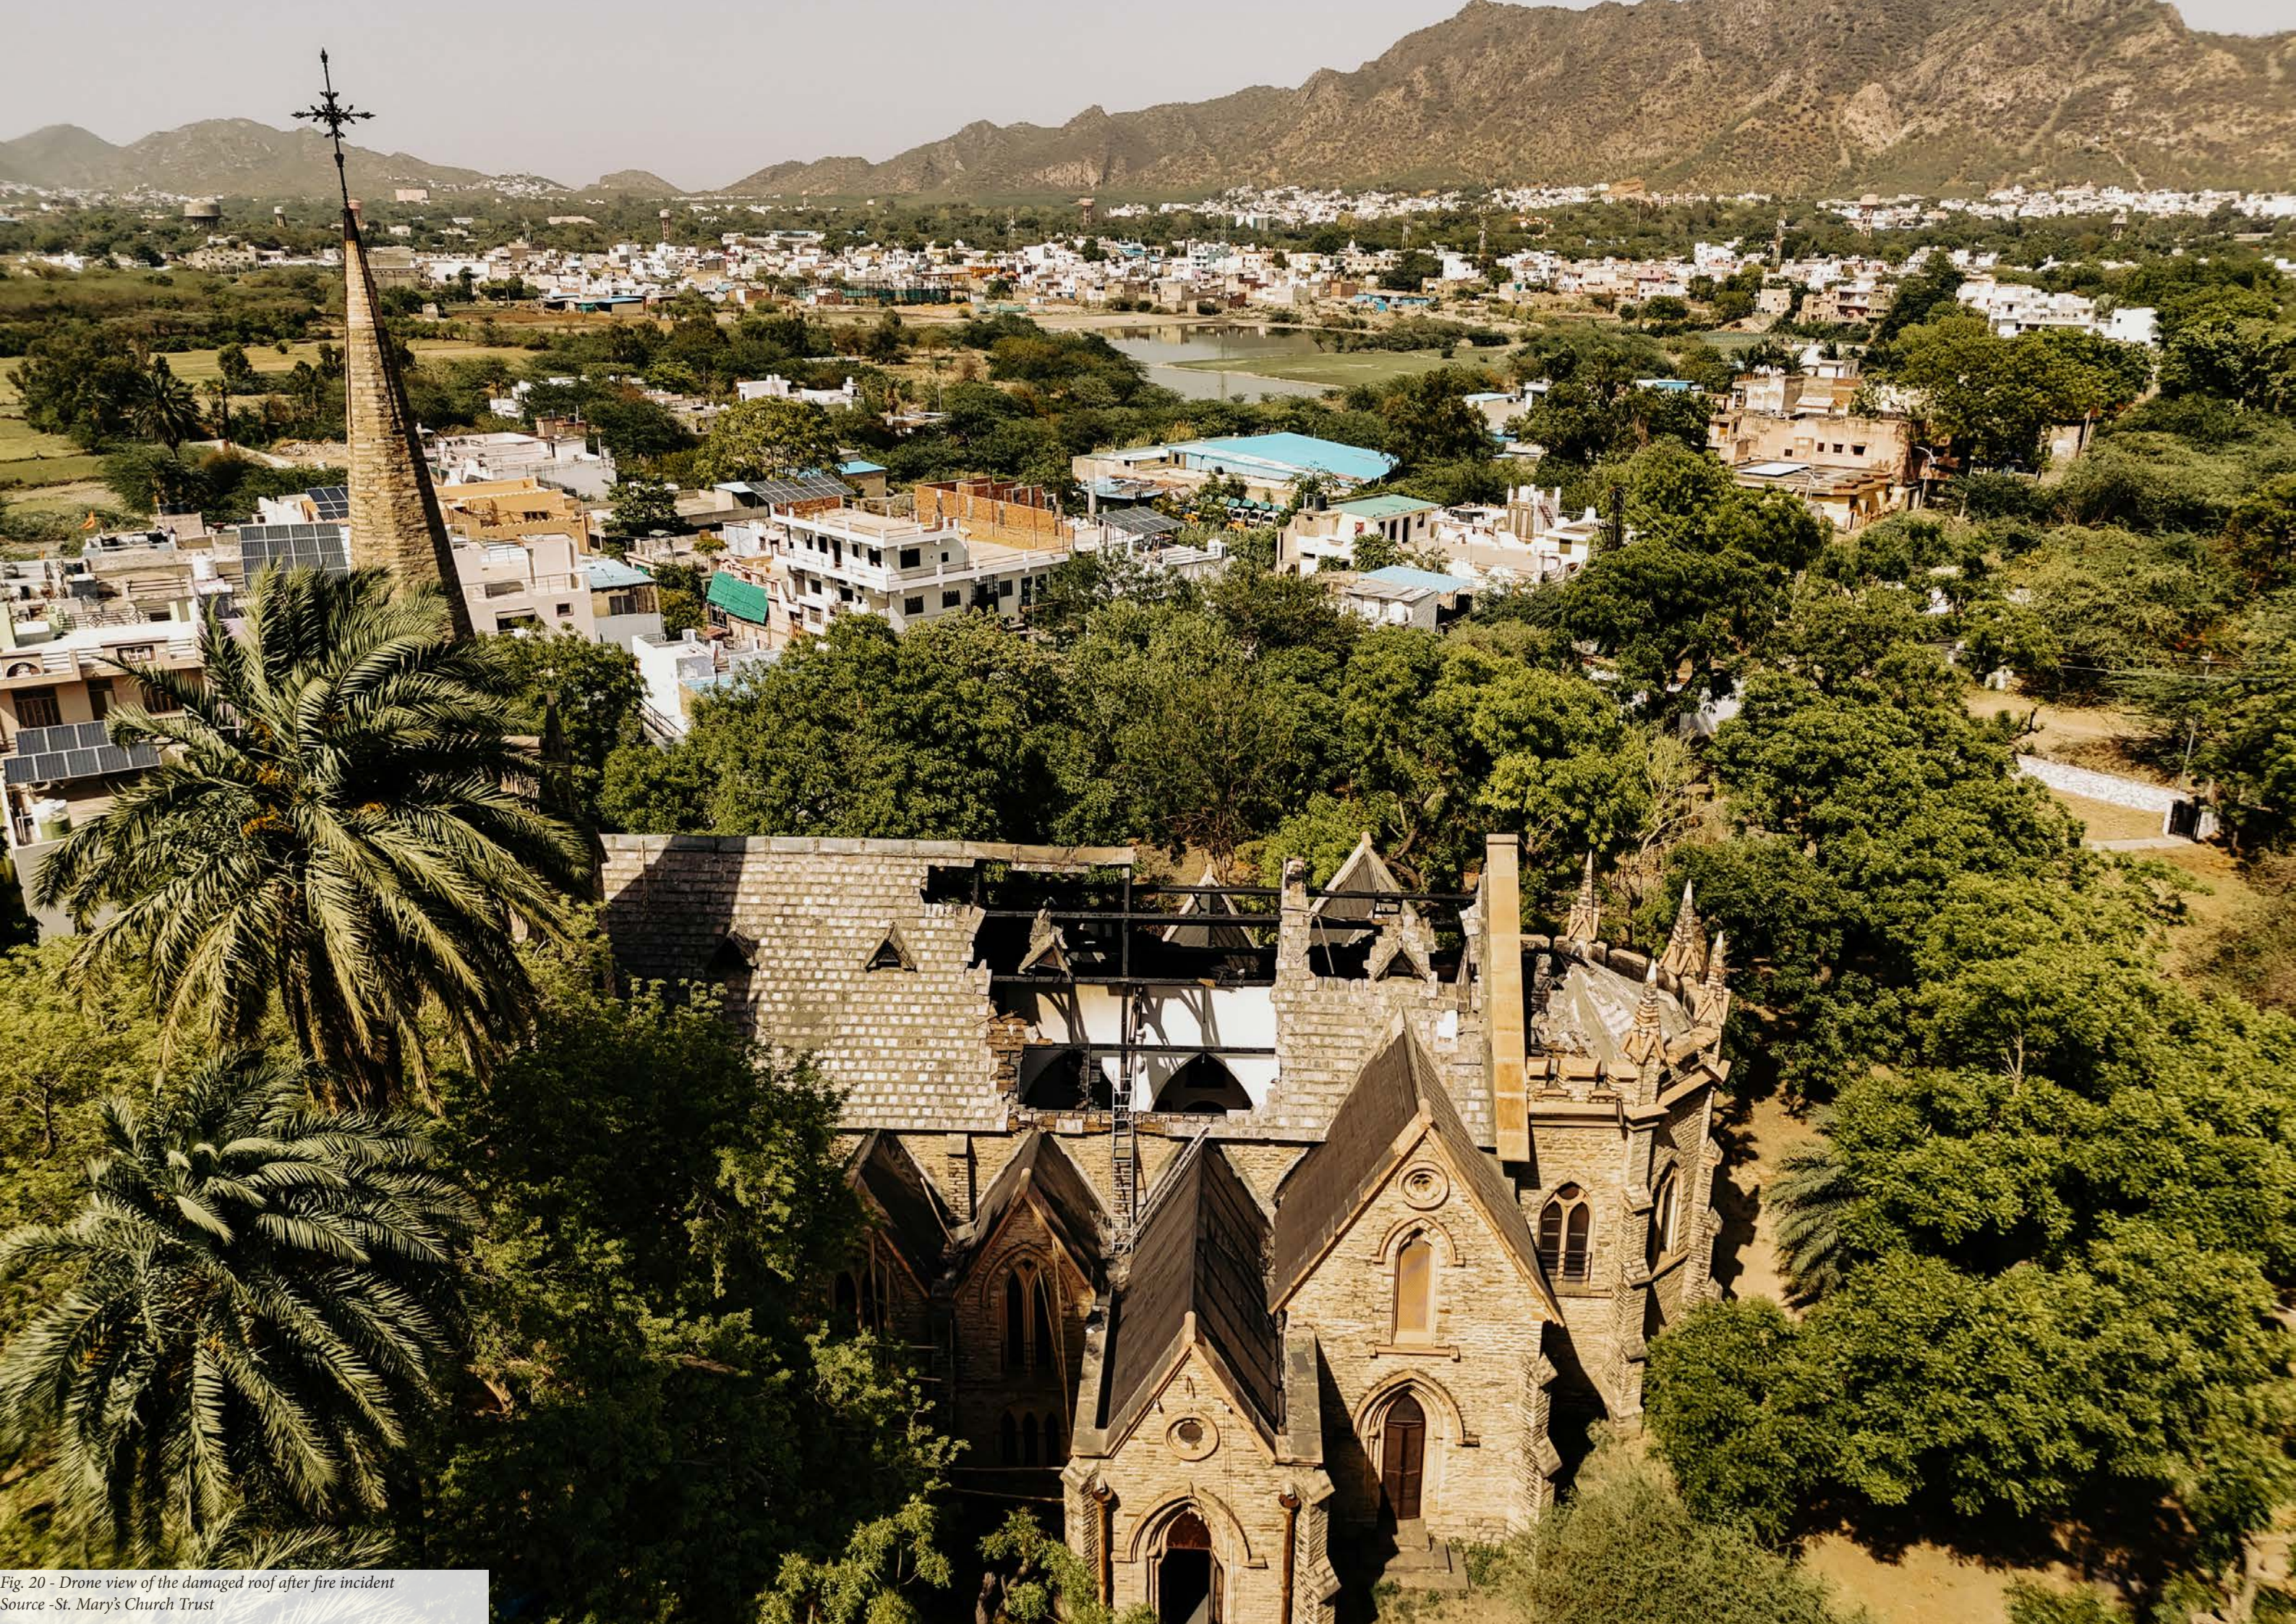
Fig. 20 - Drone view of the damaged roof after fire incident  
Source - St. Mary's Church Trust

The fire was detrimental to the church's overall condition. The fire have damaged the wooden trusses and beams of the roof, making the structure unstable. Signs of charred or cracked wood indicates compromised load-bearing capacity. Soot deposition is also visible on the walls and other elements. The church which is an important cultural center now stands non-functional due to the incident. The community's prayers is now being held outside the church under a temporary shed constructed as a gap area.

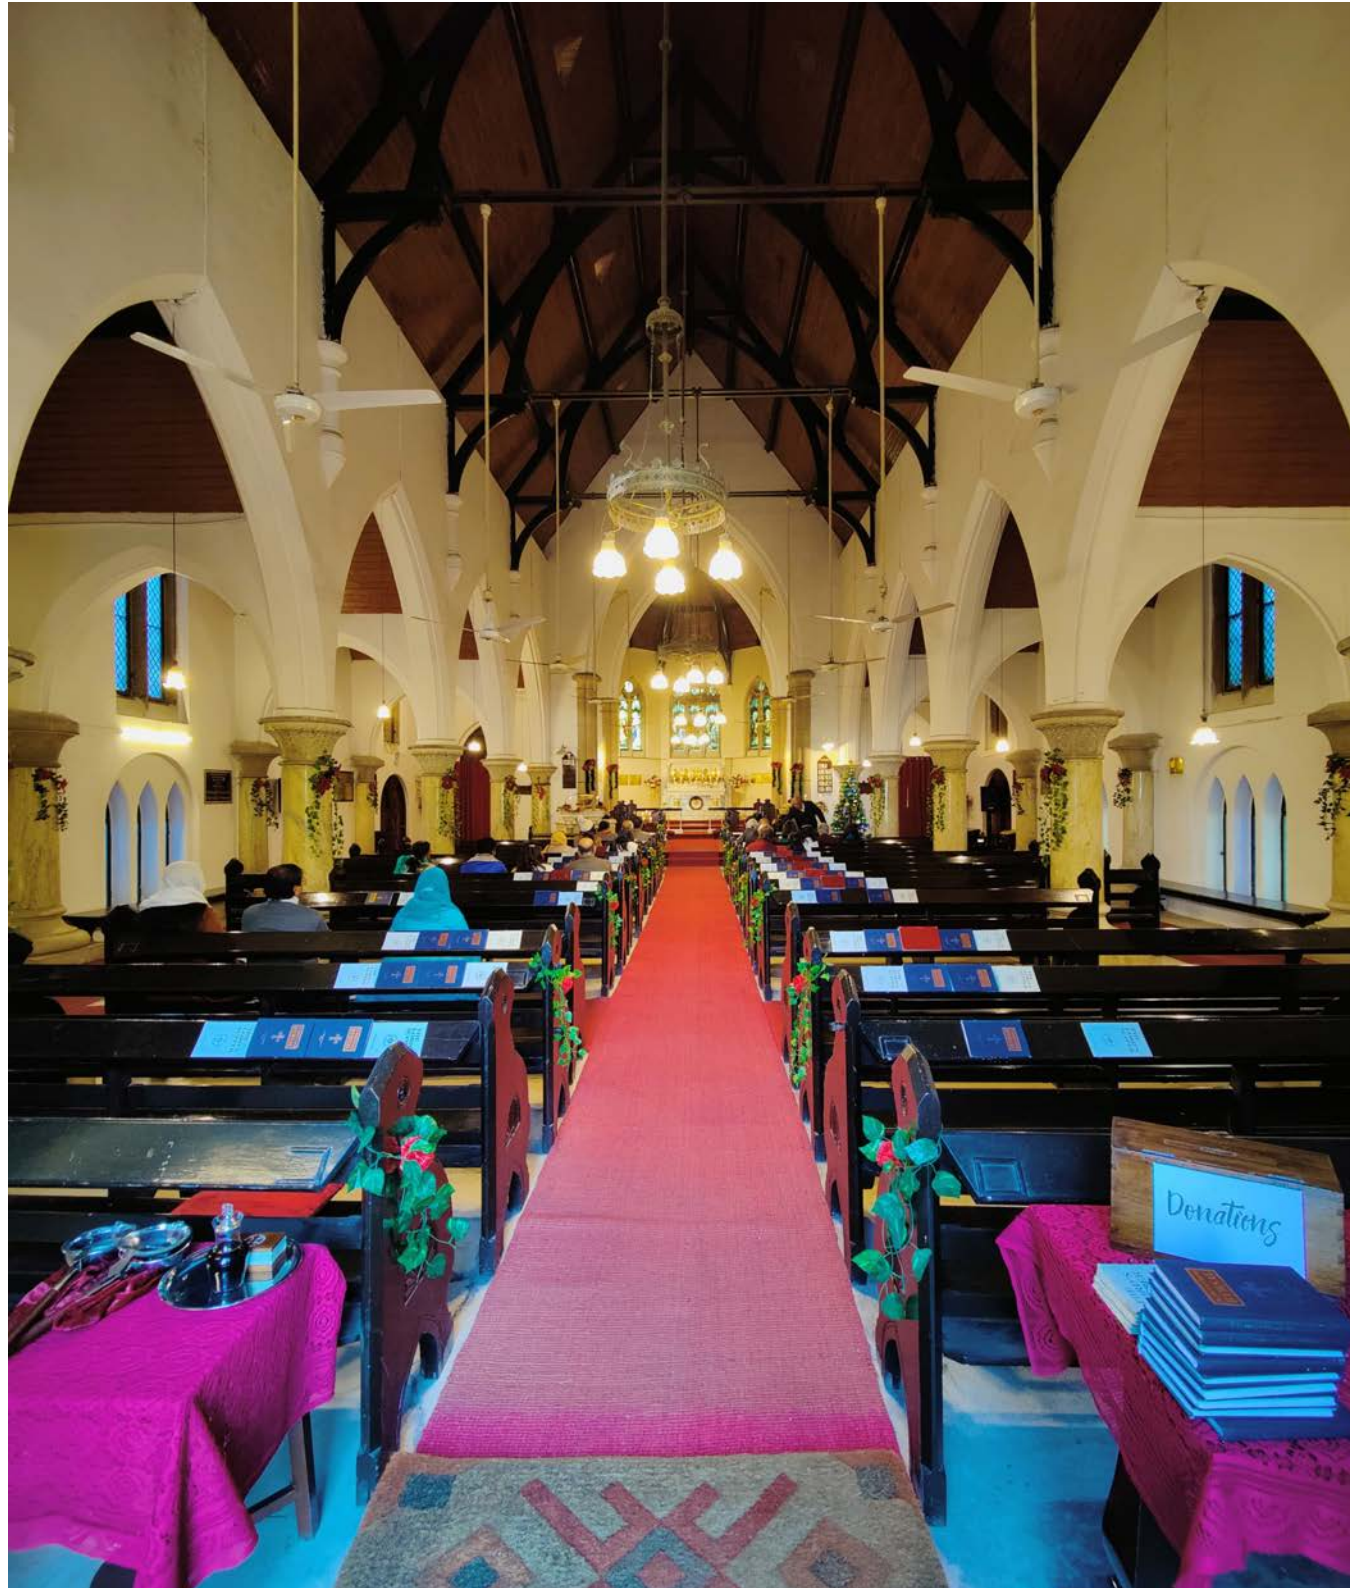
Fig. 21 - Before photo of the nave before the fire incident  
Source -St. Mary's Church Trust

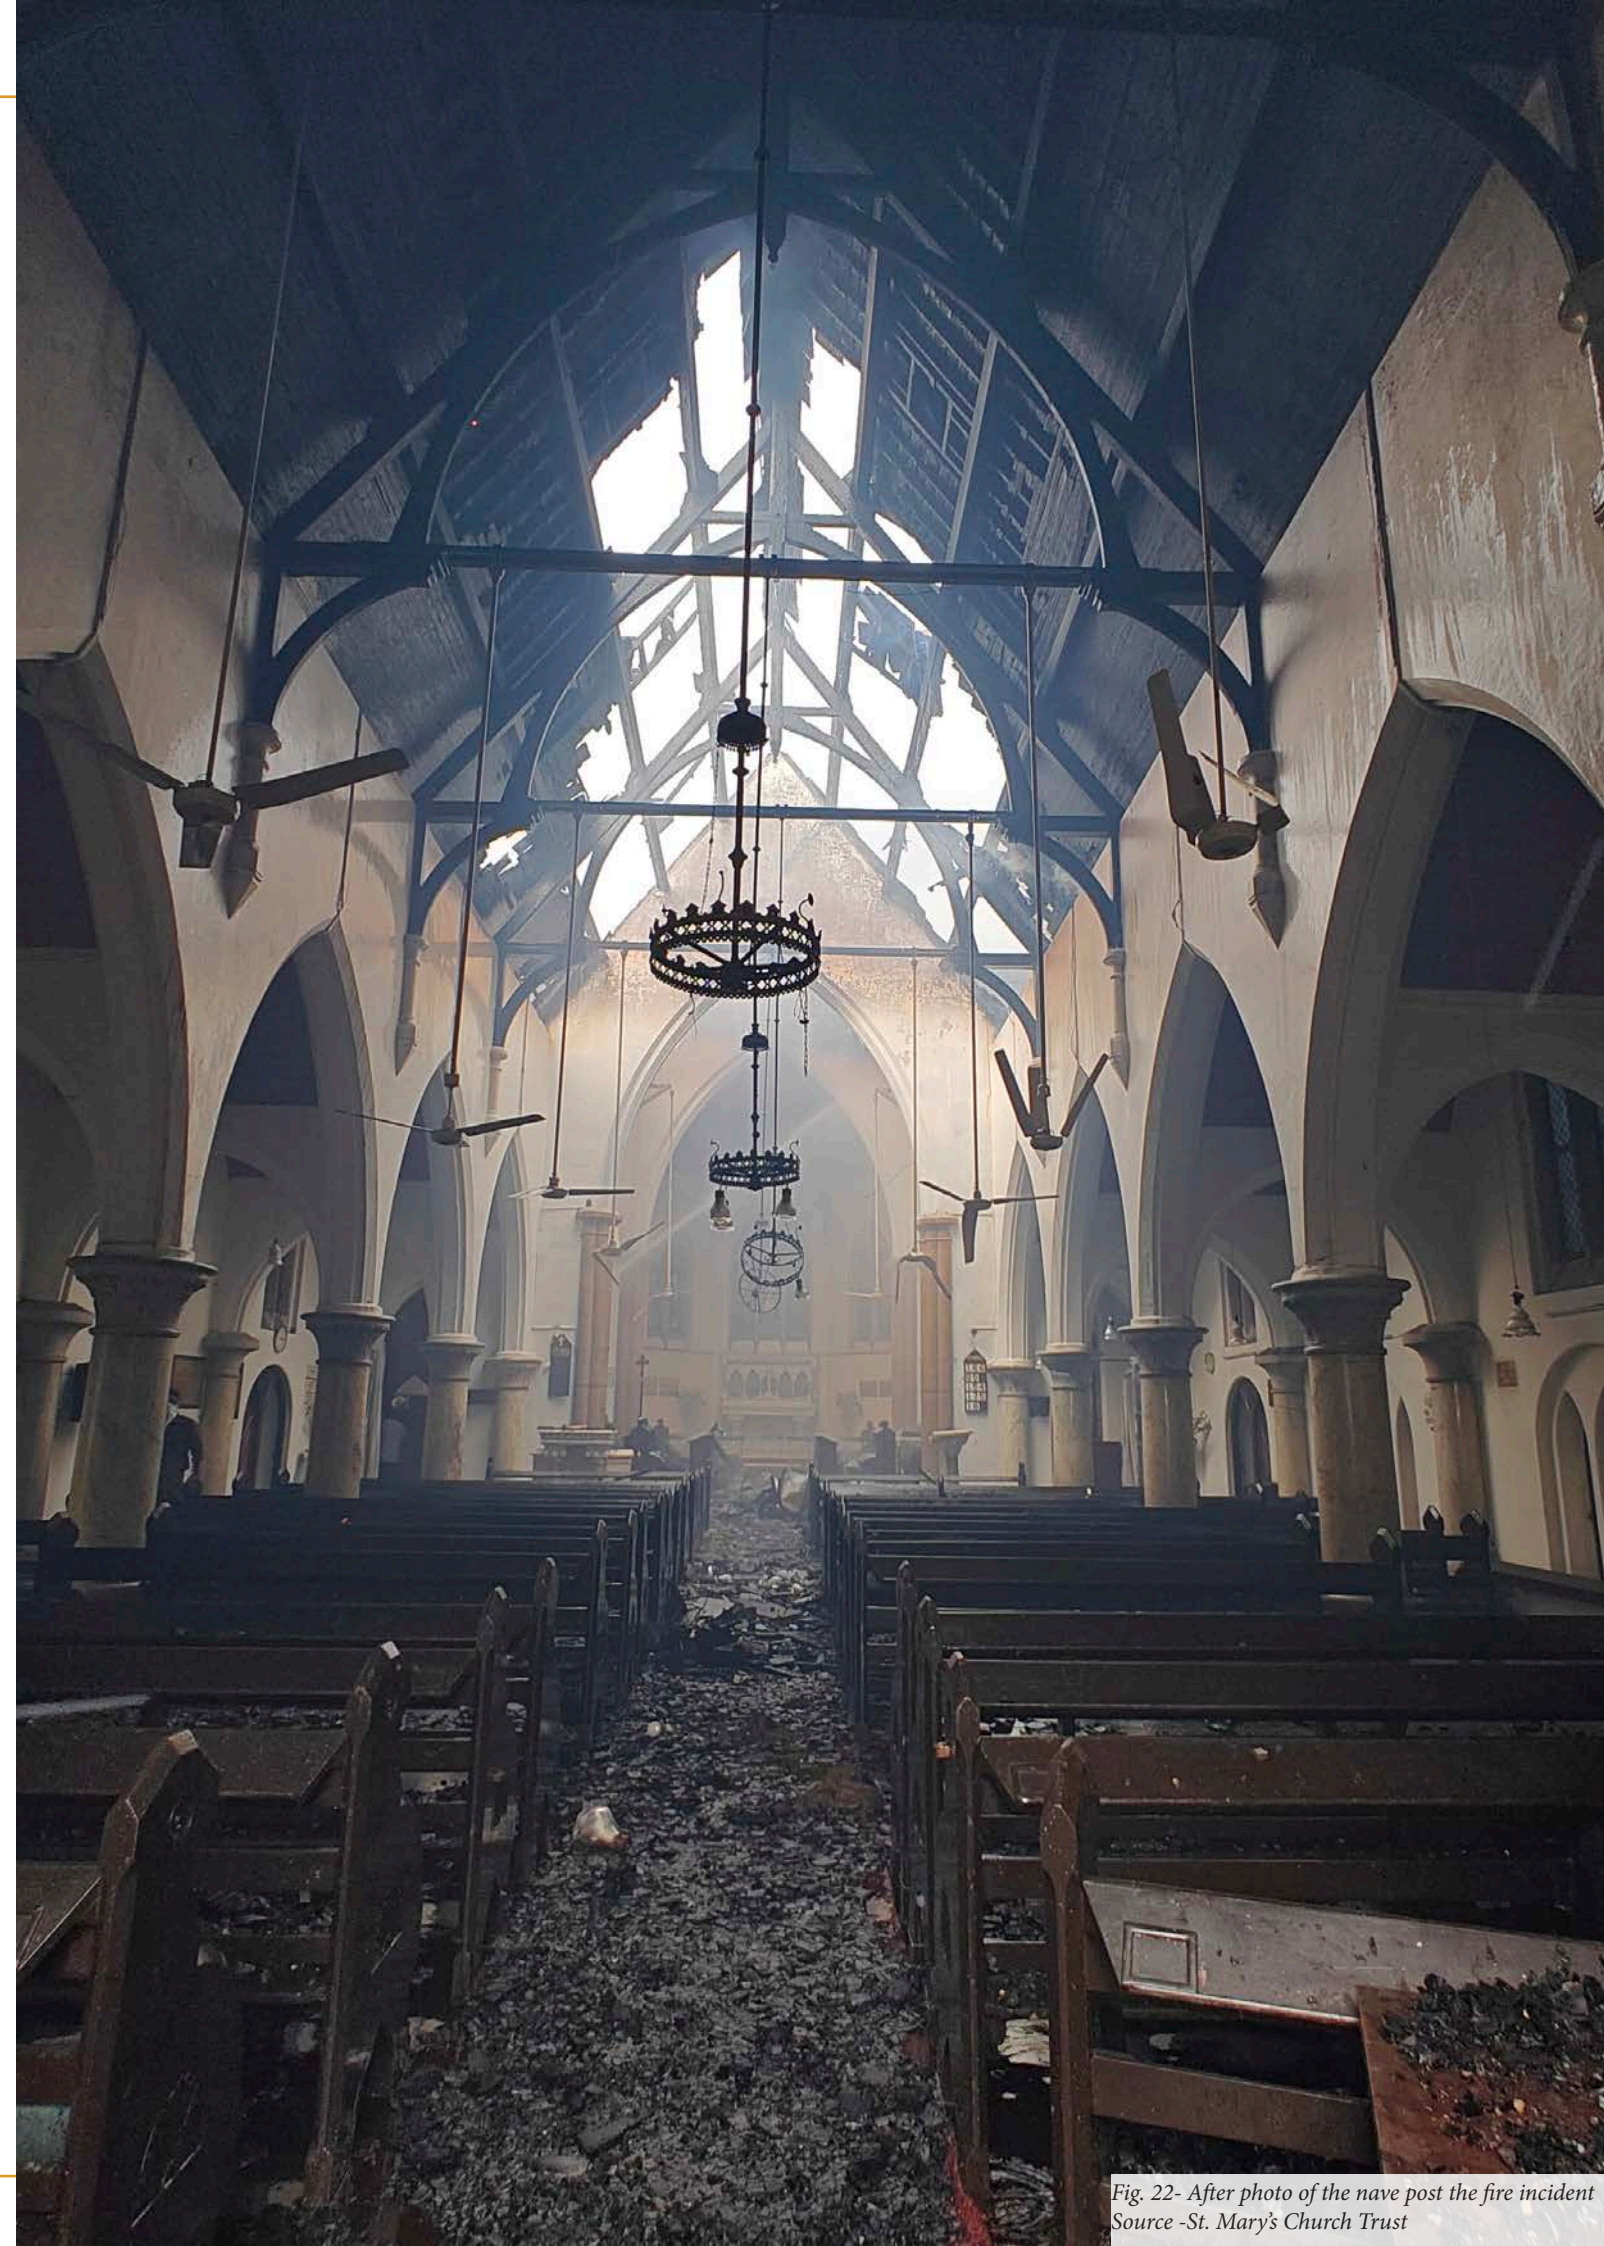
Fig. 22- After photo of the nave post the fire incident  
Source -St. Mary's Church Trust

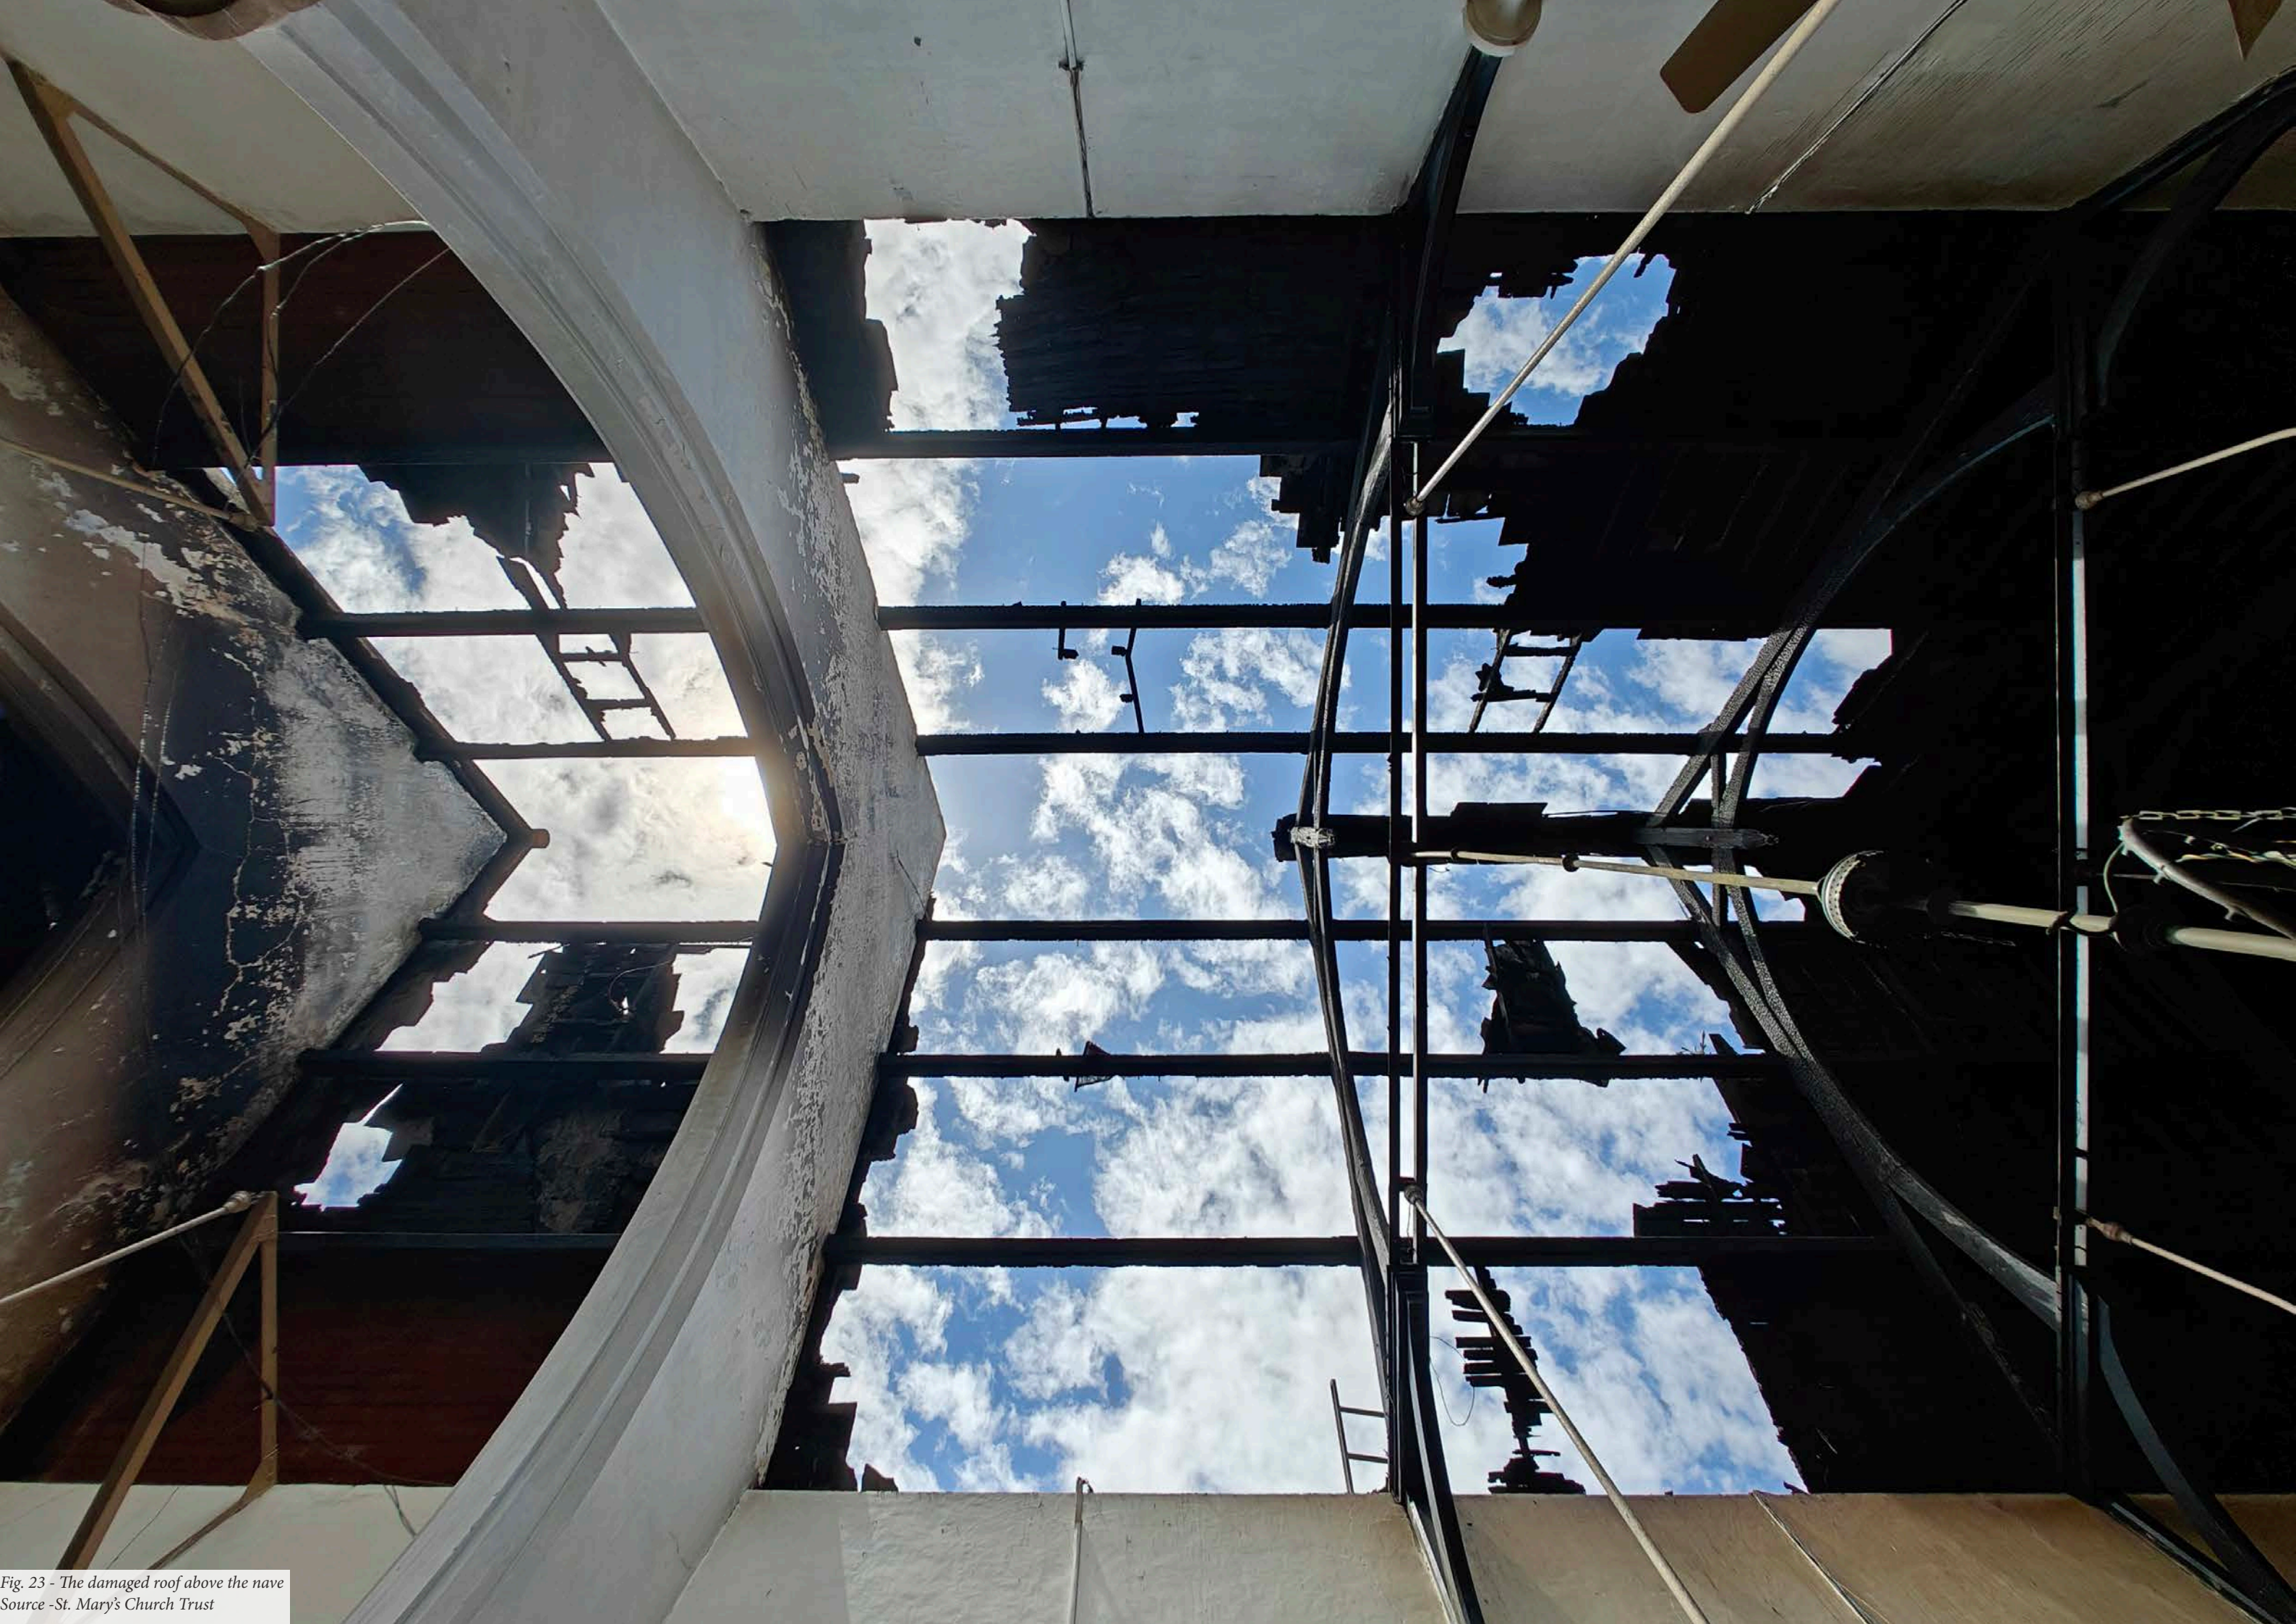
Fig. 23 - The damaged roof above the nave  
Source - St. Mary's Church Trust

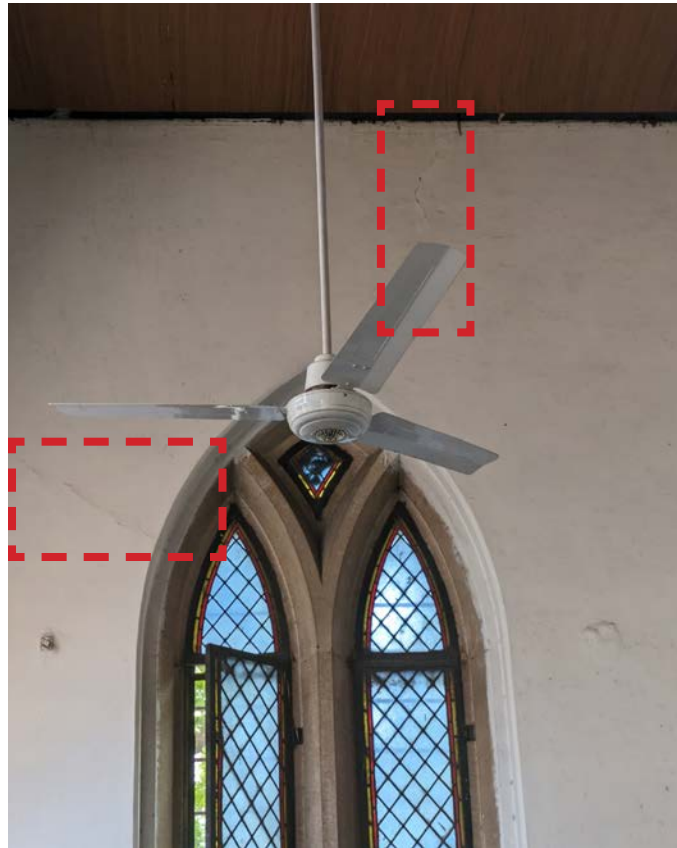
On visual inspection, cracks are only seen in the transept in the South eastern side. Some minor surface cracks can be seen on the lime plaster along with the peeling of the paint. The cracks need to be assessed in details to come up with consolidation plans. The structural members that are burnt, need scientific investigation to ensure their reuse back in the structure.

Fig. 24 - Cracks running diagonally along the wall

There is visible distress in the southeast corner of the structure, indicated by displacement in the stone joints, suggesting settlement issues. A detailed assessment is necessary to determine how to prevent further damage. The following steps are to be taken:

1. **Assessment:** Conduct a thorough evaluation of the affected area to understand the extent and cause of the settlement.
2. **Stabilization:** Stitching and Grouting: Stabilize the arches by stitching and grouting any cracks or fractures.
3. **Masonry Reconstruction:** Reconstruct any loose masonry using materials that match the original composition, color, and finish to ensure compatibility.
4. **Repairing Cracks:** Stitching/Anchoring: Repair any major fractures or cracks by stitching or anchoring them with additional compatible elements for enhanced stability.

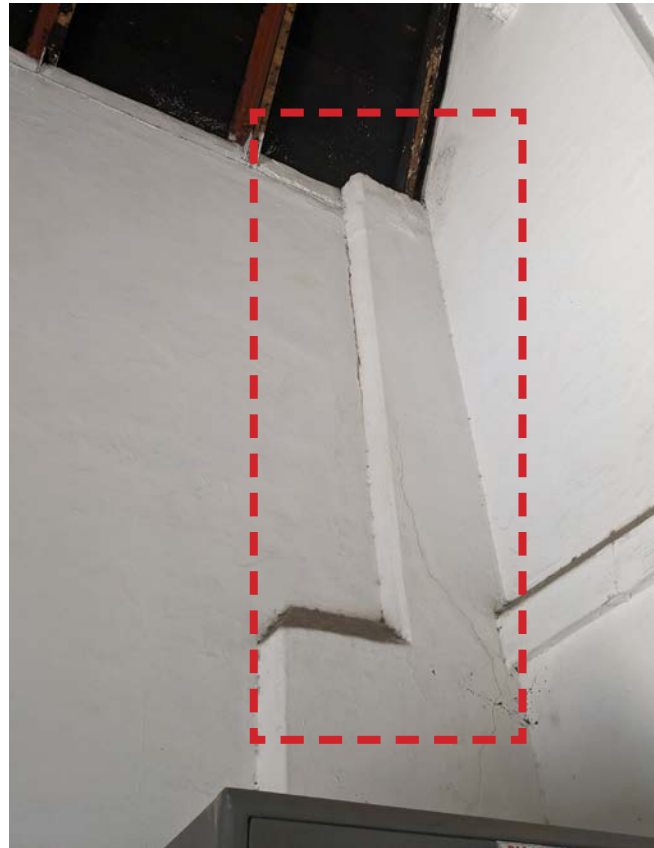
Fig. 25 - Cracks running vertically along the wall

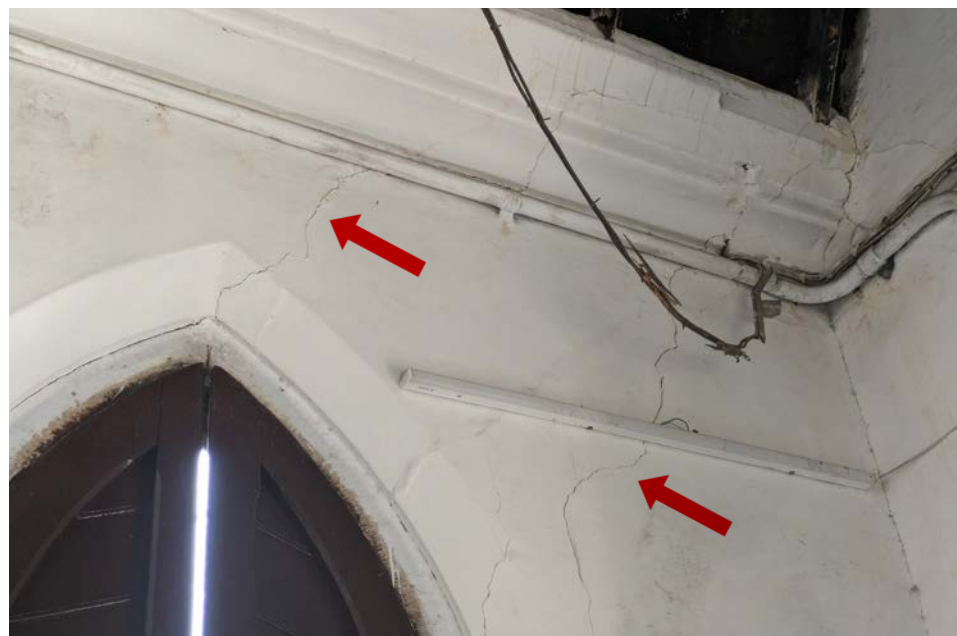
Fig. 26 - Cracks running diagonally along the wall and the cornice

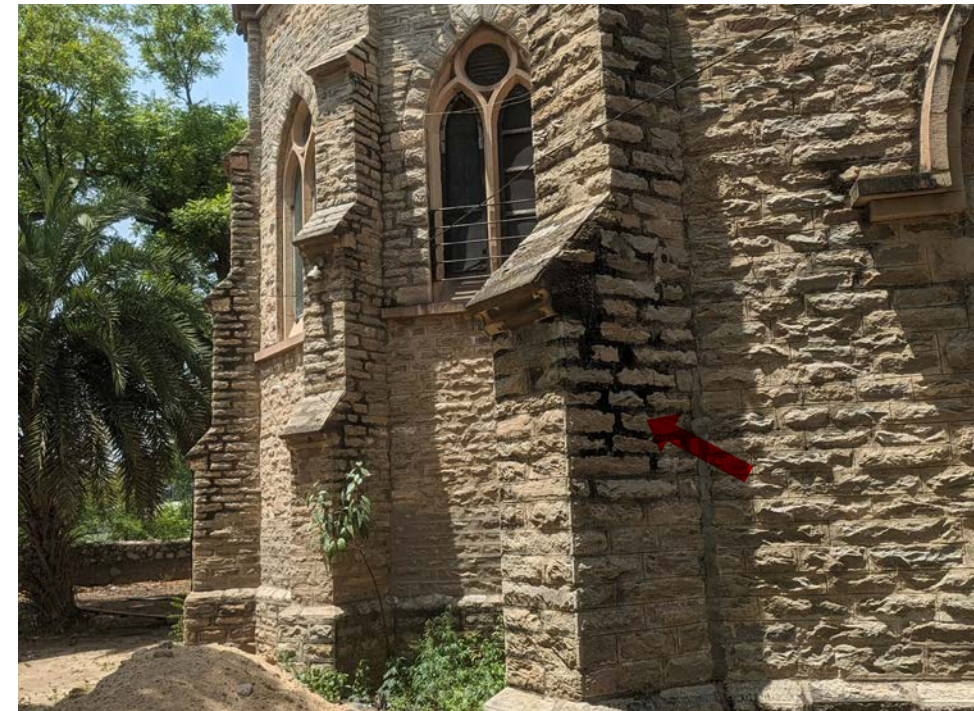
Due to exposure to moisture and lack of maintenance, vegetation growth and blackening of stone can be seen on the exterior stone masonry at several places. These surfaces need to be treated with mild chemicals with a biological wash from preventing it to occur in future.

Fig. 27 - Deposition of algae on the stone masonry

4. Raking out of joints that are done by cement and are to be re-pointed by lime.
5. **Surface Deposits:** Areas showing blackening require targeted cleaning methods. Initially, a biological wash will be applied to remove stains caused by organic matter. If these stains persist, micro sand blasting may be necessary to delicately clean the affected surfaces without causing damage.

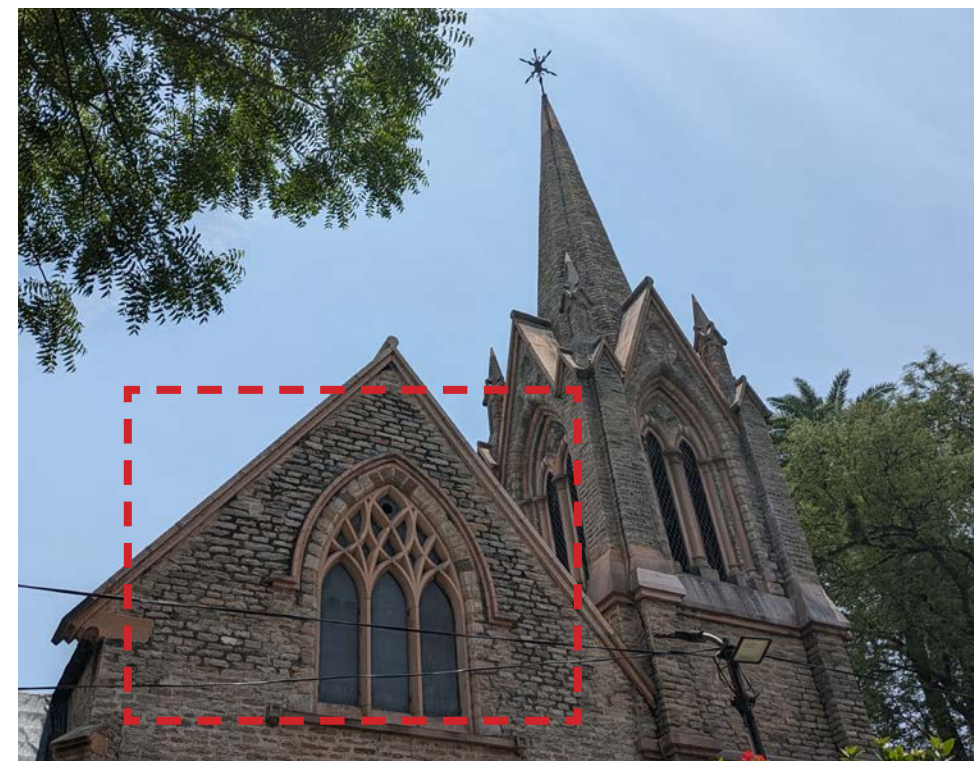
Fig. 28 - Deposition of algae on the stone masonry

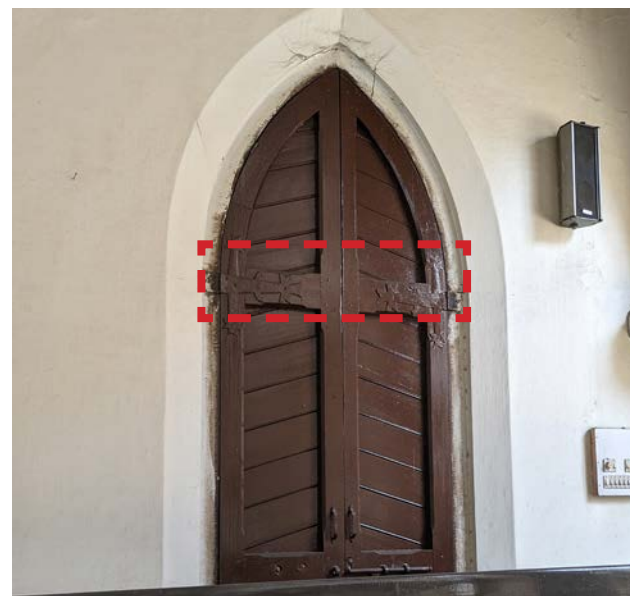
Various doors and windows have been painted over using brown emulsion paint. The application of enamel paint on wooden doors and windows is concealing the natural grain and texture of the wood, which is an essential aspect of the historical and aesthetic value of these elements. The emulsion paint is also covering the brass components and joineries, obscuring their metallic luster and intricate detailing.

Fig. 32 - Painted wooden windows and brass joineries

1. Minor in-situ floor repairs and cleaning of the marble stains of the ground floor are to be addressed.
2. Doors and windows painted with enamel paints will undergo a cleaning process to remove the existing paint layers. Following this, the natural finish of the doors will be restored, enhancing their original appearance and texture.
3. Lime plaster in certain areas is damaged, therefore minor spot repairs can be done.
4. Soot deposition has blackened the lime wash, a fresh coat of lime wash needs to be done.
5. Stained Glass painting restoration needs to be done on the window of entrance and at smaller sections of the aisle windows. The stain painting has hardened over time and needs to be taken out carefully and restored. Careful documentation is required to be done before starting any work on the stained glass.
